Master Thesis

Geological Conditions Favoring Extreme Scour of an Unlined Spillway at Ricobayo Dam, Zamora, Spain.

by Markus Kaspar

Graz, March 2012

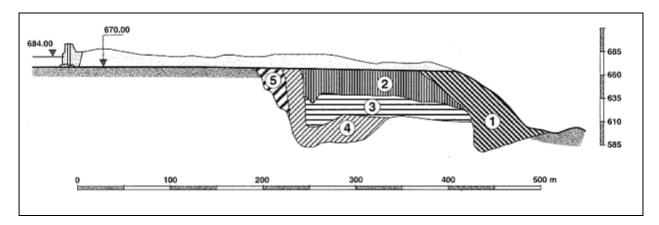
Fig.5 7: Illustration of the 5 main stages of scour at the spillway. Note steepening of the natural rock slope and progressive upstream movement of erosion towards the reservoir (Guia Tecnica, 1997)

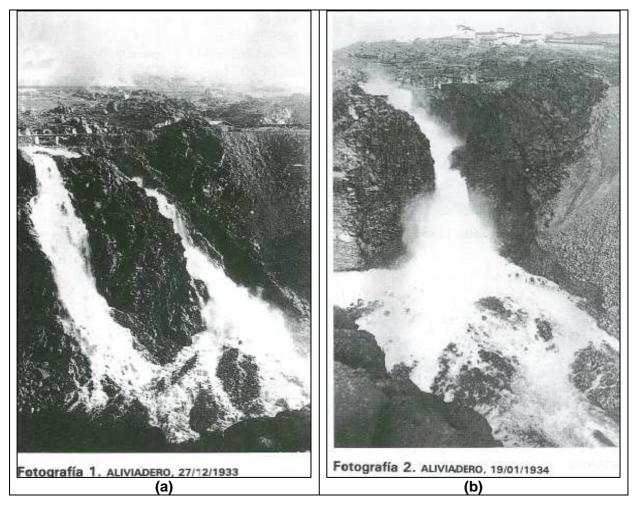
Fig.5 8: The first major scour at the Ricobayo spillway. (a): View to the original front slope of the spillway in the first month of operation. The water flow was discharged unregulated over bare rock. (b): The original slope is already eroded after one month of operation leaving a gorge behind as the water works its way towards the reservoir (Pictures: Guia tecnica, 1997).

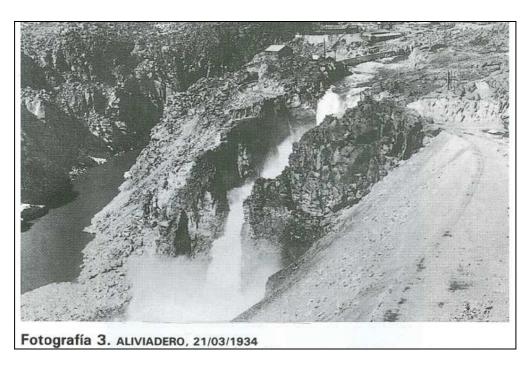
Fig.5 9: An approx. 200m long gorge has developed working its way back to the reservoir

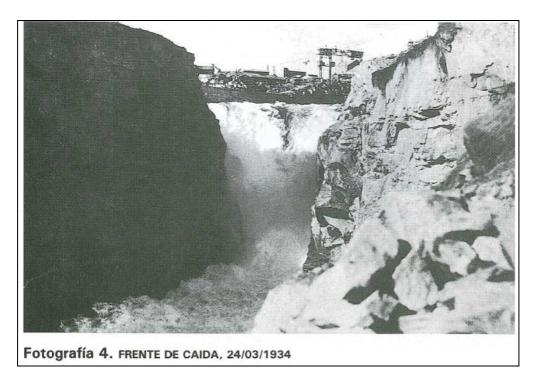
Fig.5 10: Situation of the spillway during the 2nd major scour stage in March 1934. View upstream into the gorge. Sidewalls are almost vertically inclined and the front slope has steepened up compared to its original state, to form a waterfall at the exit of the spillway (Guia tecnica, 1997).

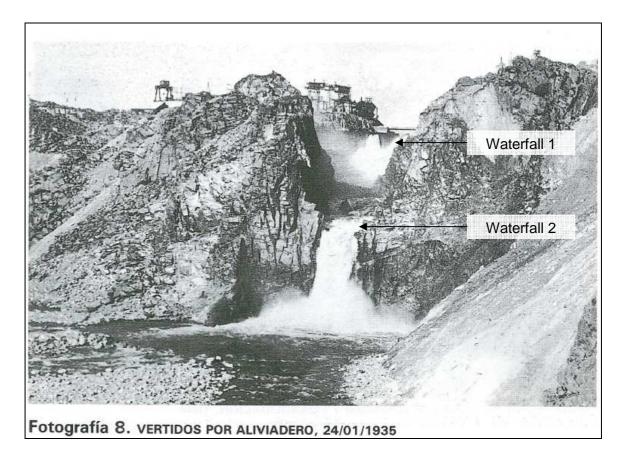
Fig.5 13: Situation of the spillway in 1935. Water release in January. By that time two waterfalls are developed. One in the back at the front slope of the spillway, the second one at the exit of the gorge. (Guia tecnica, 1997).

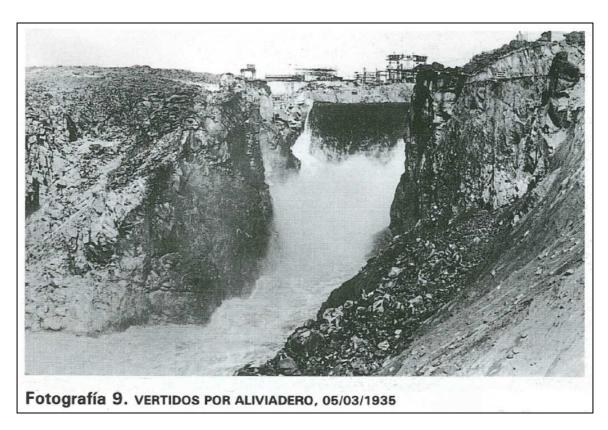
Fig.5 14: Only about one month later the vertical erosion has abraded the bottom of the channel. The second waterfall has disappeared (Guia tecnica, 1997).

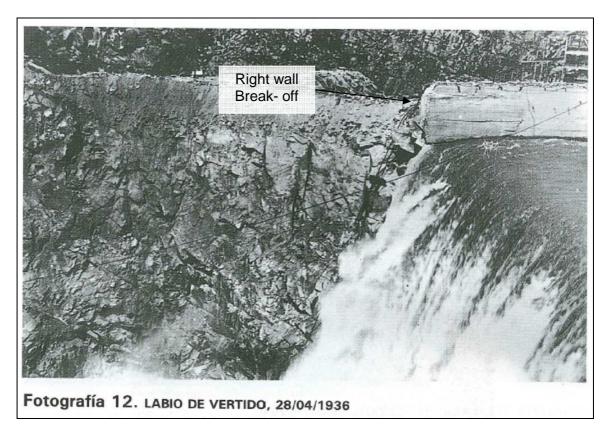
Fig.5 16: Look to the right wall of the plunge pool while the spillway is operating. The wall is already destroyed and the water impacting again right at the toe of the slope. Parts of the right sidewall are also damaged (Guia tecnica, 1997).

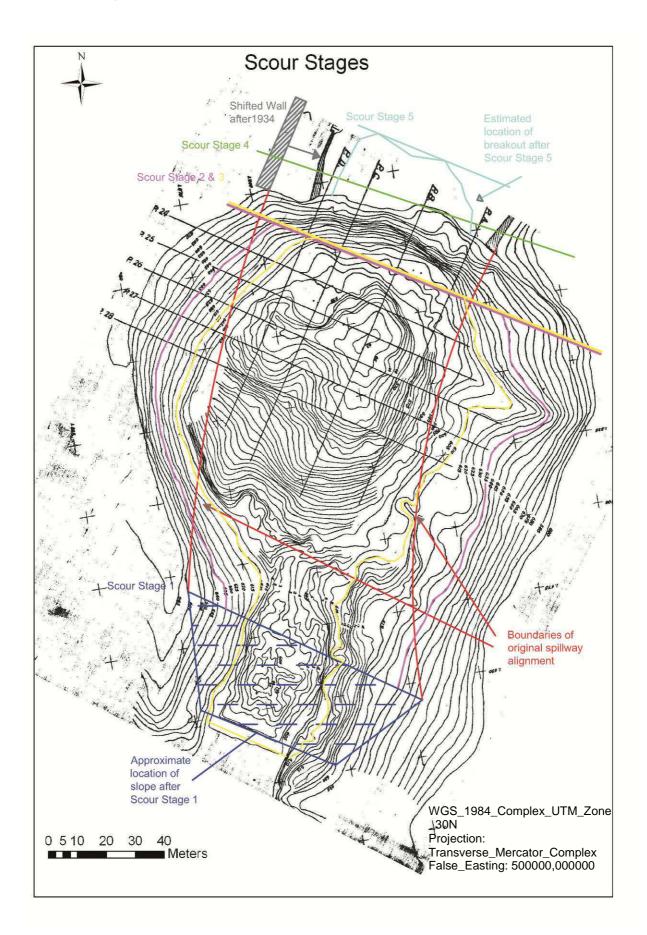
Fig.5 17: Shape and topography of the plunge pool without concrete. Note the deep hole right where the overtopping water impacted the rock. Profile lines are meaningless in this figure (Modified after Iberduero S.A, 1937)

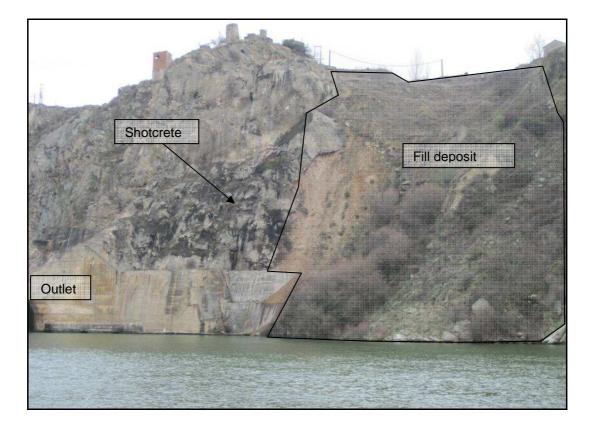
Fig.6 14: View to the fill deposit right at the end of the outlet of the plunge pool. Some raveling occurred where the shotcrete failed.

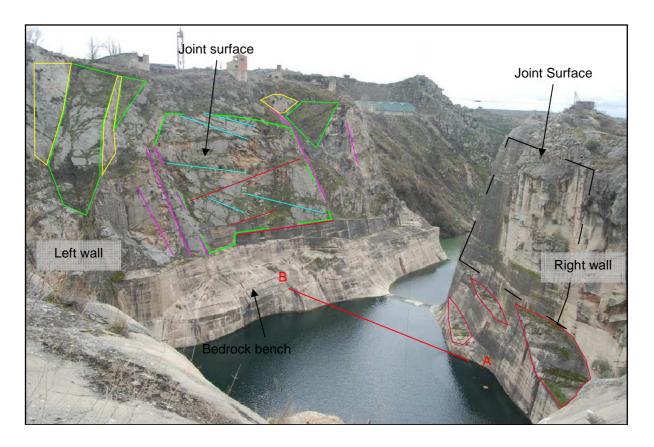
Fig.6 33: View into the plunge pool. The left wall provides a large scale exposure of the rock at the site showing the joint patterns. Joint set colors refer to those of Tab.6.8. Note that failure plane on the left wall is bound by Joint set 4 and its surface follows approx. the orientation of joint set 2. Red line indicates location of profile shown in Fig.6.35.

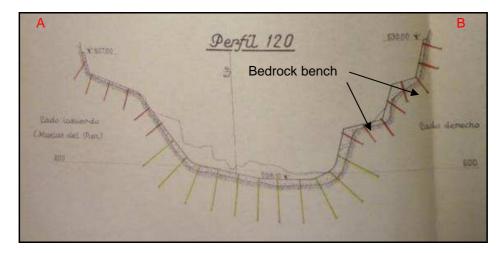
Fig.6 34: Transverse profile through the entrance of the outlet (view upstream). Plans from the 1940s show the original topography of the pool with step like bedrock terraces (straths) and the performed repair works(red and yellow anchors) (Iberduero S. A, 1940).

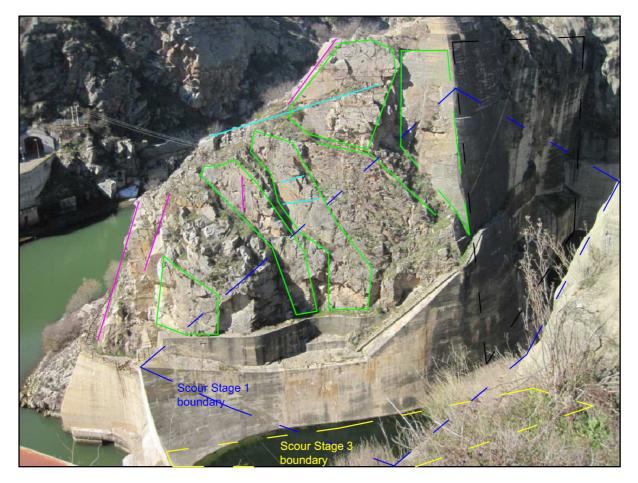
Fig.6 35: Right wall at the outlet channel downstream of the plunge pool. The wall exposures the joint pattern in this area where the first and third scour stage had occurred. Blue dashed line indicates approximate slope orientation after scour stage 1, yellow dashed line after stage 3. Joint set colors refer to those of Tab.6.9.

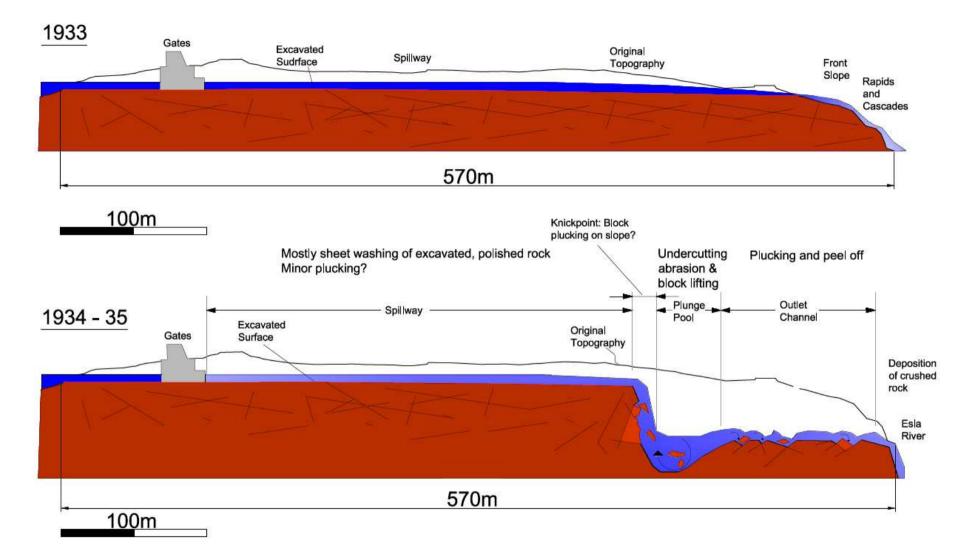
Fig.8 2: Schematic profiles illustrating the scour processes believed having shaped the appearance of the spillway in the years between 1933 and 1934 – 35, respectively.
