# Seismic Safety Aspects of Gated Spillways of Large Storage Dams

**Martin Wieland<sup>1</sup>, Sanaz Ahleghagh<sup>2</sup>**

**1.Chairman, ICOLD Committee on Seismic Aspects of Dam Design, c/o Poyry Switzerland Ltd.,  
Herostrasse 12, CH-8048 Zurich, Switzerland**

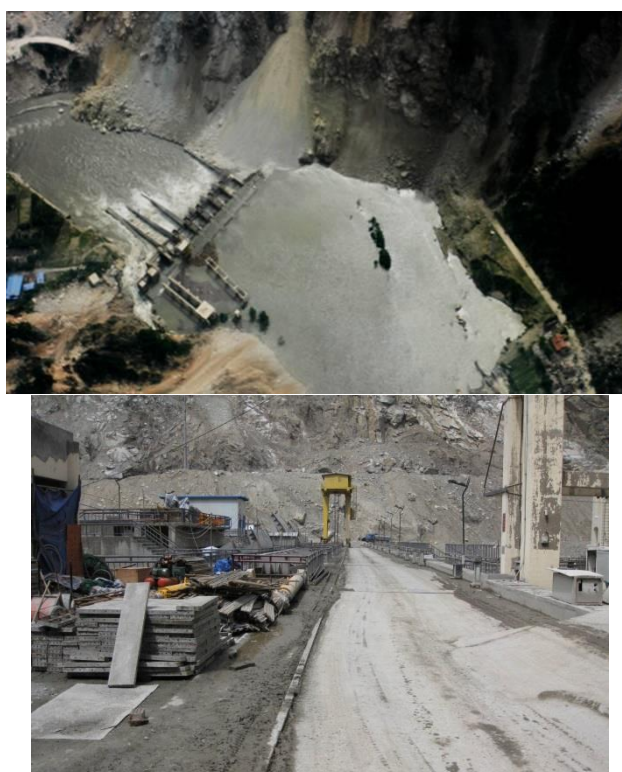
**Figure 1. Overtopping of run-of-river power plant due to failure of gate operation (left) and mud deposited on crest of overtopped run-of-river power plant (right) (Wenchuan earthquake in China)**

In most gated spillways, the gates are of the same type; therefore, if a gate or its electro-mechanical components should be damaged by ground shaking, then the other gates may have the same problem. Therefore, the redundancy principle, which is important in any probabilistic safety analysis, no longer holds and the probability that one or all gates fail during a strong earthquake is the same. This can also be seen in Fig. 1.

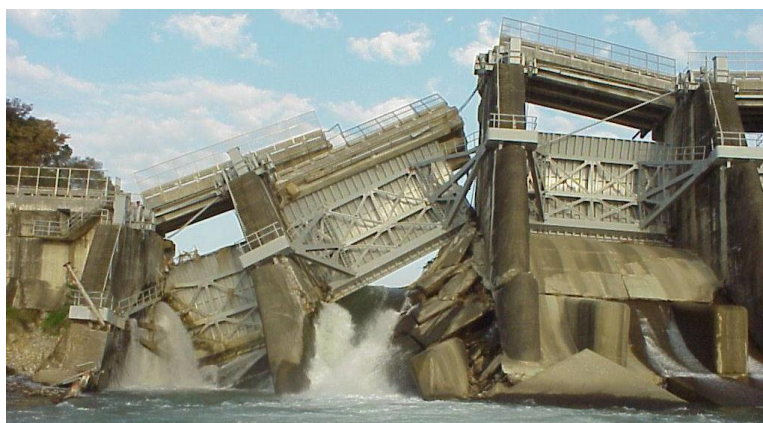
**Figure 2: Failure of two bays of the Shih-Kang weir caused by (mainly vertical) fault movements during the 1999 Chi-Chi earthquake in Taiwan**

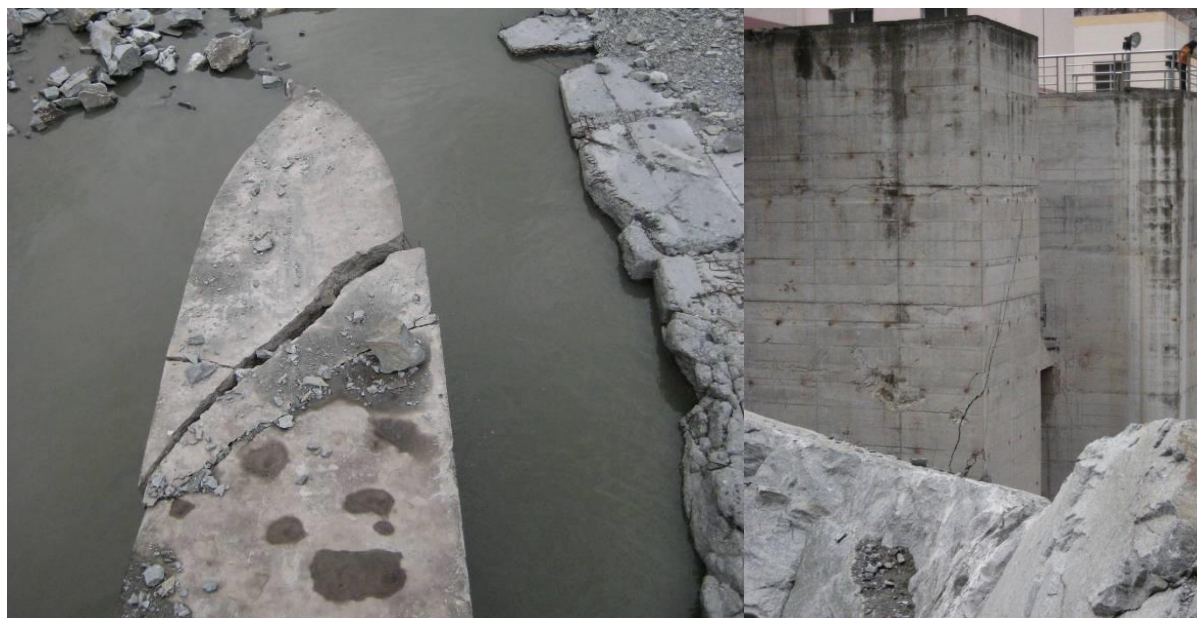
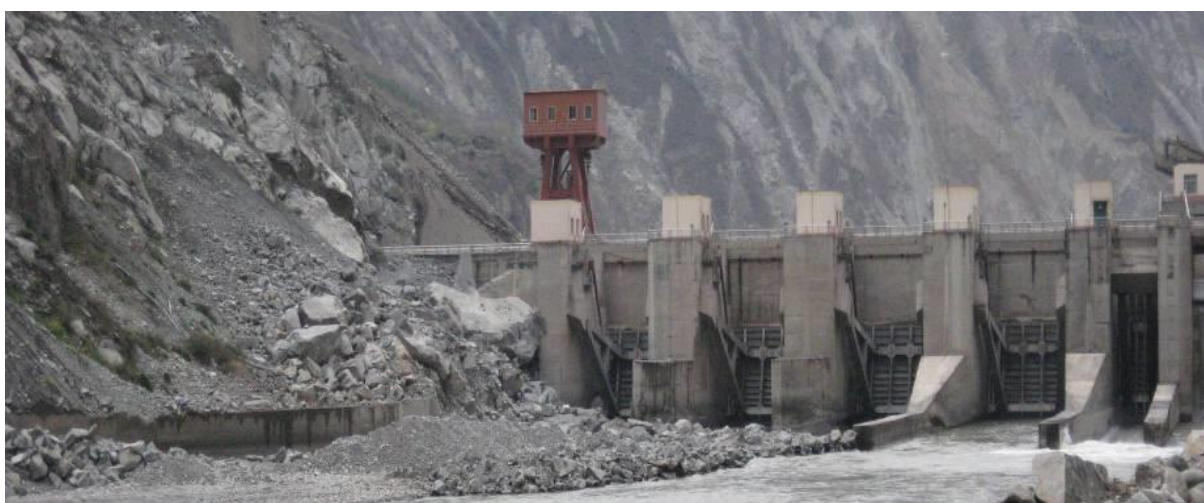
**Figure 3: Damage of spillway piers caused by rockslides during the 2008 Wenchuan earthquake in China**

Figure 3 shows damage of spillway piers caused by mass movements during the Wenchuan earthquake. Mass movements are also visible in Fig. 1. Rockfalls are, however, a major problem for the unprotected electro-mechanical equipment of spillway gates and can also cause failure of radial gates as shown in Fig. 4. Mass movements can also block the spillway chute or in tunnel spillways the portal zones are those, which can be blocked or damaged by rockfalls.

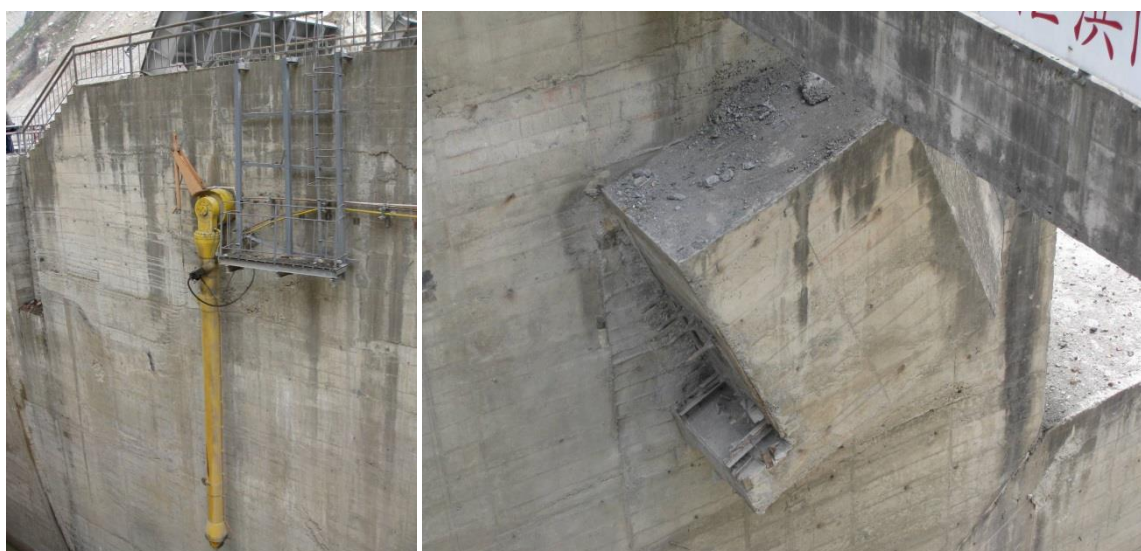
**Figure 4: Left-over of radial gate destroyed by rockfall during Wenchuan earthquake in China [5]**

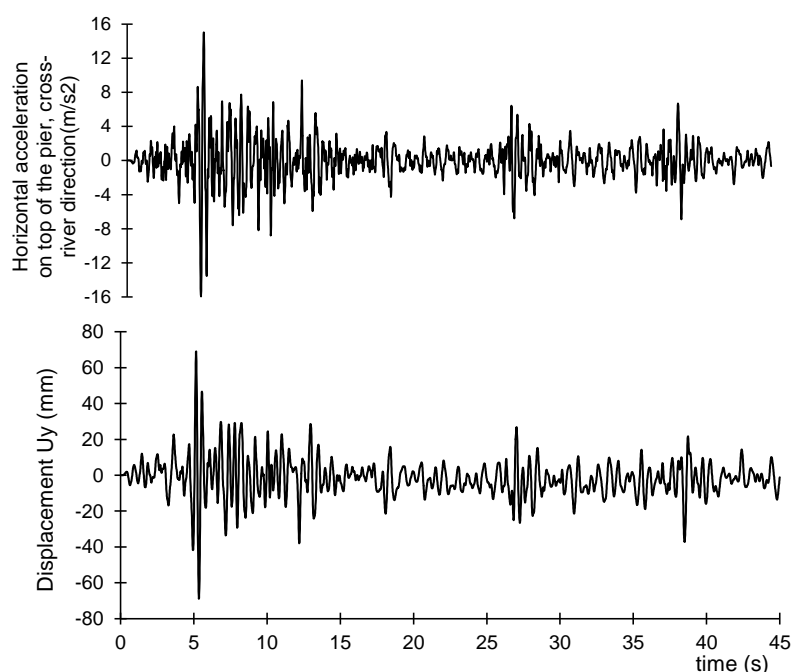
The linear elastic dynamic analysis of the pier was carried out using three different acceleration time histories. Fig. 7 shows the time histories of the absolute acceleration and displacement in cross-river direction on top of the pier for one of the three ground motions. The maximum value of absolute acceleration is about 1.6 g, which is about 2.5 times the peak ground acceleration. The maximum top displacement of the slender pier is about 70 mm.

**Figure 7: Time histories of absolute acceleration (top figure) and relative displacement (bottom figure) in cross-river direction on top of the spillway pier**

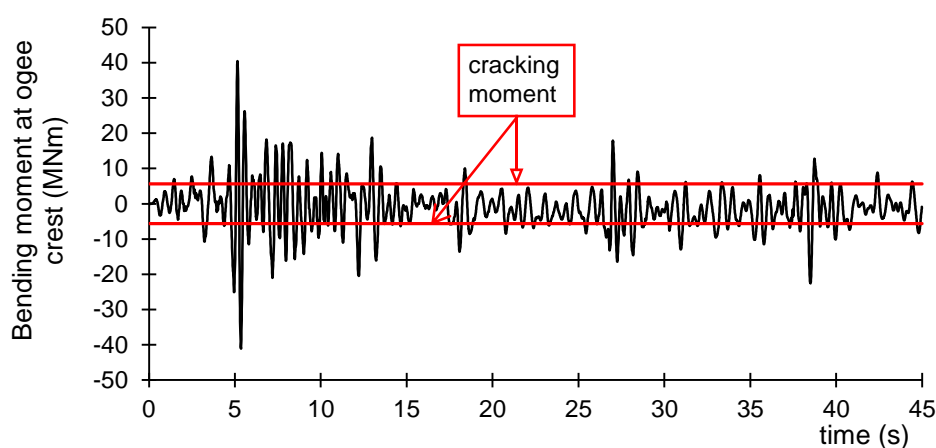
Figure 8 shows the time history of the bending moment in the spillway pier at the ogee elevation as well as the dynamic cracking moment. For the axial compressive force of 1000 kN, the dynamic cracking moment of the 3.0 m thick concrete pier is 5600 kNm/m.

The spillway piers were normally reinforced with minimum temperature and shrinkage reinforcement. In the analyzed prototype the reinforcement at the location of the maximum bending moment (near the ogee crest) is diameter 25 mm at 200 mm spacing. For this section the nominal moment capacity of reinforced concrete section is less than the cracking moment of concrete. As yielding and nominal moment capacities of the pier are less than the cracking moment, brittle failure is expected.

**Figure 8: Bending moment time history at bottom of pier, dynamic cracking moment is shown in red**

The high deformations obtained from the dynamic analysis and high flexural demands signify the necessity of strengthening of the spillway piers.

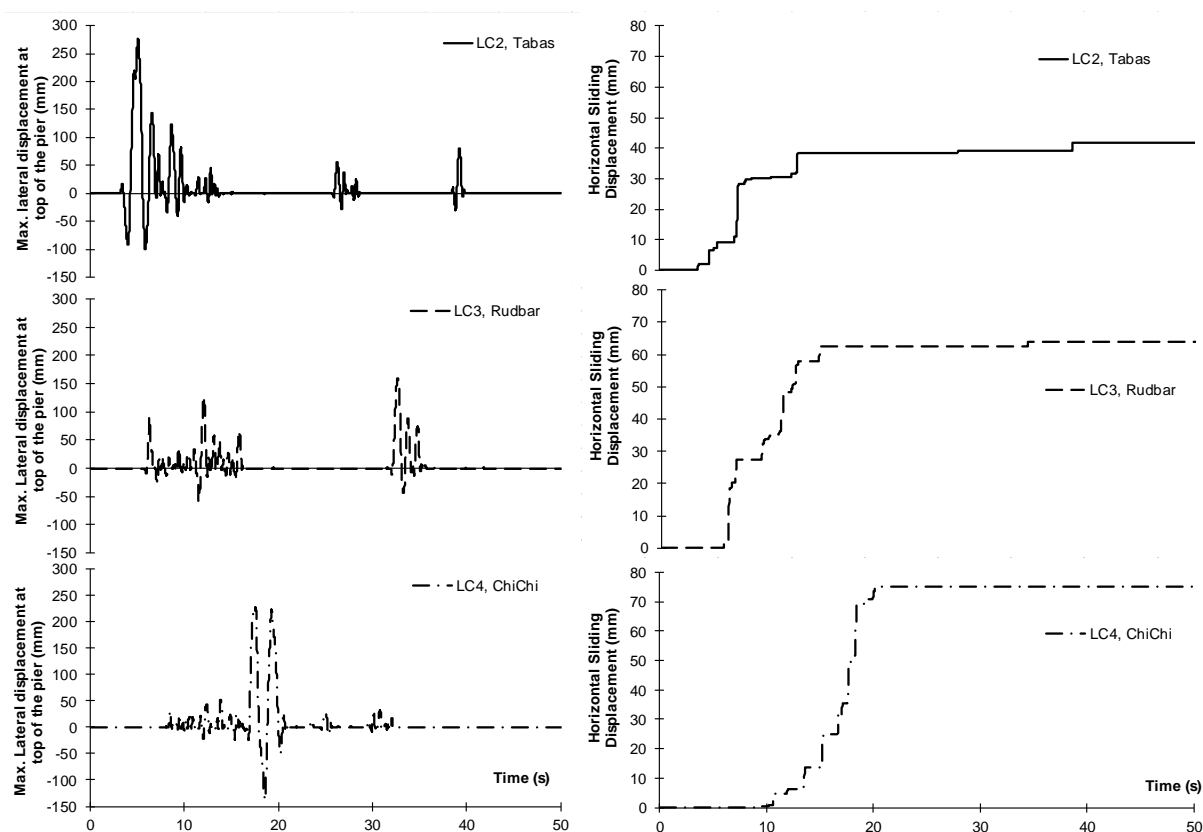
Figure 9 shows the maximum cross-river displacement at the top of the detached pier obtained from a rigid body rocking analysis due to three sets of earthquake time histories. The maximum cross-river displacement varies from about 170 to 280 mm and occur at different times. In this figure also along-river sliding displacements obtained from a rigid body sliding analysis due to three sets of earthquake time histories are shown. The maximum residual displacement of about 75 mm is estimated assuming that the ogee block under the pier will not experience any displacements in case of earthquake.

From Fig. 9 it can be clearly seen that after the earthquake there is no residual tilting of the pier, however, sliding is a cumulative process, which continues if the duration of strong ground shaking would be extended. This is not the case for the rocking motion where the duration of strong ground shaking has hardly any effect on the maximum cross-river displacement.

These rigid body displacements may be different at the two supporting piers of the radial gate and may lead to gate damage and/or jamming of the gate.

**Figure 9: Rocking motion and sliding displacement of detached concrete pier: Time histories of cross-river displacement at top of spillway pier (left) and along-river sliding displacement (right) due to three spectrum-matched acceleration time histories with peak ground acceleration of 0.65 g**
