STAMP Modeling of the Accident

N4252G

MASTER'S THESIS to achieve the university degree of
Master of Engineering

Master's Degree Program: Traffic Accident Research - Aviation Safety

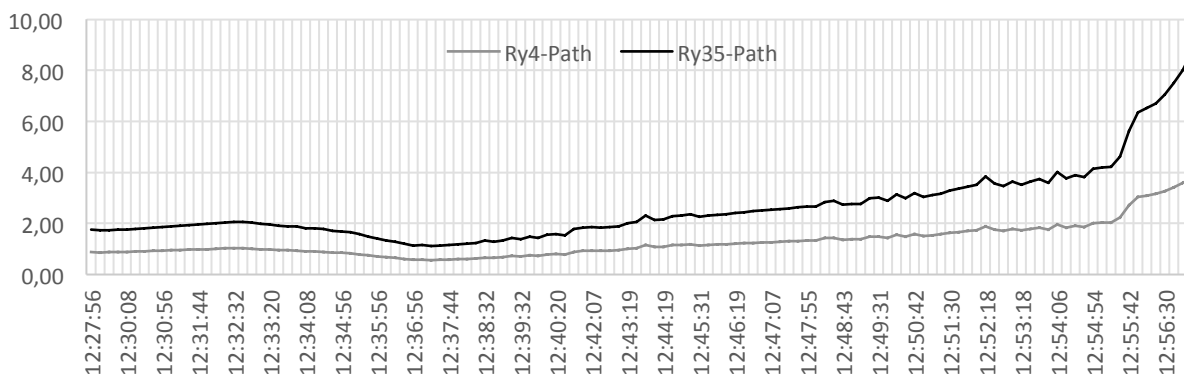
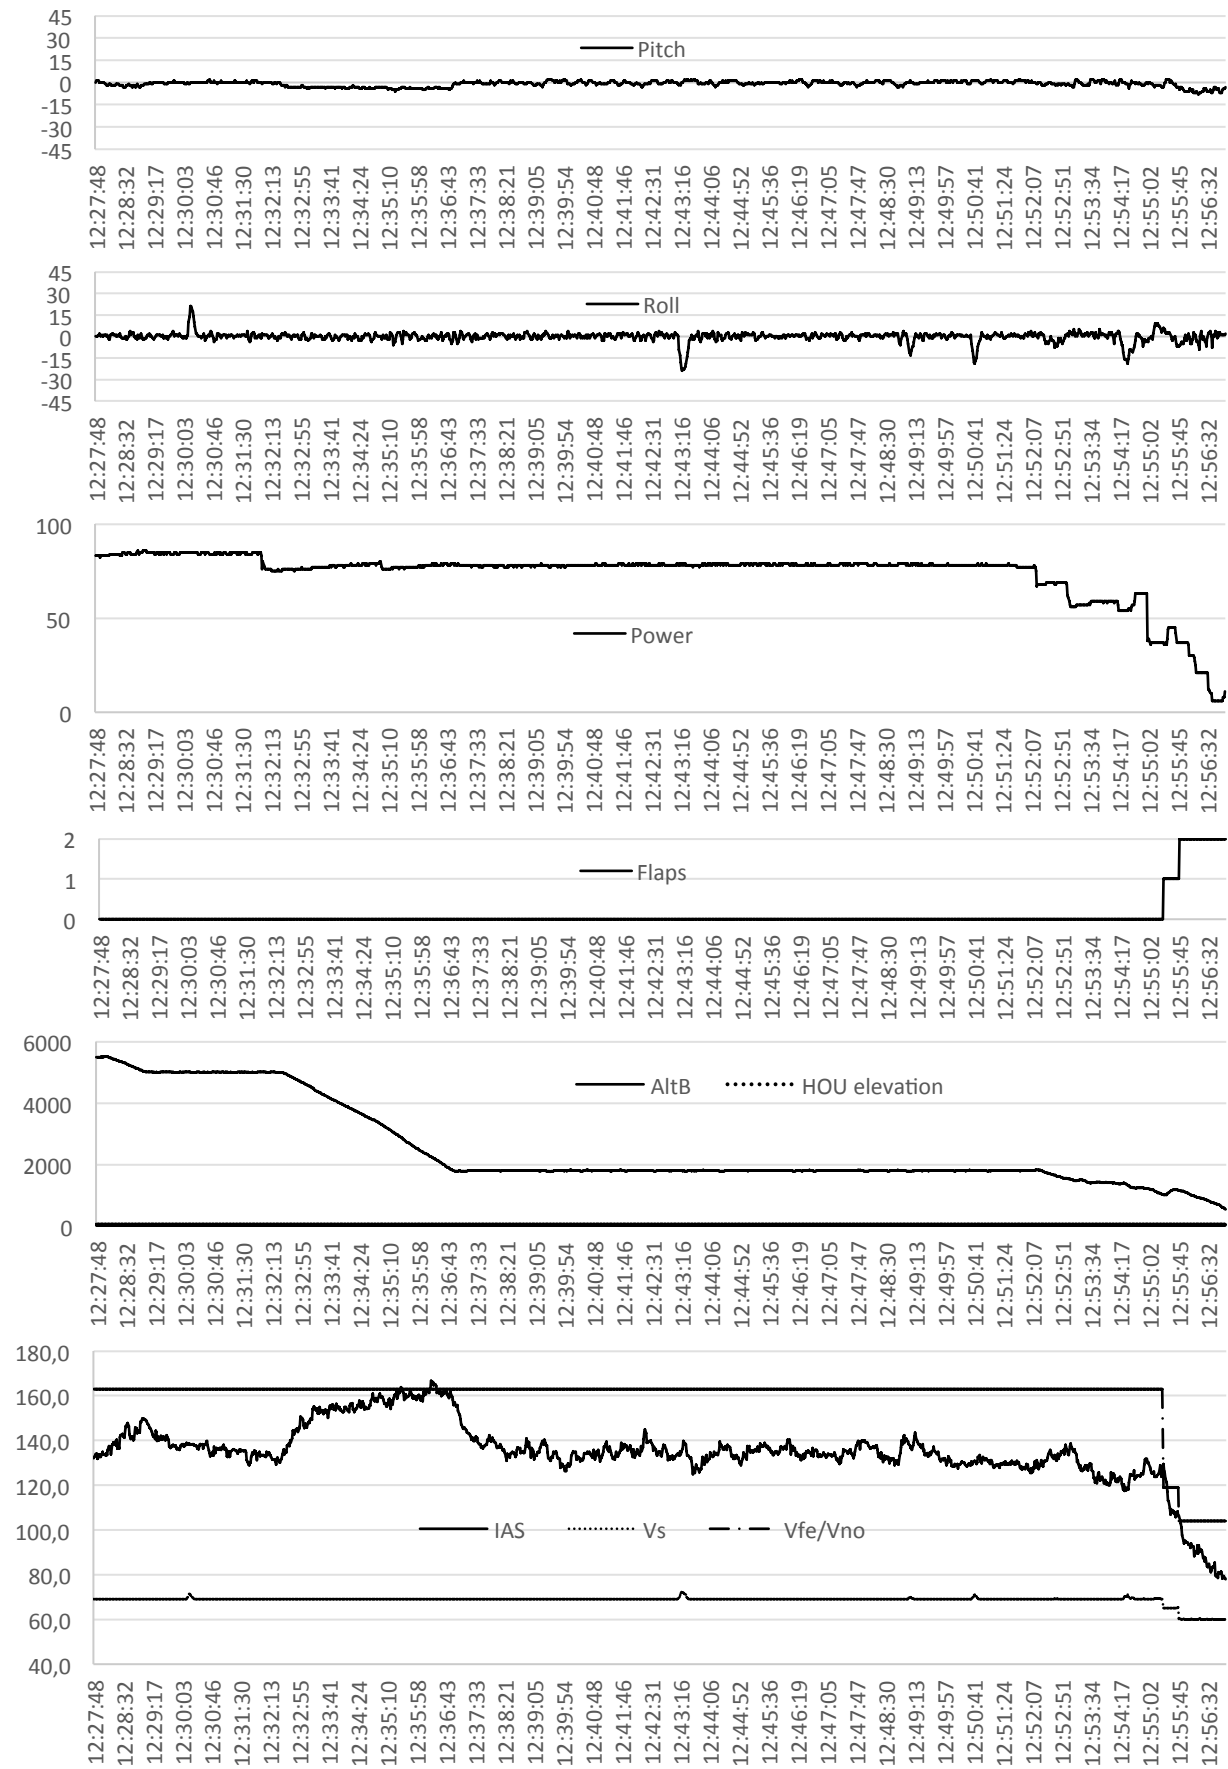
The detailed analysis of the flight data and the graphical presentation of the aircraft's flight parameters in Diagrams 2-1 (12:27:56 - 12:56:30 CDT) and 2-2 (12:27:48 - 12:56:32 CDT) in relation to the ATC transcript in Table 2-1 (12:52:47 - 12:57:02 CDT) for the first approach of N4252G were analysed in detail.

It reveals that between 12:35:34 CDT and 12:36:27 CDT the V_{no} was exceeded by up to 3.7 kts. This is permitted in smooth flight conditions. As the conditions of turbulence could not be extracted, exceeding the V_{no} cannot be considered as an unsafe control action. At 12:55:23 CDT, the pilot selected the flaps to 50% at a speed of 129.5 KIAS, thereby exceeding V_{fe} of 119 KIAS by 10.5 kts. Until 12:55:28 CDT, the V_{fe} limit was exceeded (considering the ATC request to "keep speed up"). When selecting the flaps to 100% at 12:55:47 CDT, V_{fe} was exceeded by 2 kts for 1 second. The aircraft's final approach speed was gradually decreasing but not deceeding the normal approach speeds (83 KIAS for flaps 50%, 78 KIAS for flaps 100%, for procedural details refer to E Appendix), which - together with the minor flight path corrections and the visual descent angle of around 3 degrees to the aiming point of runway 4 - concluded that stabilized approach criteria were fulfilled. According to the Cirrus Envelope of Safety (refer to L Appendix, Figure 6-3 Envelope of Safety), the reported wind ("080 degrees at 13 kts gusting to 18 kts") exceeded³ the personalized x-wind limit (wind limit 15 kts, x-wind limit 5 kts, maximum gust 5 kts) according to the Pilot's Capability Category (for details, refer to D Appendix).

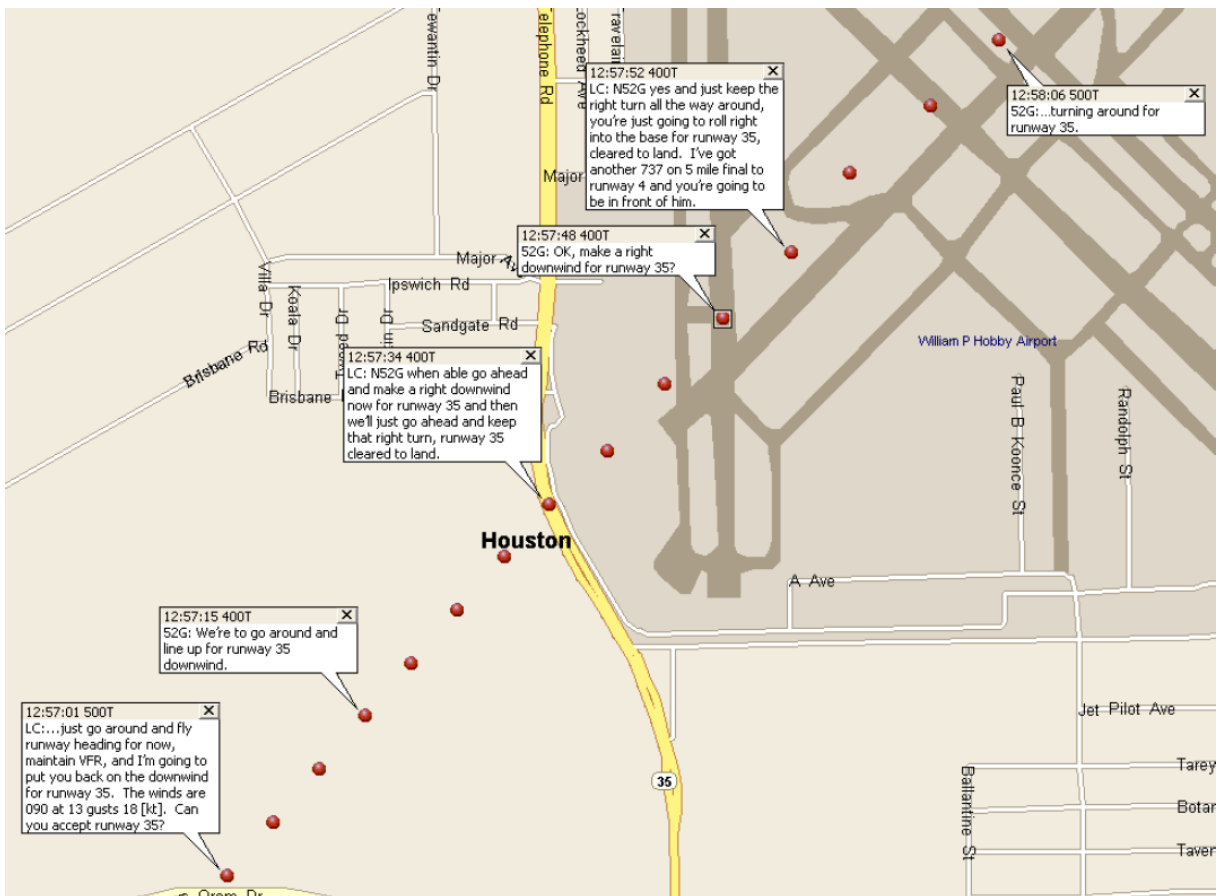
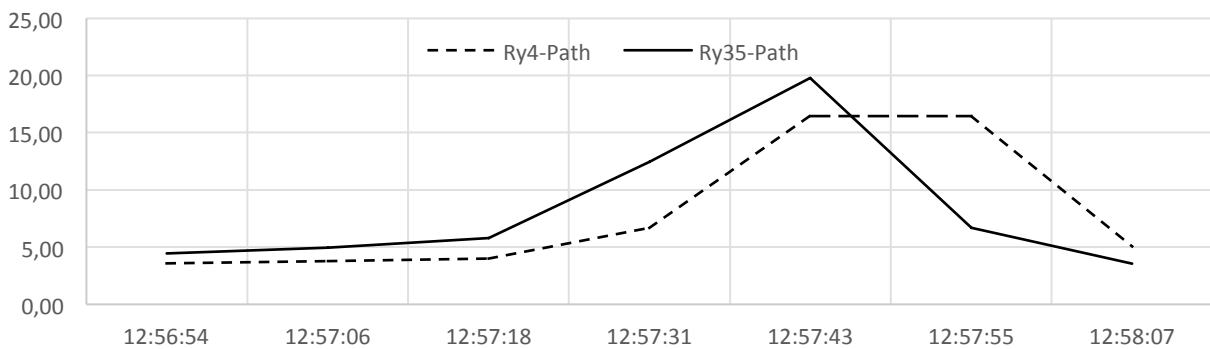
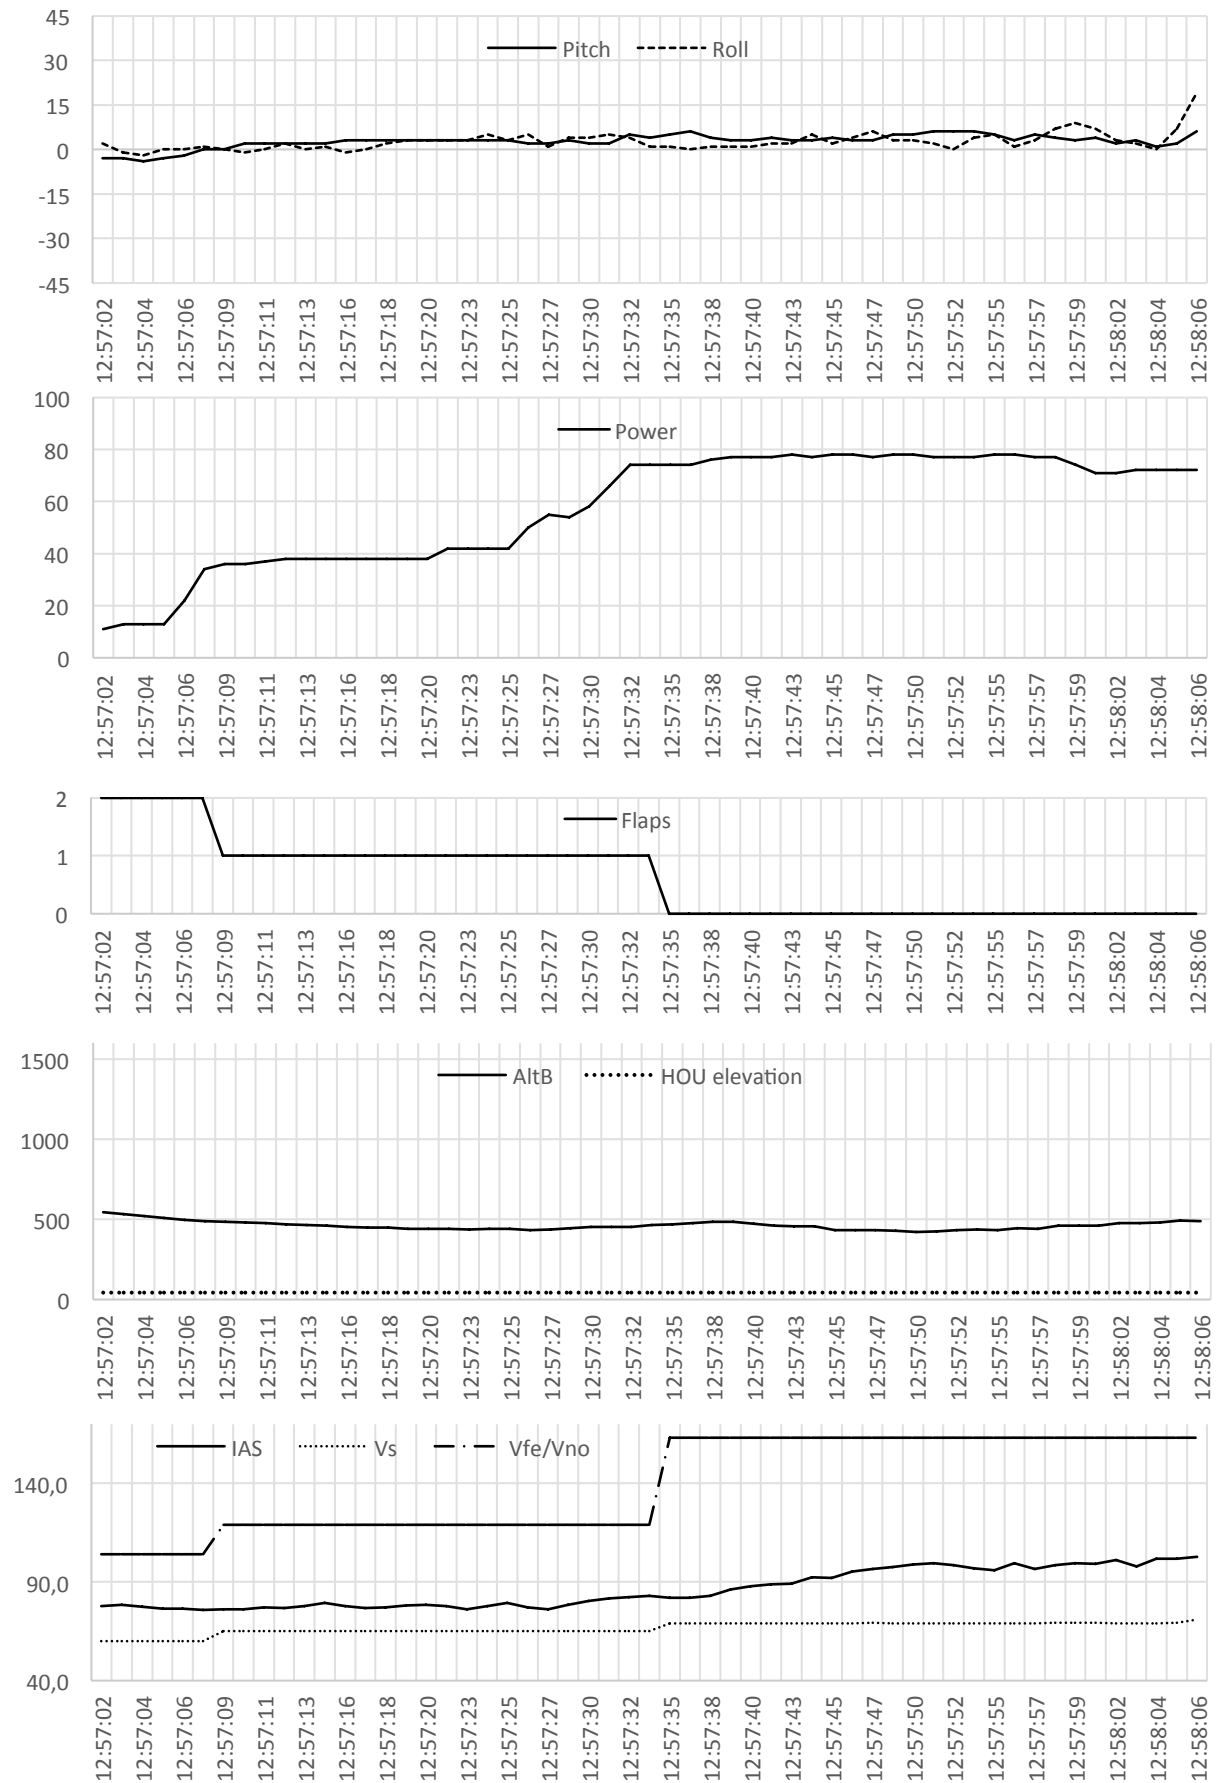
Figure 2-2 Initial approach to runway 4 and ATC-directed go-around

The detailed analysis of the flight data and the graphical presentations of the flight track with the associated ATC transcript in Figure 2-2 and the graphical presentation of the aircraft's flight parameters in Diagrams 2-3 (12:56:54 - 12:58:07 CDT) and 2-4 (12:57:02 - 12:58:06 CDT) in relation to the ATC transcript for the initial approach of N4252G to runway 4 were analysed in detail.

It reveals that the approach was cancelled by ATC at 12:57:01 by requesting N4252G to go-around. Up to then, the aircraft had been fulfilling stabilized approach criteria for landing on runway 4. When initiating the go-around, maximum power for the go-around procedure was not set (for procedural details, refer to E Appendix), which the author assumes as the pilot's intention to maintain the present altitude (AltB) of approximately 500 ft and avoid overspeed conditions with excessive power. The flaps were retracted to 50% at 75 KIAS and to 0% at 83 KIAS, which is within safe limits and according to the POH procedures (for procedural details, refer to E Appendix). Questioning the right downwind for runway 35 at 12:57:48 CDT by the pilot shows that uncertainty about the ATC intentions was present.

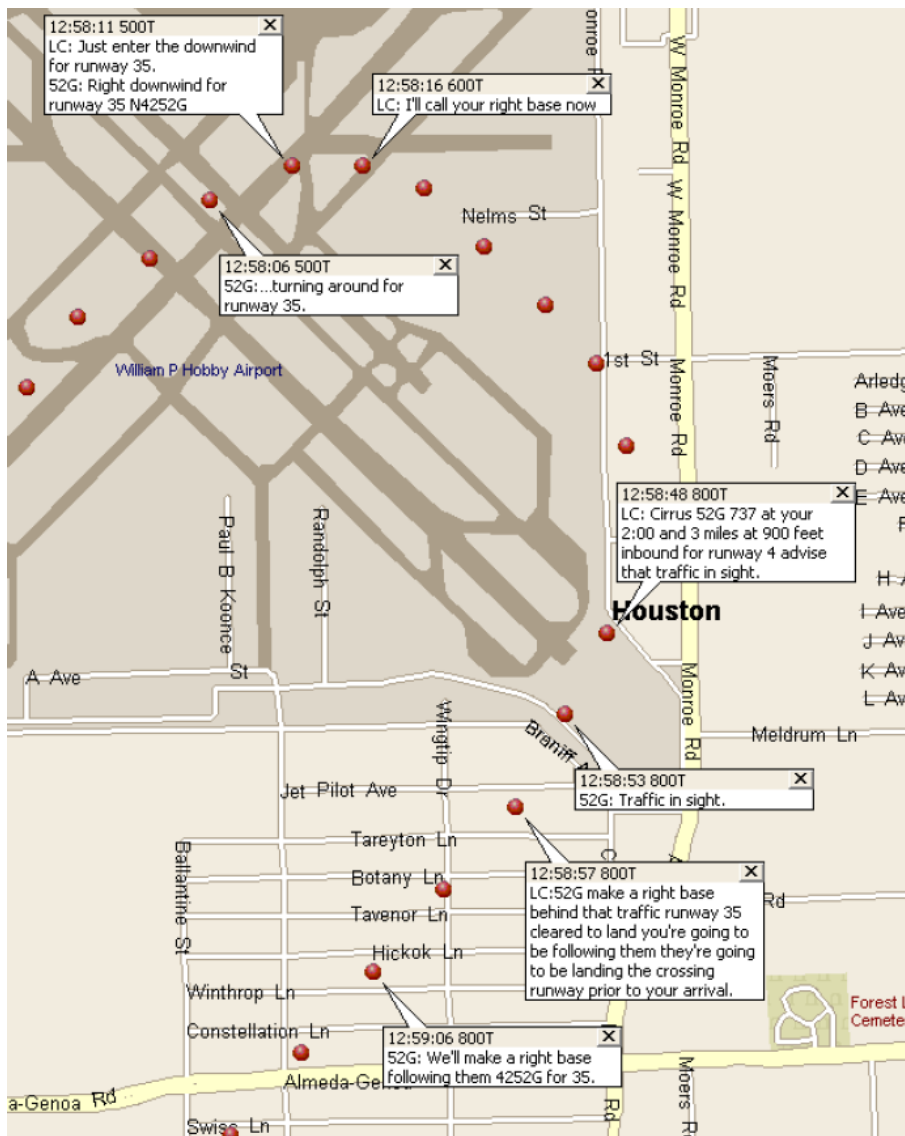
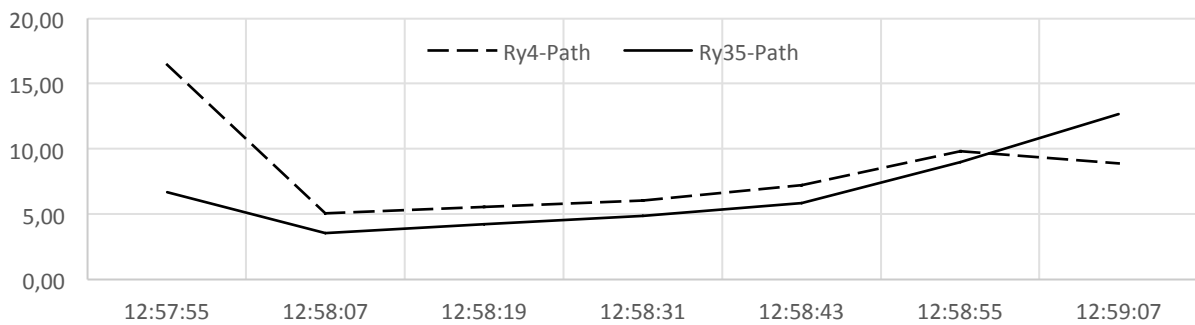
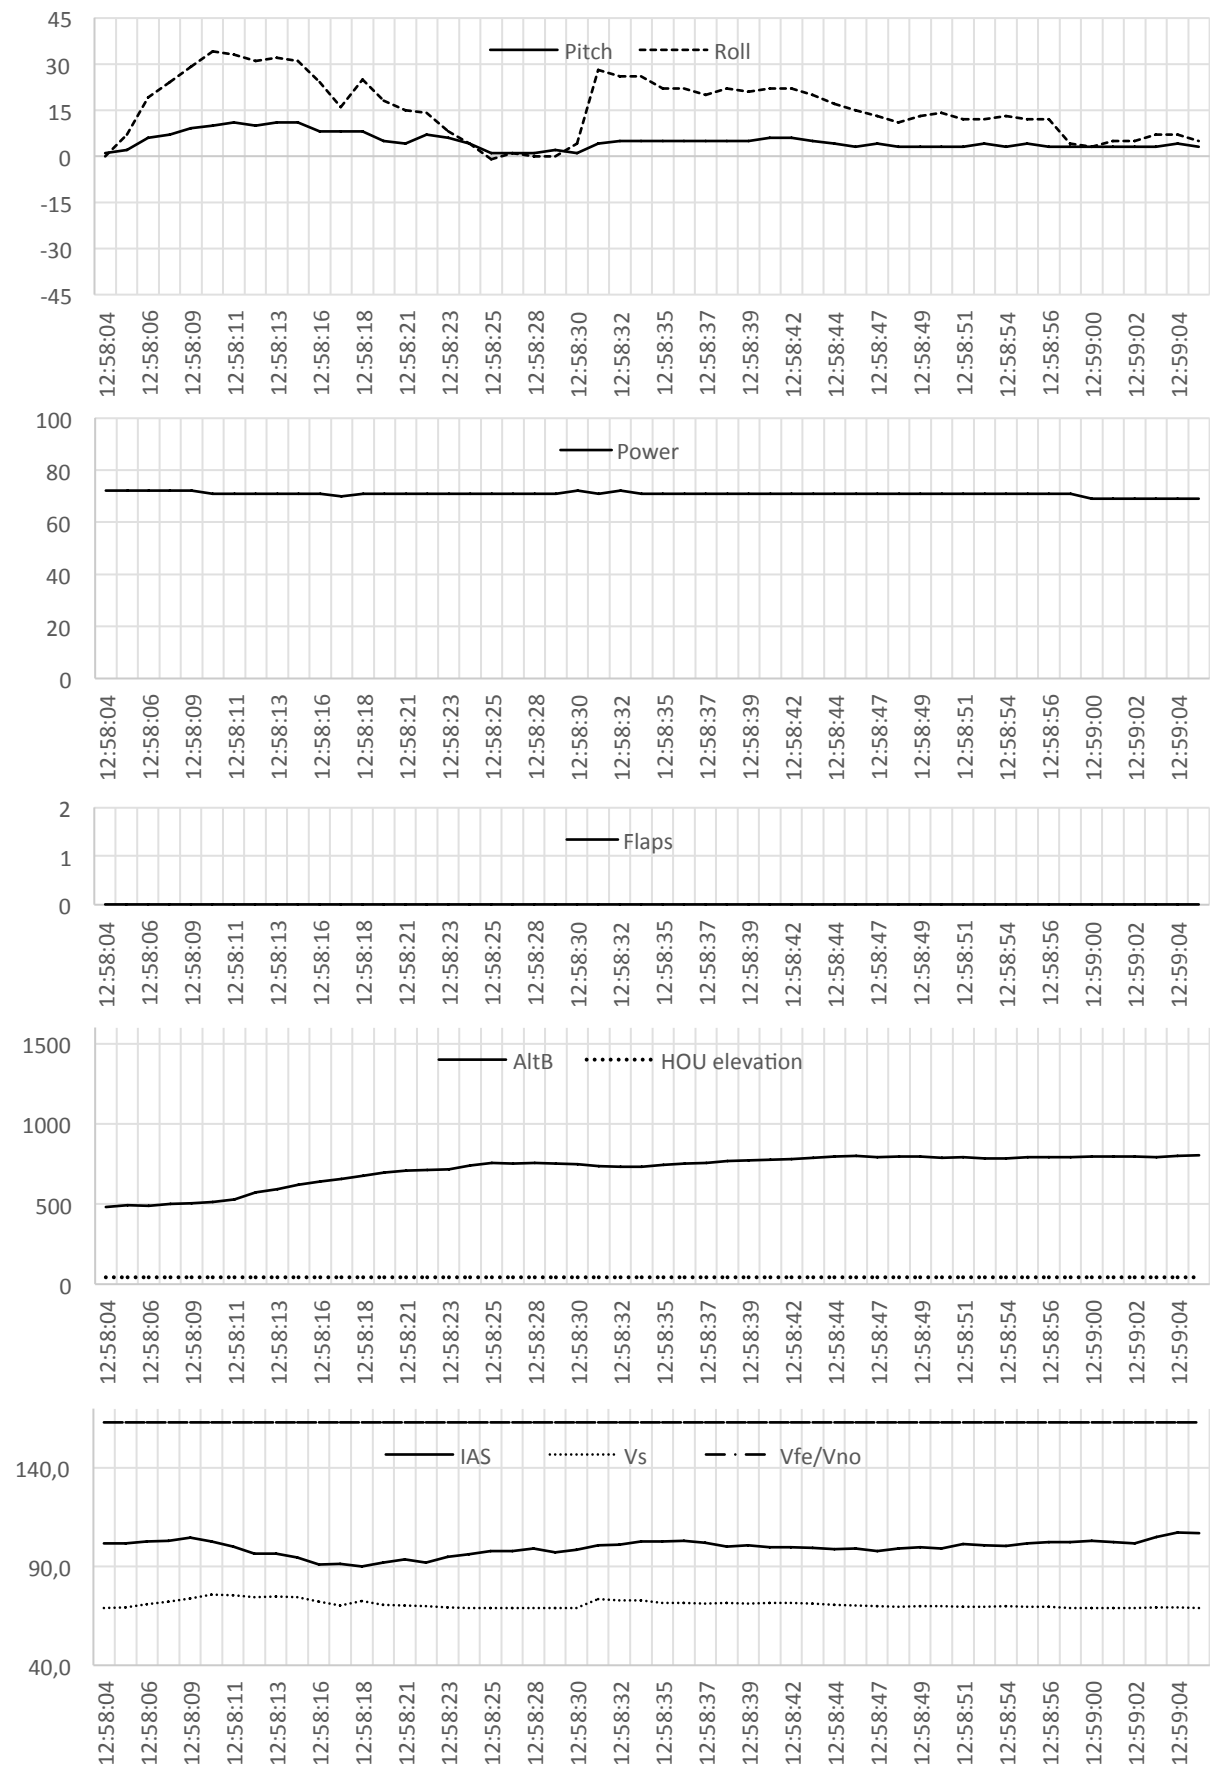
Figure 2-3 Maneuvers following the initial go-around

The detailed analysis of the flight data and the graphical presentations of the flight track with the associated ATC transcript in Figure 2-3 and the graphical presentation of the aircraft's flight parameters in Diagrams 2-5 (12:57:55 - 12:59:07 CDT) and 2-6 (12:58:04 - 12:59:04 CDT) for the maneuvers following the initial go-around of N4252G reveals that no unsafe control actions had been performed by the pilot.

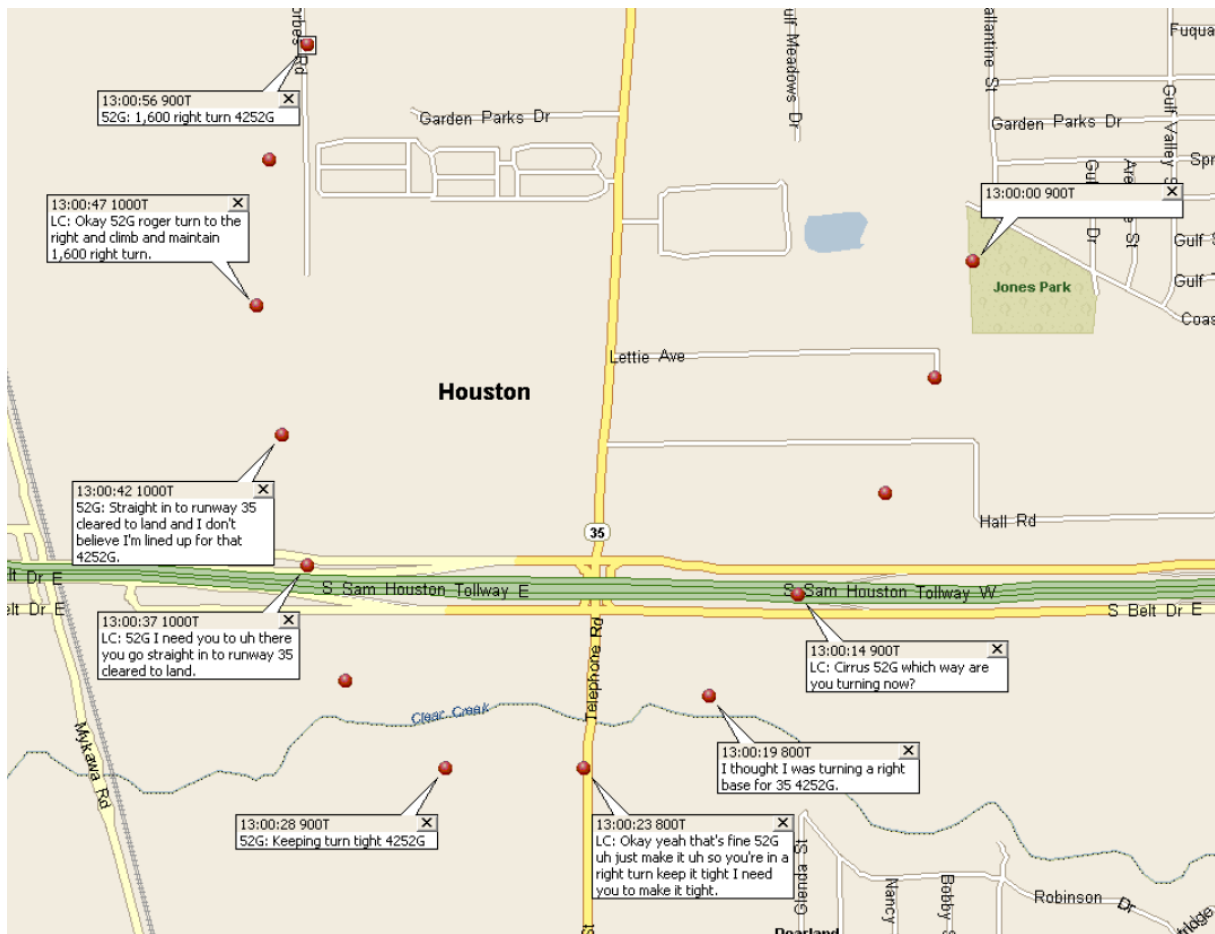
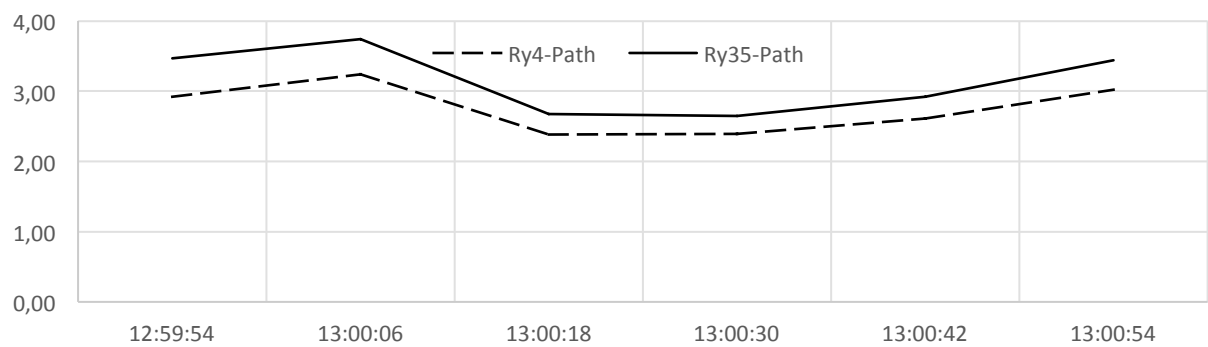
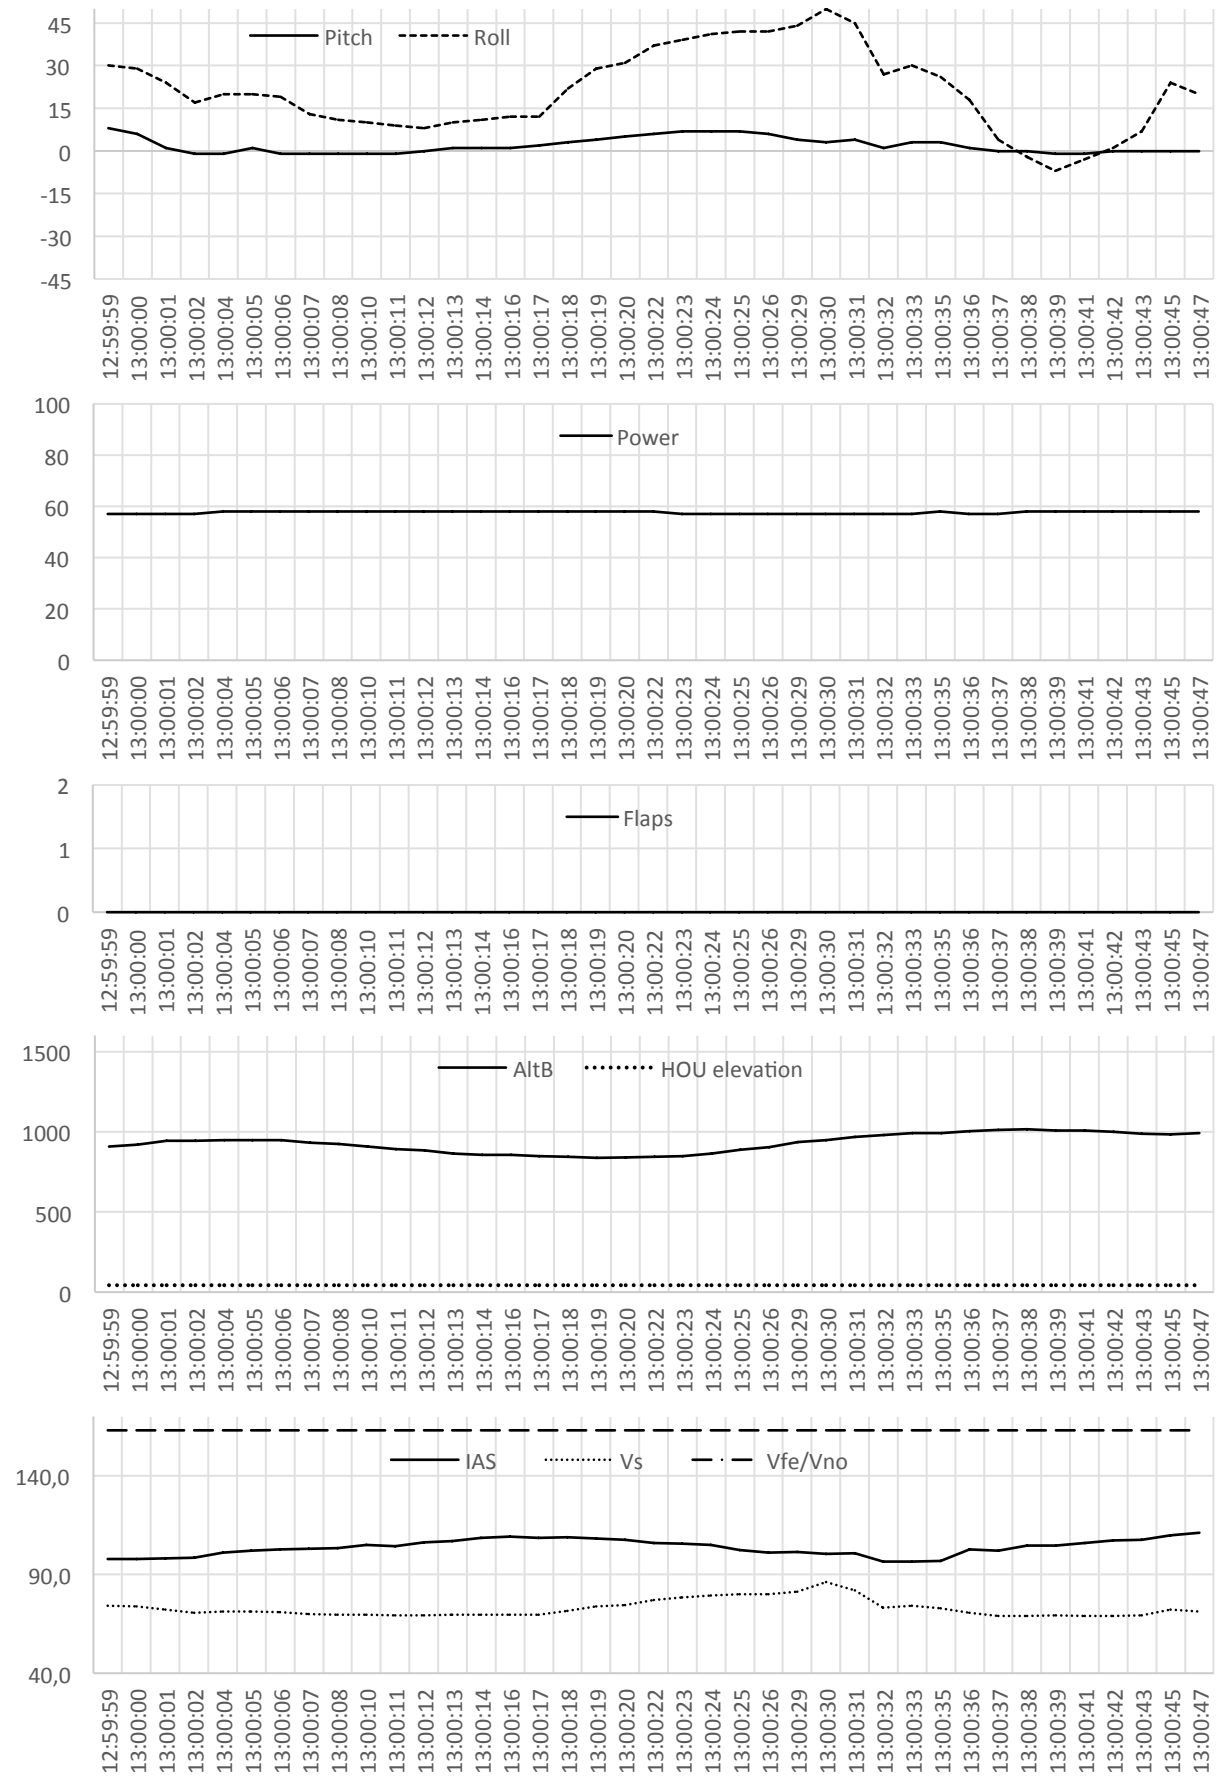
Figure 2-5 Continued pattern maneuvers

The detailed analysis of the flight data and the graphical presentations of the flight track with the associated ATC transcript in Figure 2-5 and the graphical presentation of the aircraft's flight parameters in Diagrams 2-9 (12:59:54 - 13:00:54 CDT) and 2-10 (12:59:59 - 13:00:47 CDT) for the continued pattern maneuvers of N4252G were analysed in detail.

At 13:00:42, the aircraft was at a position (altitude 998 ft, direct visual descent angle 2.92°, speed 107 KIAS, approximately⁷ 15 degrees left of centerline) suitable for landing at runway 35. For an unknown reason, the pilot advised ATC about her uncertainty of being correctly lined up for runway 35, most probably due a severe degradation of situational awareness due to the high workload situation. At 13:00:47 CDT, ATC cleared the pilot to turn right (without any heading assignment, which is not in compliance with ICAO standard phraseology) and a climb to 1600 ft⁸.

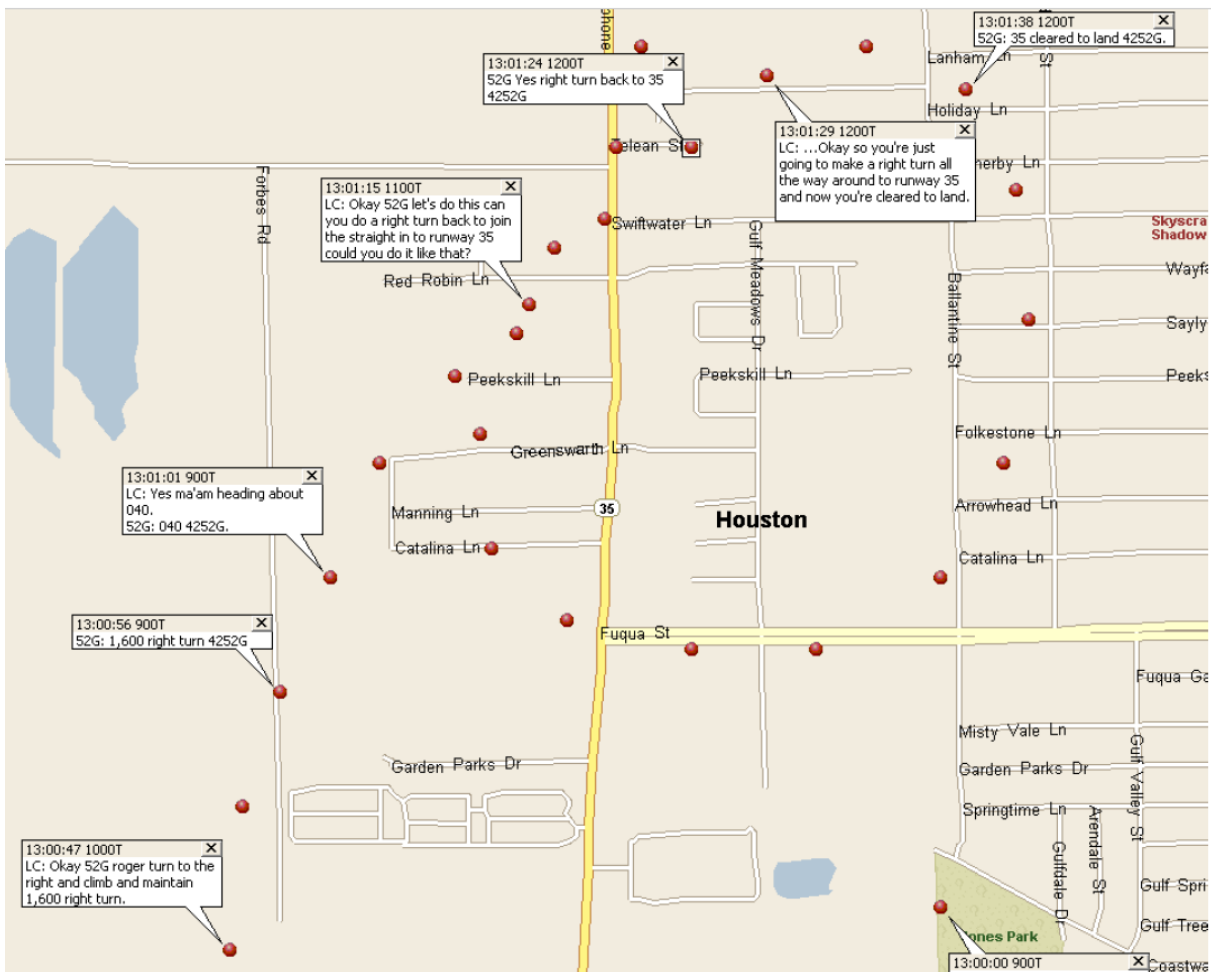
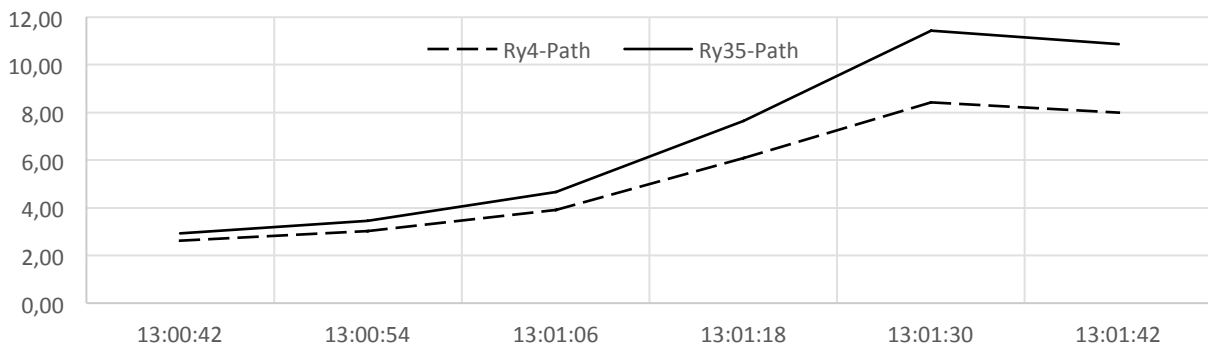
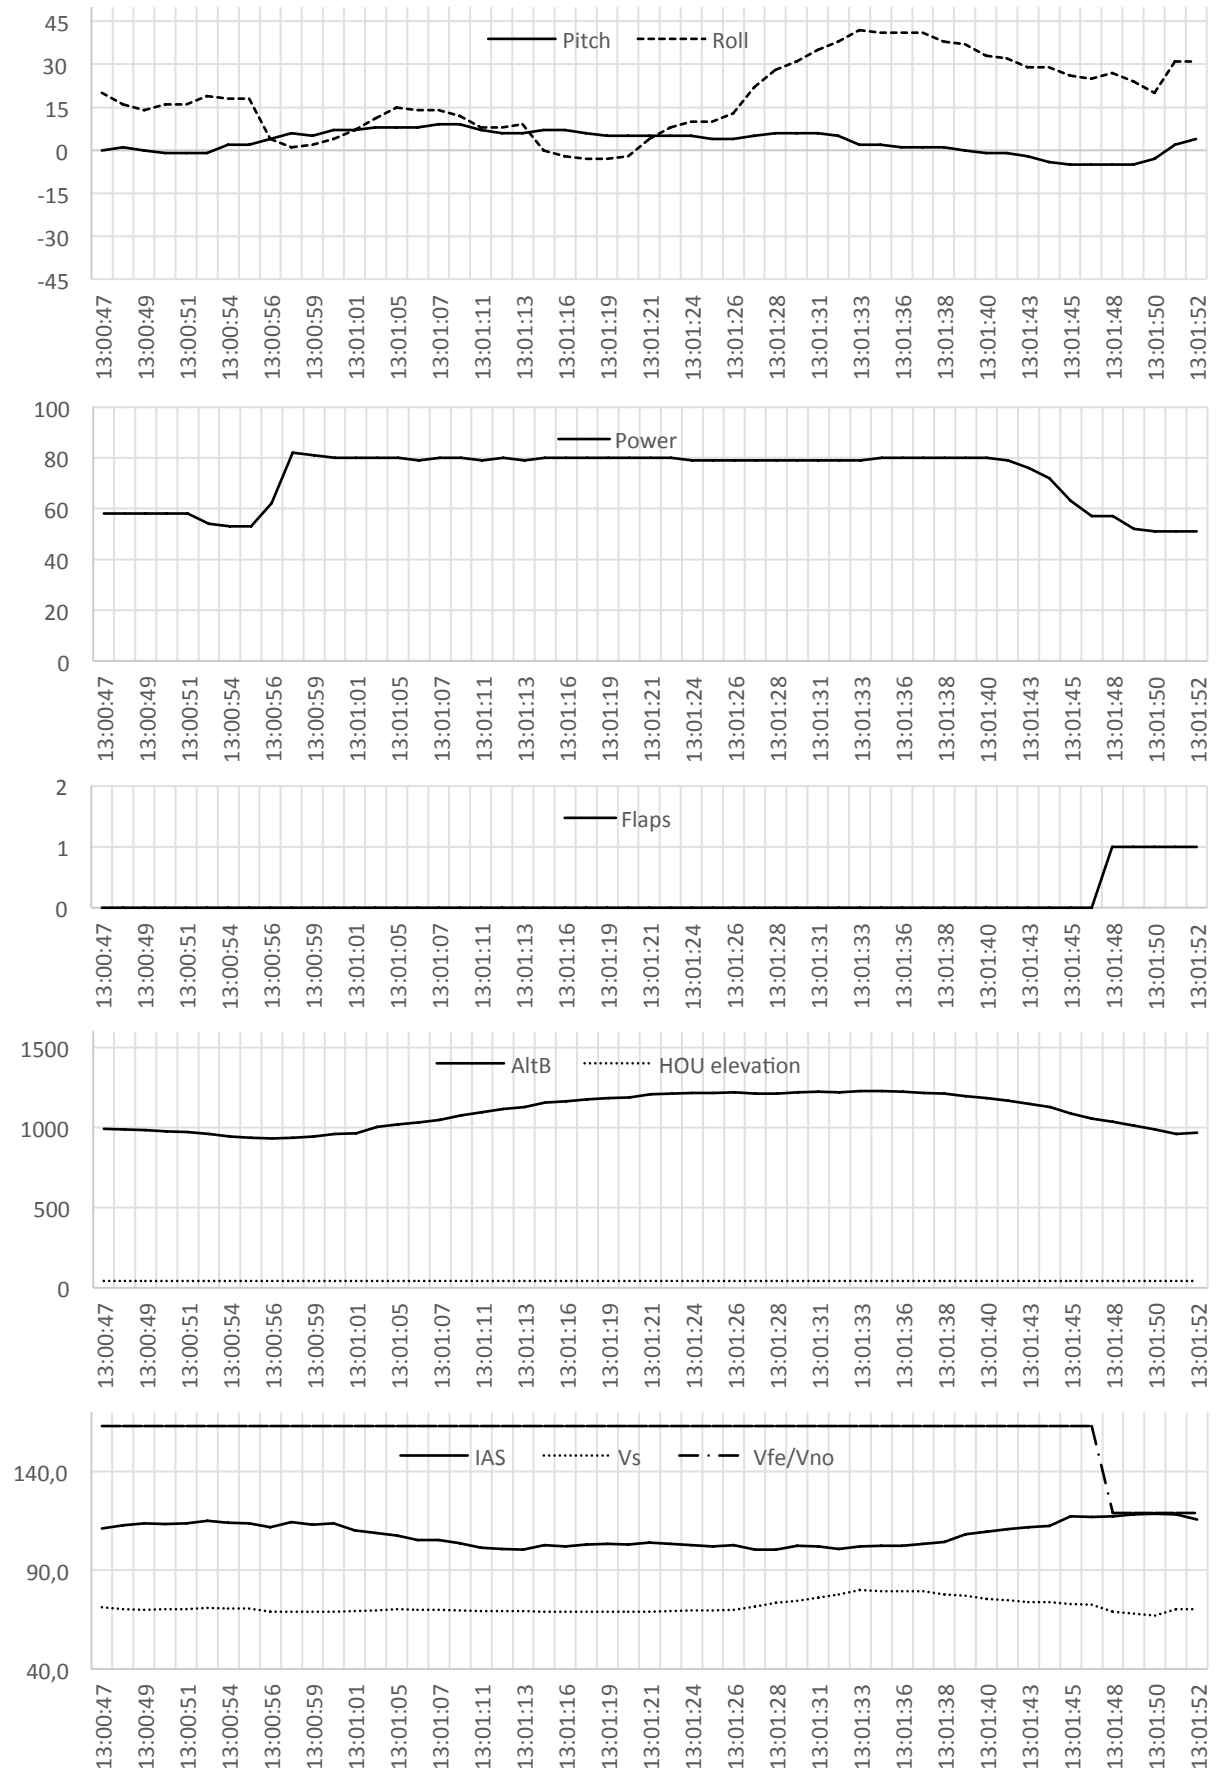
Figure 2-6 Changing approach from runway 4 to runway 35

The detailed analysis of the flight data and the graphical presentations of the flight track with the associated ATC transcript in Figure 2-6 and the graphical presentation of the aircraft's flight parameters in Diagrams 2-11 (13:00:42 - 13:01:42 CDT) and 2-12 (13:00:47 - 13:01:52 CDT) for the pattern maneuvers of N4252G when the approach was changed from runway 4 to runway 35 were analysed in detail.

It reveals that for the discontinued approach the power was increased from 53% to 82% at 13:00:57 CDT. As the flaps were not extended the missed approach procedure was performed without the requirement to retract the flaps. The airspeed at the time of the missed approach was 114 KIAS. From 13:01:33 CDT till 13:01:37 CDT the bank angle was exceeding 40 degrees. At 13:01:29 CDT ATC advised to make a right turn "all the way around" to runway 35, while the pilot was increasing the bank angle up to 42 degrees (at 13:01:33 CDT) in a right turn. At 13:01:42 CDT the aircraft was on a visual descent angle to the aiming point of runway 35 of 10.9 degrees (note that the PAPI for runway 35 was calibrated for 3.0 degrees) in a right banking turn of 32 degrees. At 13:01:46 CDT the pilot selected the flaps to 50% with a speed of 117 KIAS (2 kts below V_{fe}) in a right turn with a bank angle of 25 degrees.

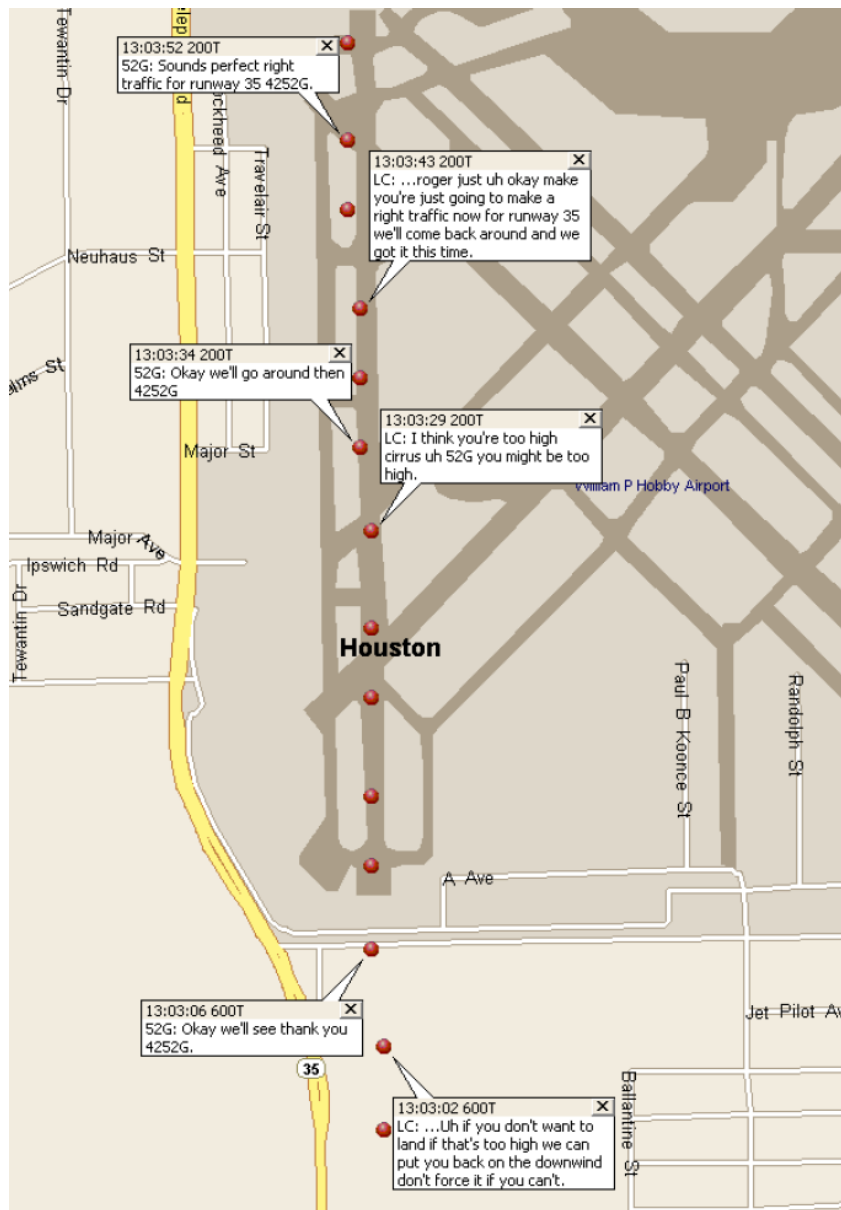
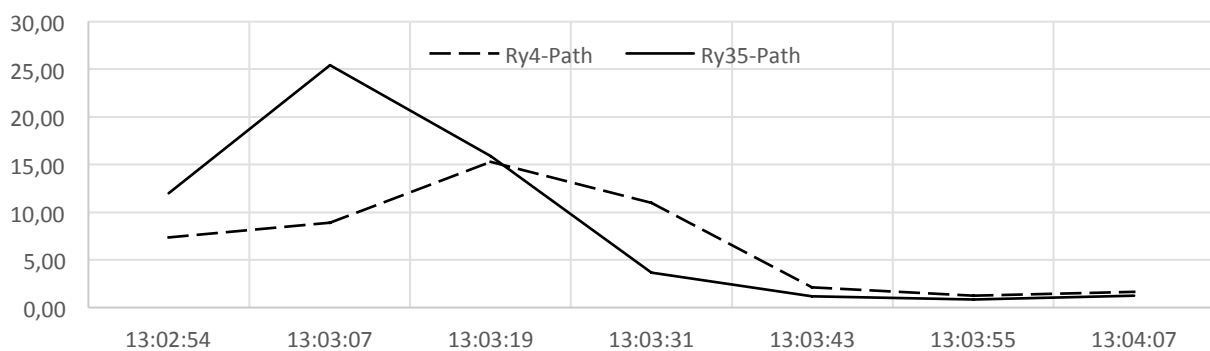
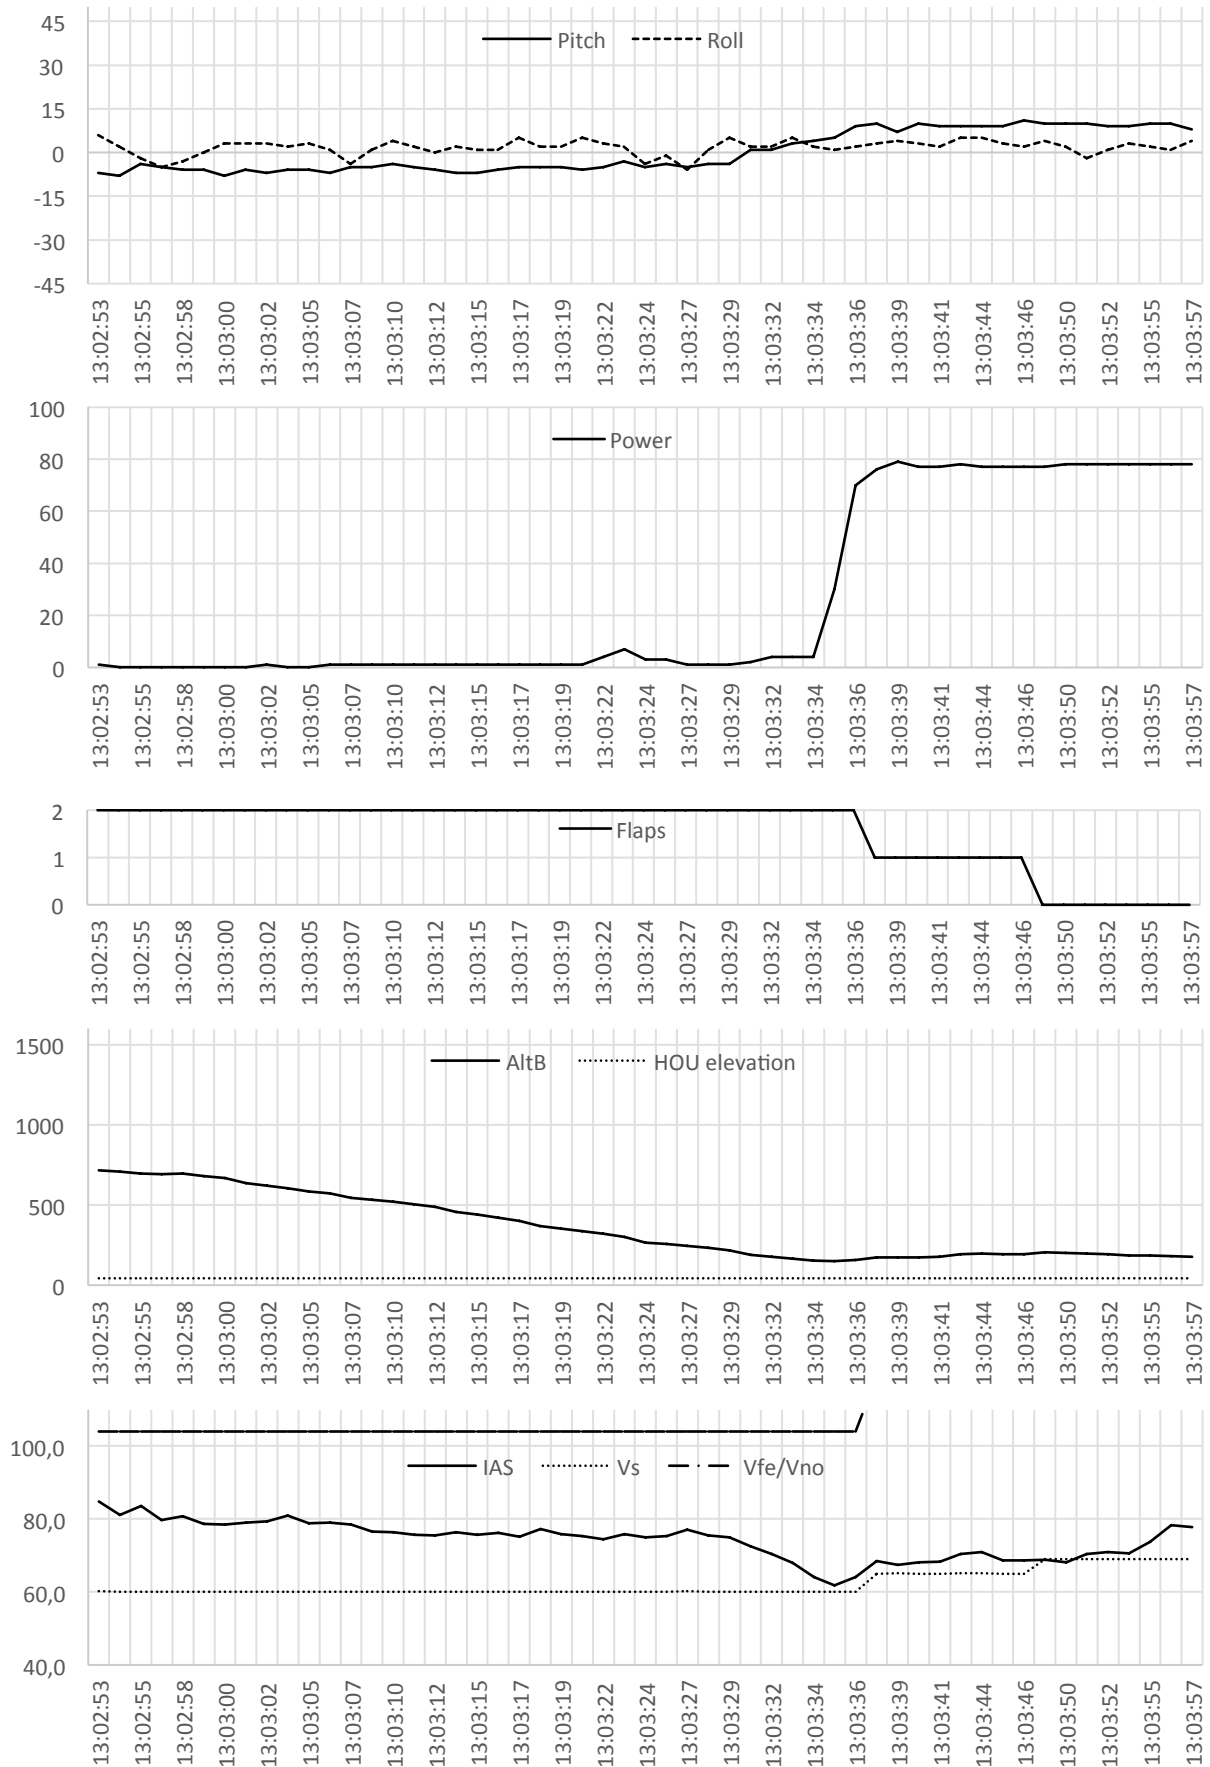
Figure 2-8 Runway 35 first approach and go-around

The flight data and the graphical presentations of the flight track with the associated ATC transcript in Figure 2-8 and the graphical presentation of the aircraft's flight parameters in Diagrams 2-15 (13:02:54 - 13:04:07 CDT) and 2-16 (13:02:53 - 13:03:57 CDT) for the first approach and go-around of N4252G to runway 35 were analysed in detail.

At 13:03:46 CDT, at an altitude of 192 ft the flaps were retracted to 0% at 68.7 KIAS (well below the recommended speed of 83 KIAS) with a stall speed margin of 4 kts and the power set to 77% instead of maximum power (for procedural details, refer to E Appendix). The pitch angle was not reduced and the speed further decreased until reaching the stall speed at 13:03:49 CDT. Subsequently, the pitch angle was slightly reduced and the aircraft left the speed regime triggering a stall warning at an altitude of 183 ft at 13:03:56 CDT with a positive speed trend.
