STAMP Modeling of the Accident

N4252G

MASTER'S THESIS to achieve the university degree of
Master of Engineering

Master's Degree Program: Traffic Accident Research - Aviation Safety

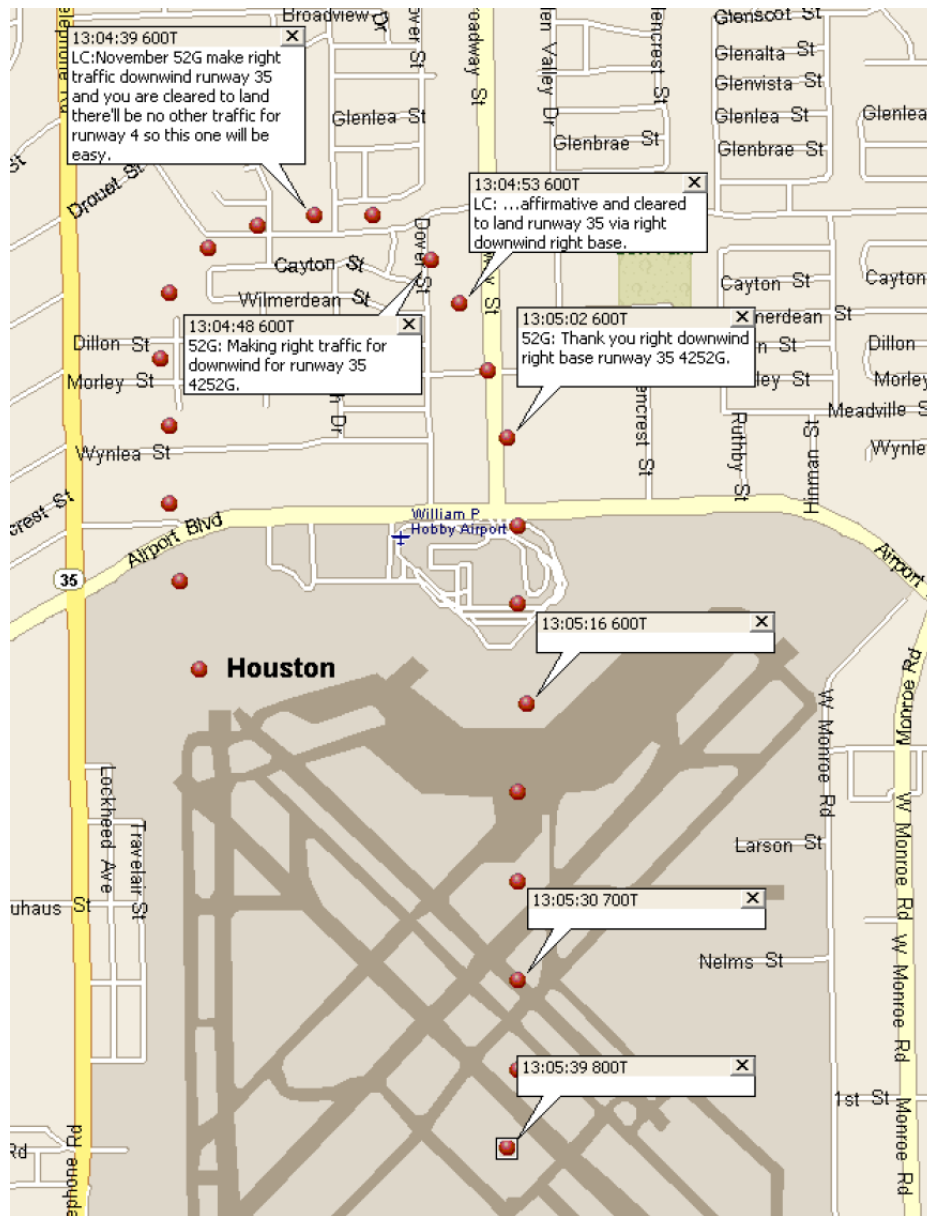
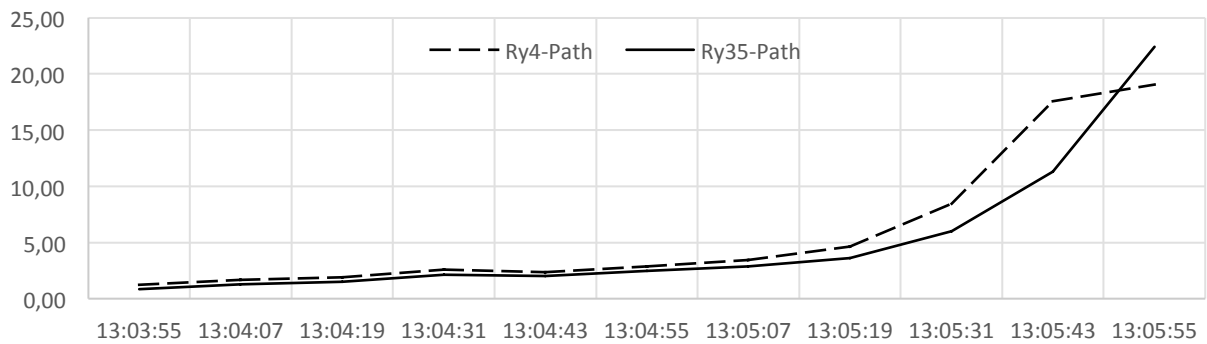
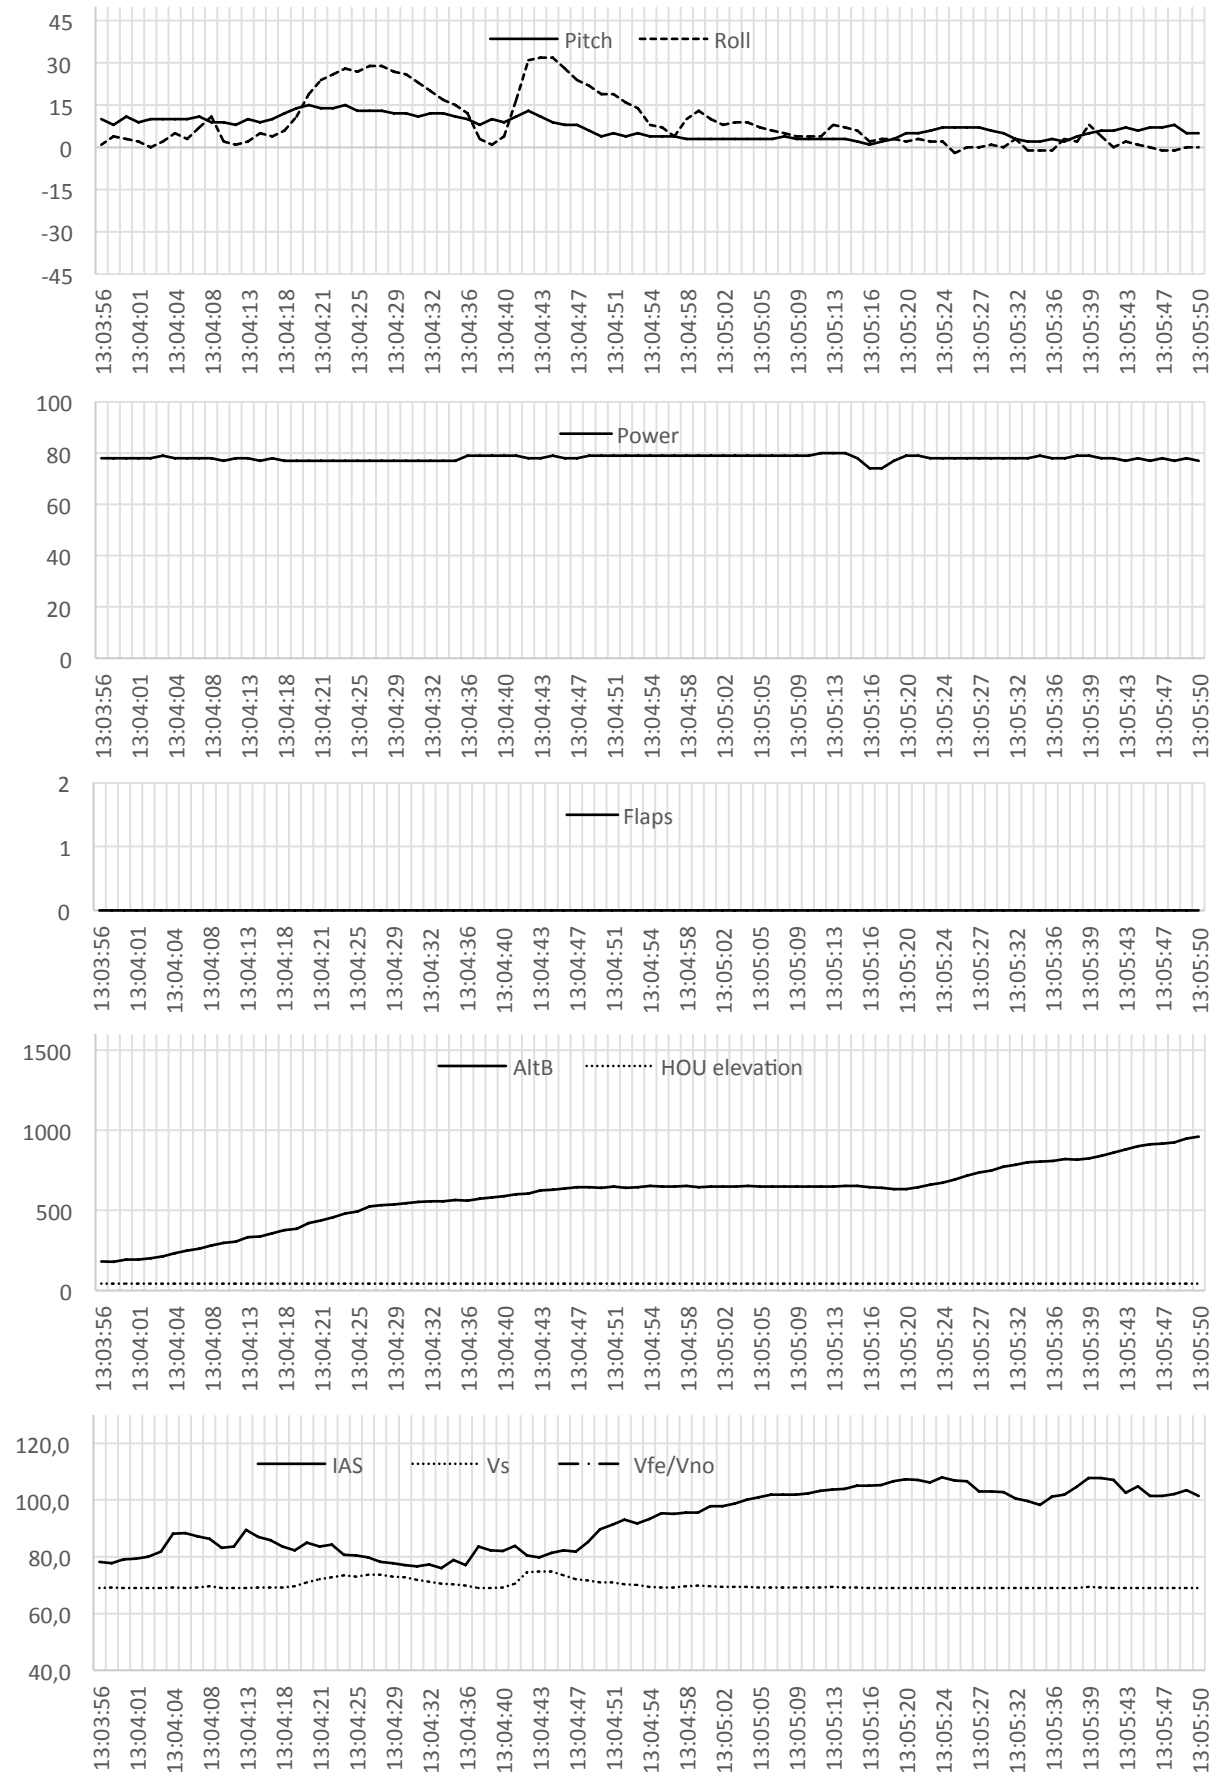
Figure 2-9 Preparing for second approach to runway 35

The flight data and the graphical presentations of the flight track with the associated ATC transcript in Figure 2-9 and the graphical presentation of the aircraft's flight parameters in Diagrams 2-17 (13:03:55 - 13:05:55 CDT) and 2-18 (13:03:56 - 13:05:50 CDT) whilst preparing for the second approach of N4252G to runway 35 were analysed in detail. At 13:04:39 CDT the ATC advised to enter the right downwind for runway 35. As there was no other traffic reported for runway 4 by ATC, proper application of risk assessment had resulted in requesting runway 4 to improve the prevailing wind conditions for approach and landing.

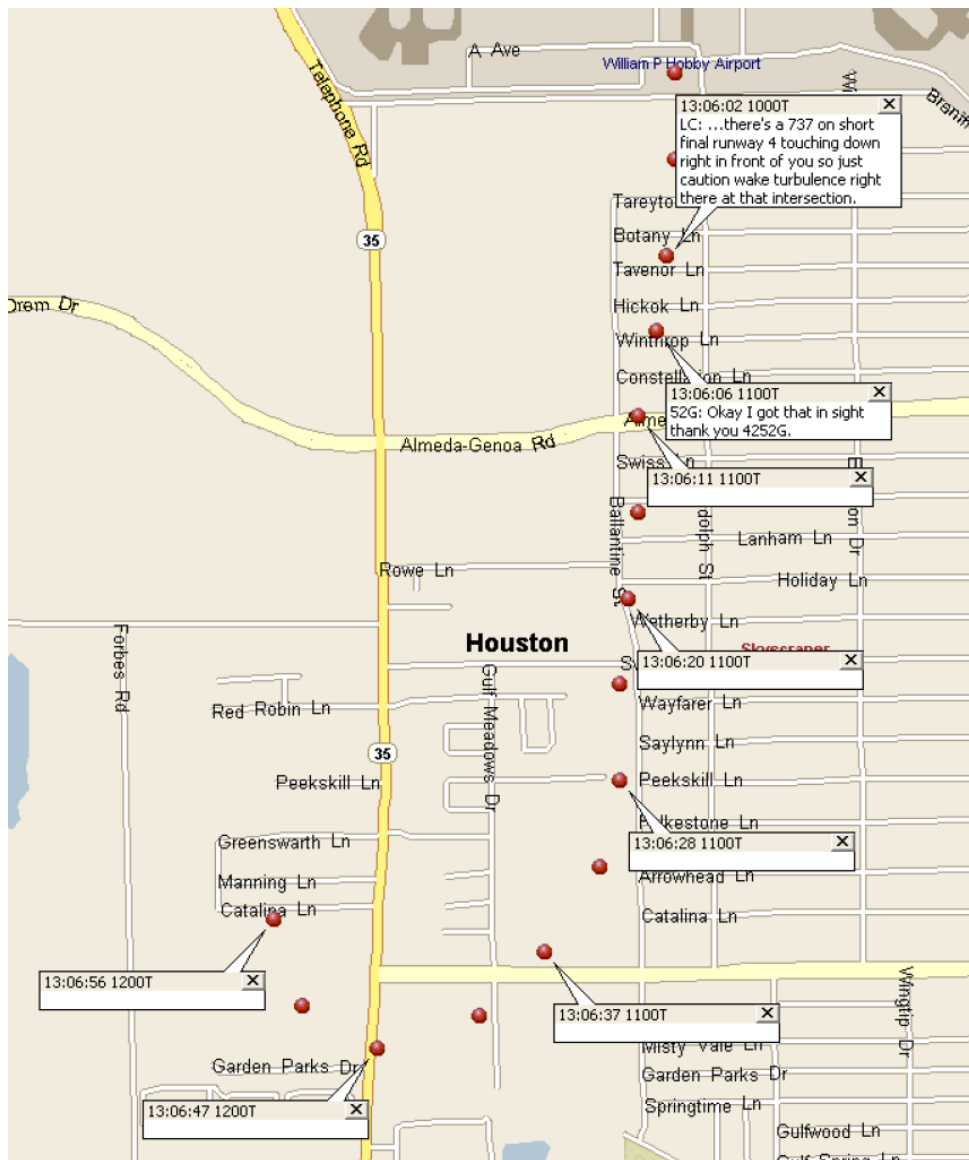
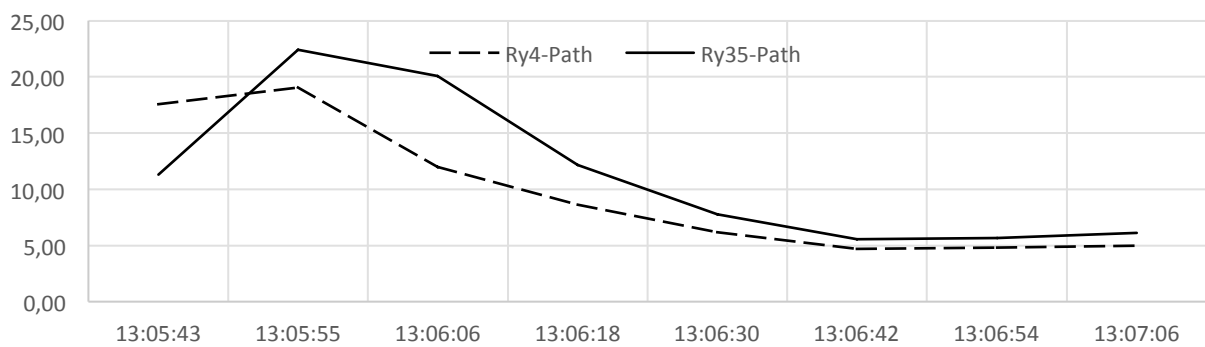
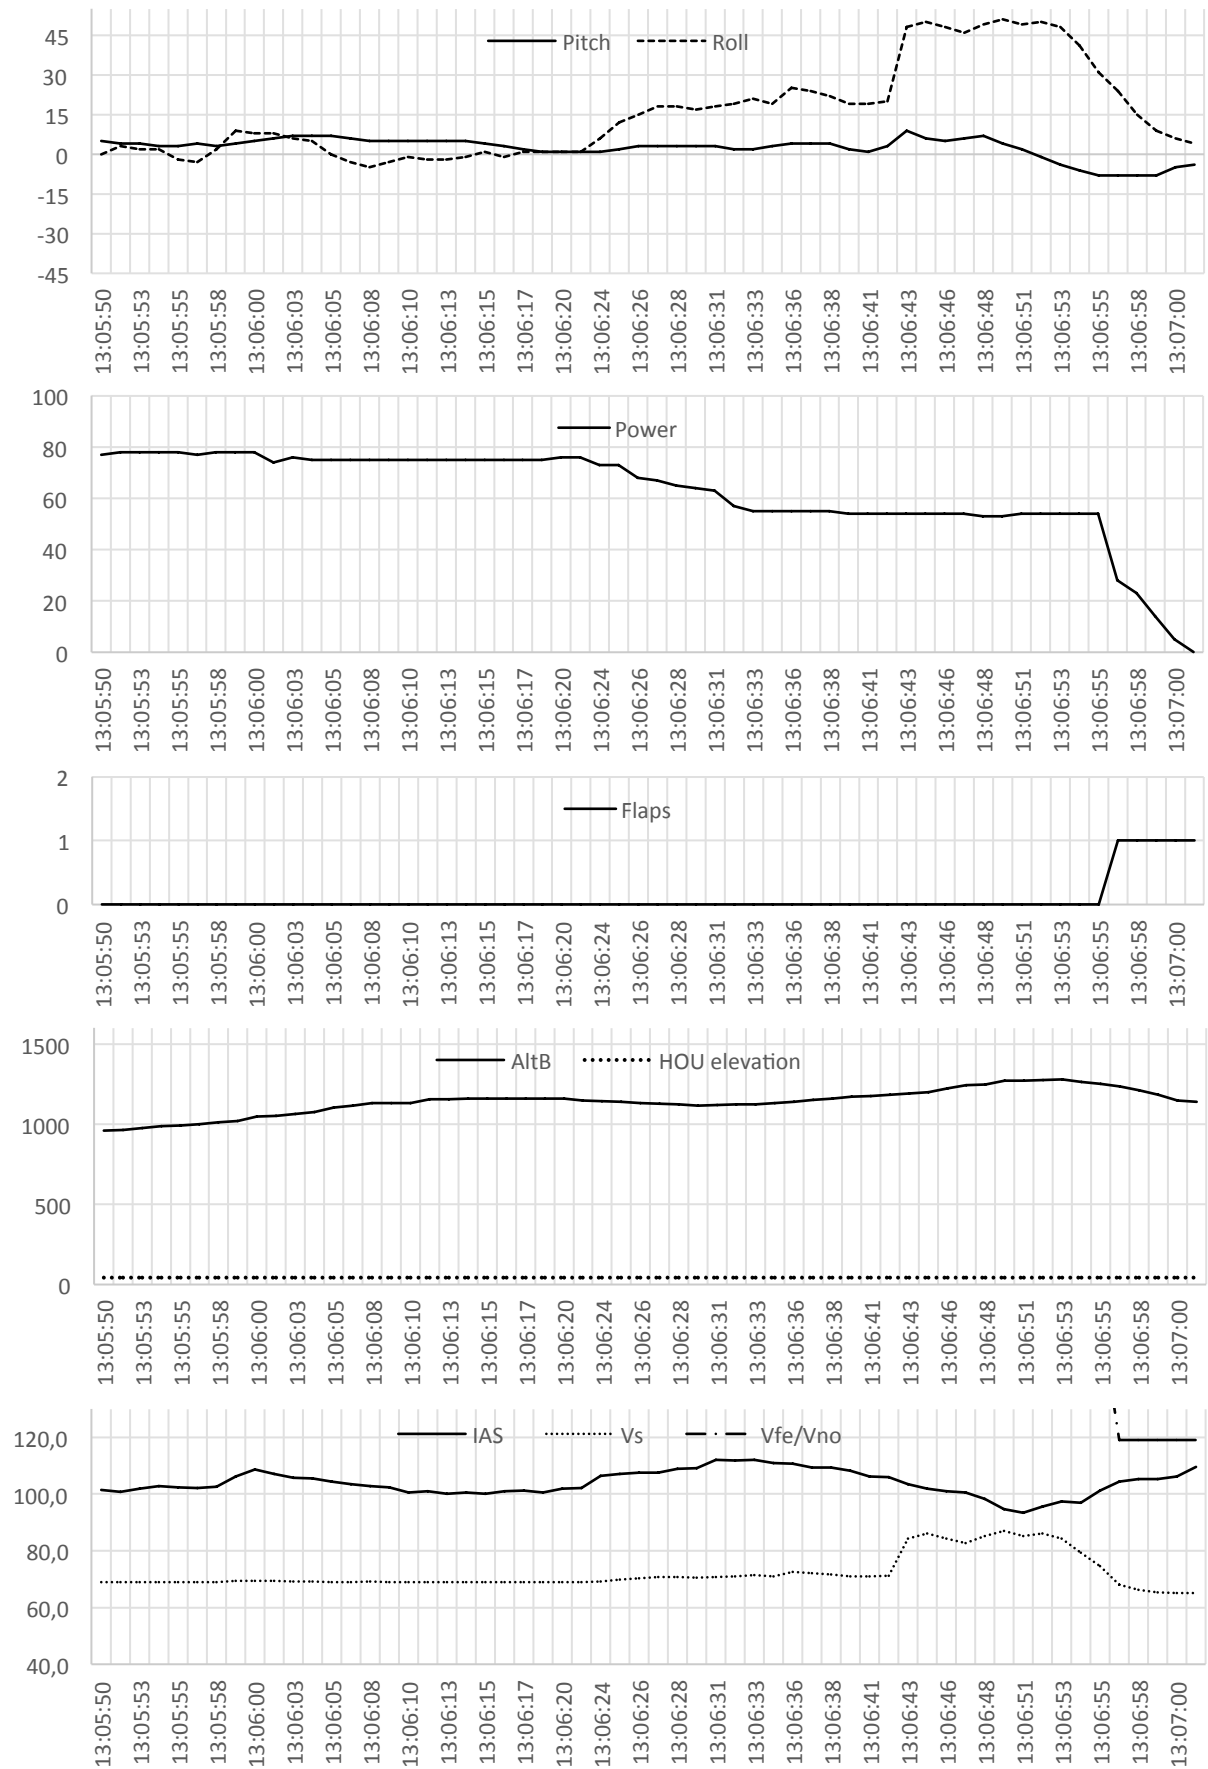
Figure 2-10 Downwind to final turn, second approach to runway 35

The flight data and the graphical presentations of the flight track with the associated ATC transcript in Figure 2-10 and the graphical presentation of the aircraft's flight parameters in Diagram 2-19 (13:05:43 - 13:07:06 CDT) and 2-20 (13:05:50 - 13:07:00 CDT) whilst proceeding on downwind and to the final turn for the second approach to runway 35 of N4252G were analysed in detail. Between 13:06:42 and 13:06:53 CDT, when turning on final for runway 35 the bank angle was increased up to a maximum of 51 degrees. At 13:06:55 CDT, the flaps were extended to 50% and the power reduced to idle, whilst the visual descent angle was at 5.7 degrees (note that the PAPI for runway 35 was calibrated for 3.0 degrees) with 101.3 KIAS in a 31 degrees of bank angle turn.

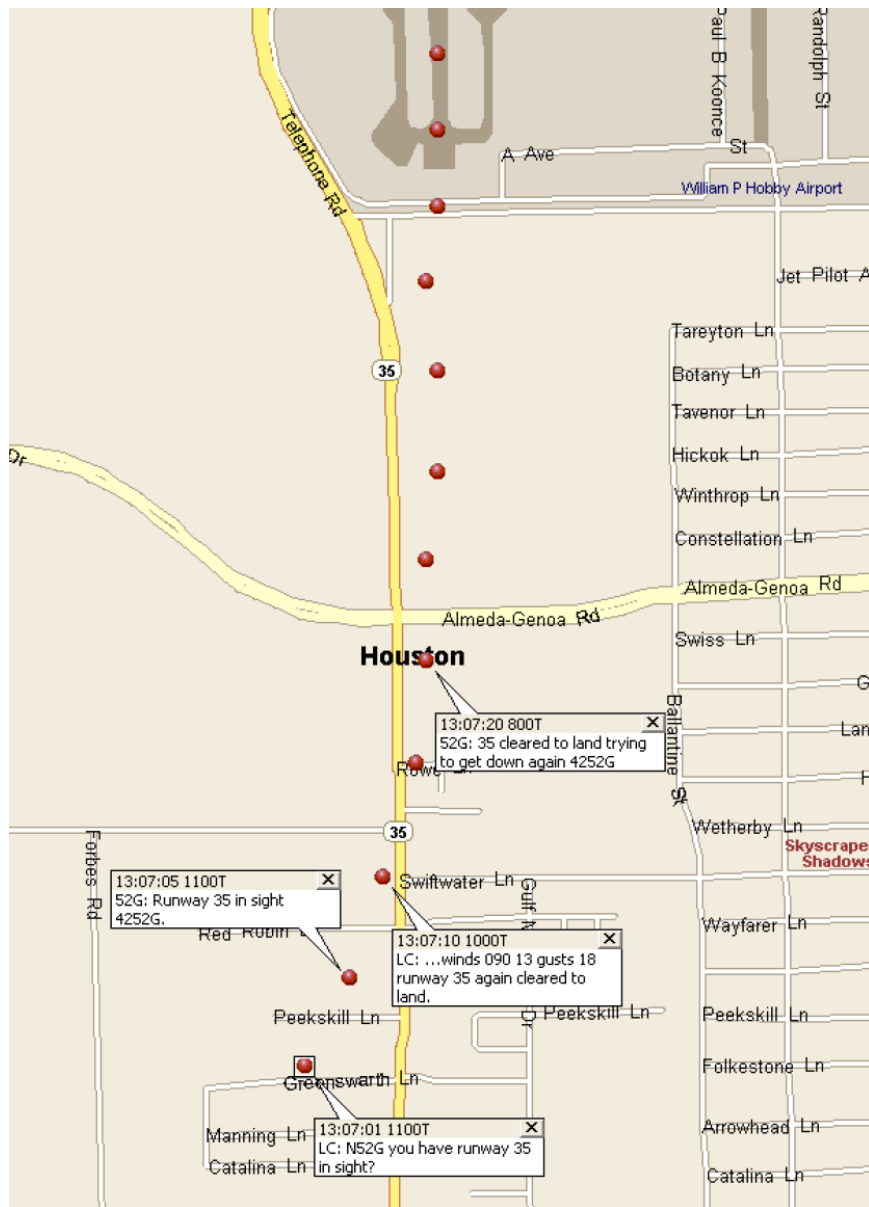
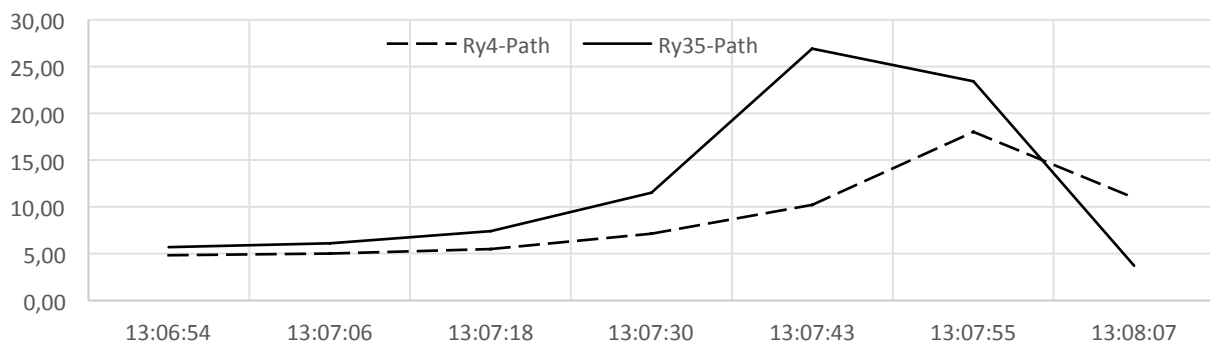
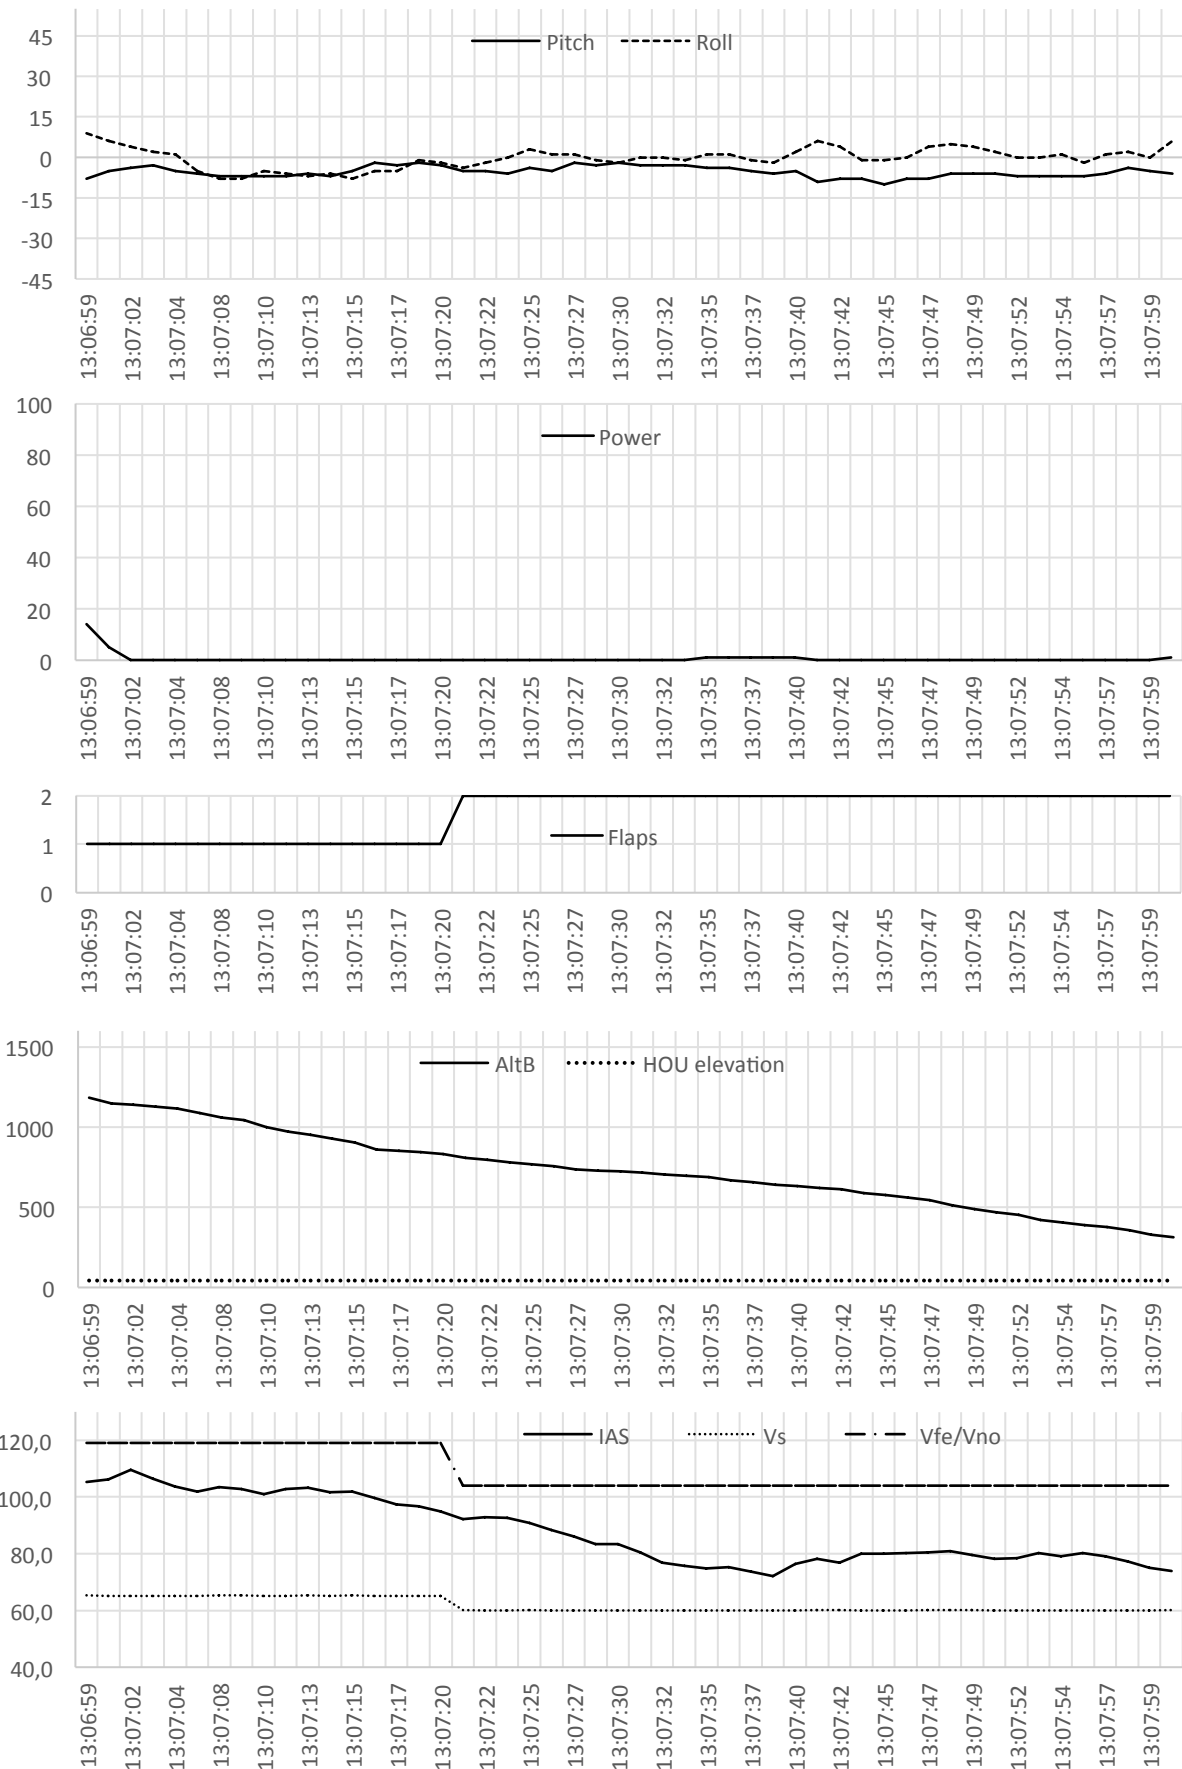
Figure 2-11 Second approach to runway 35

The flight data and the graphical presentations of the flight track with the associated ATC transcript in Figure 2-11 and the graphical presentation of the aircraft's flight parameters in Diagrams 2-21 (13:06:54 - 13:08:07 CDT) and 2-22 (13:06:59 - 13:07:59 CDT) whilst performing the second approach to runway 35 of N4252G were analysed in detail.

At 13:07:18 CDT, before the flaps were set to 100% the visual descent angle was 7.7 degrees with an increasing trend (note that the PAPI for runway 35 was calibrated for 3.0 degrees). When the pilot of N4252G read back the landing clearance for runway 35 and advised "trying to get down again", the flaps were simultaneously extended from 50% to 100%, whilst the speed was at 94.8 KIAS. From 13:07:32 until 13:07:42 CDT the speed was decreasing below 78 KIAS (down to a minimum of 72 KIAS at 13:07:38 CDT), which is the recommended approach speed (for procedural details refer to E Appendix) for the 100% flaps configuration.

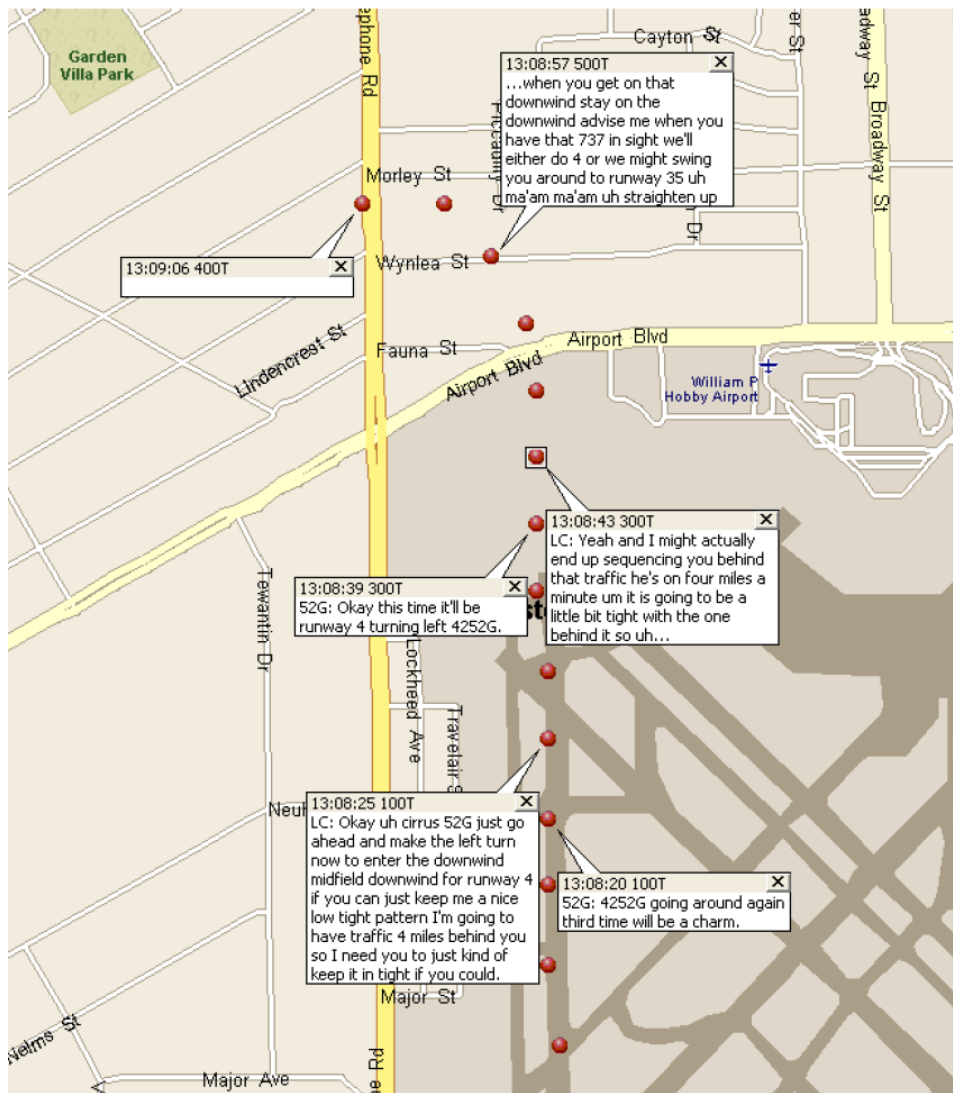
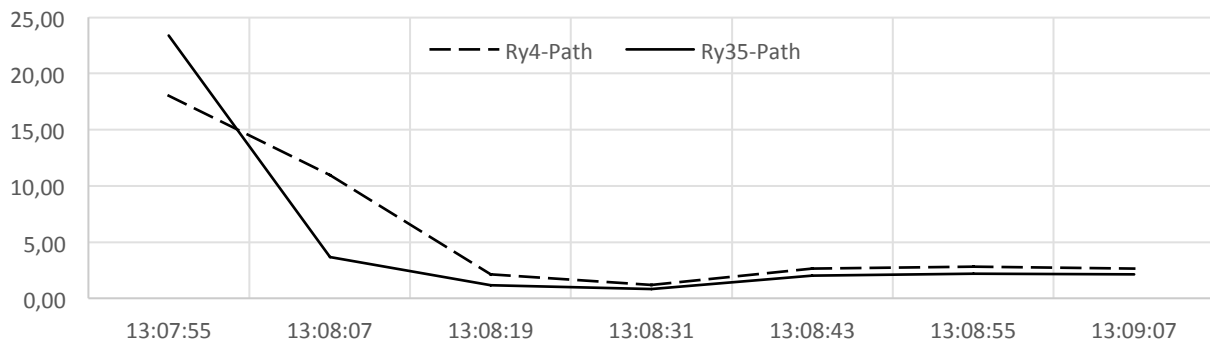
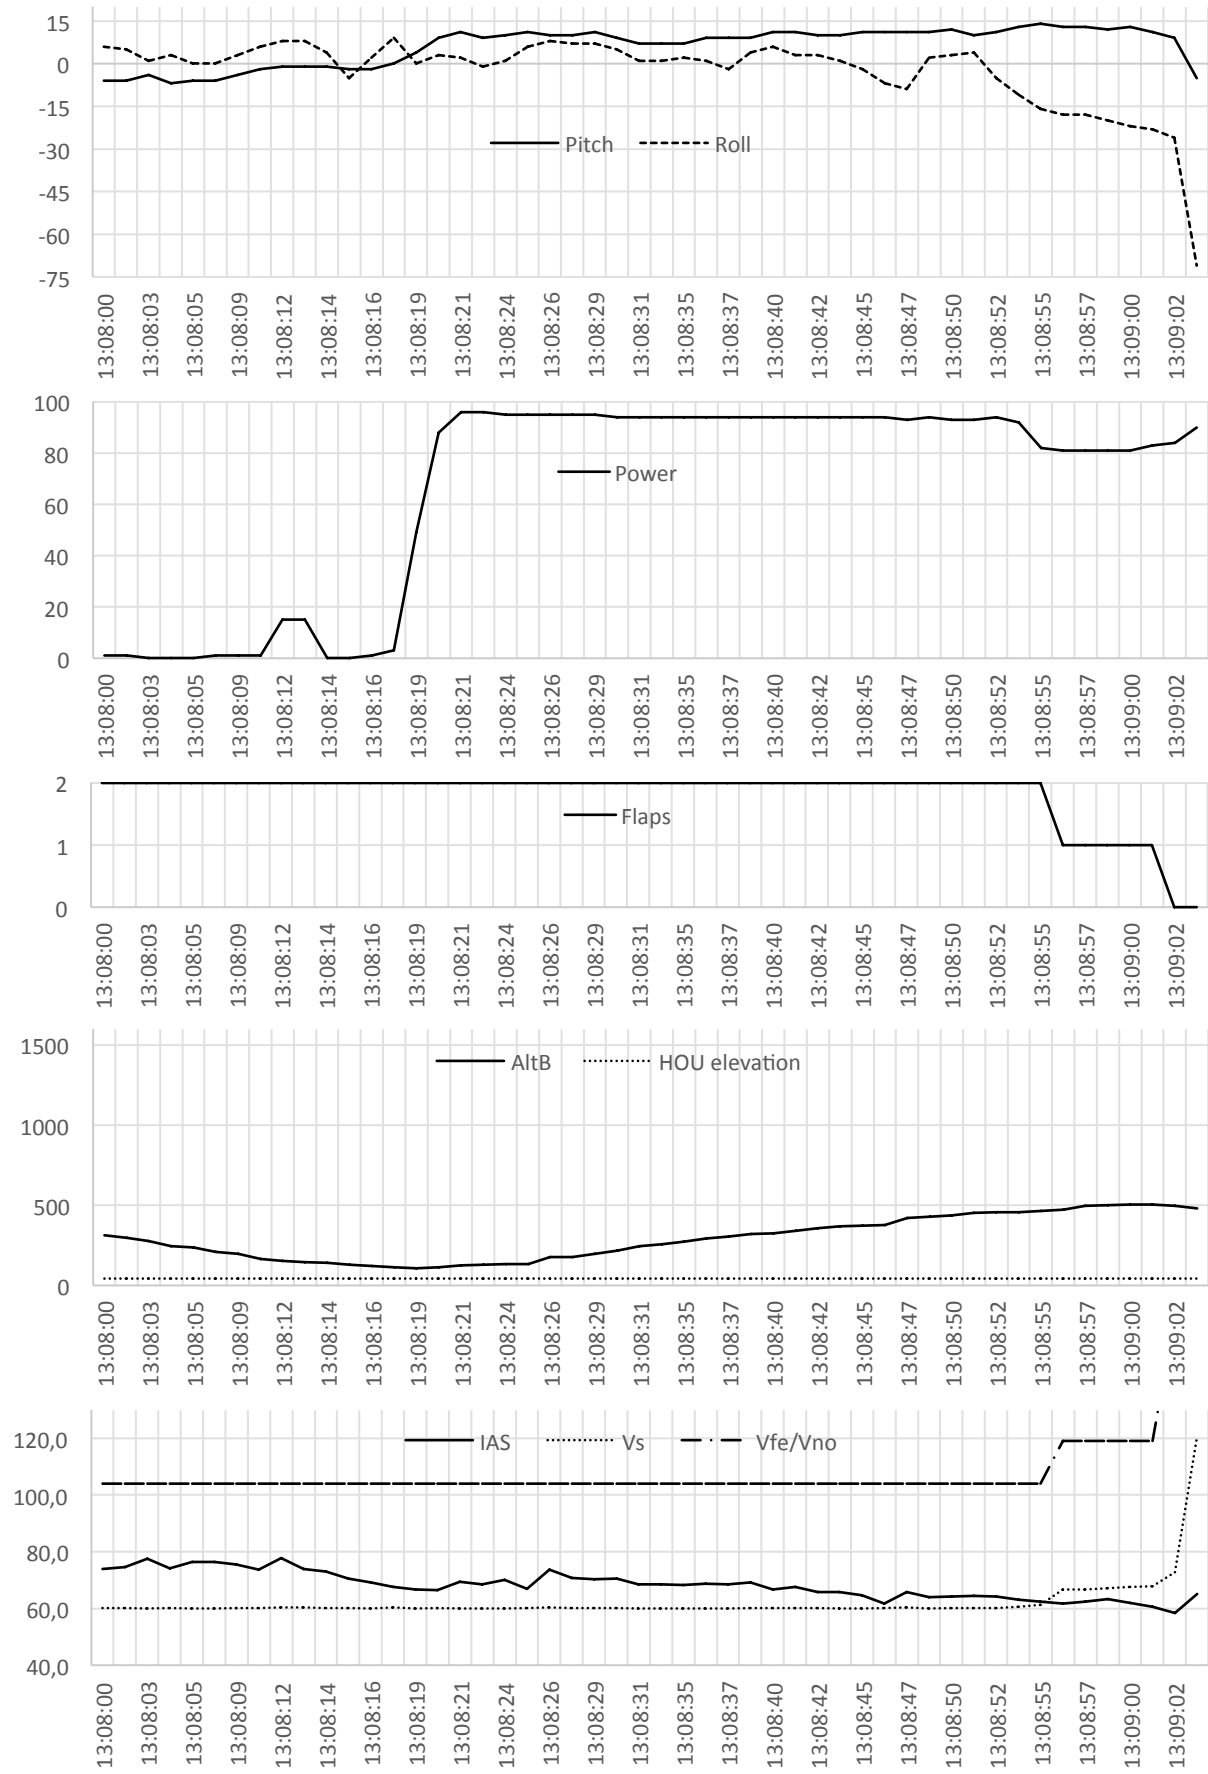
Figure 2-12 Go-around following second approach to runway 35 and loss of contact

The flight data and the graphical presentations of the flight track with the associated ATC transcript in Figure 2-12 and the graphical presentation of the aircraft's flight parameters in Diagrams 2-23 (13:07:55 - 13:09:07 CDT) and 2-24 (13:08:00 - 13:09:02 CDT) whilst performing the second approach to runway 35 of N4252G were analysed in detail.

The pilot continued the final approach to runway 35. At 13:08:19 CDT at a position in the last third of runway 35 (refer to Figure 2-12) at an altitude of 107 ft (64 ft above ground) and at a speed of 66.7 KIAS (note that the recommended approach speed with flaps 100% is 78 KIAS; for procedural details, refer to E Appendix) the go-around was initiated. The power was set to 96%. The airspeed at the time of go-around was 66.4 KIAS. The flaps were not retracted and left at 100%.
