**Engineering geological and geomechanical analysis of a rock
slope in the Ödenwinkelkees – Focus on the determination of the
discontinuity network and its characteristics**

Master's Thesis

Graz University of Technology

Graz, March 2021

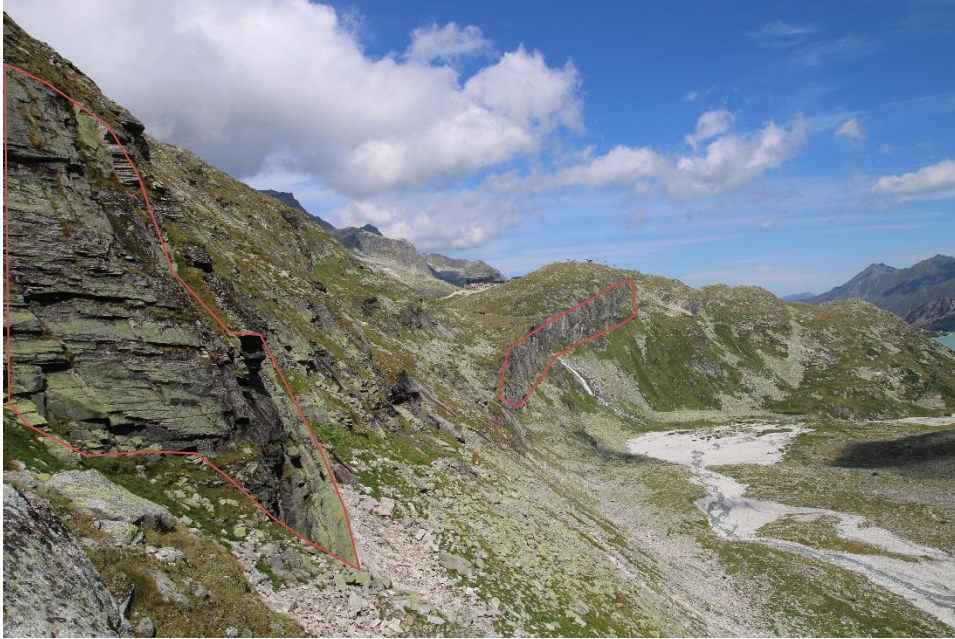
Figure 55 The mean slope angle might be stable but there are steep and exposed rock walls that may be prone to fail. For example, the highlighted areas.

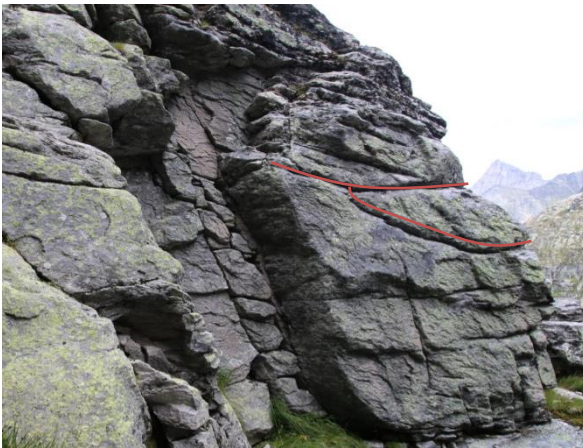
Figure 59 Splay shaped pattern of JS1.

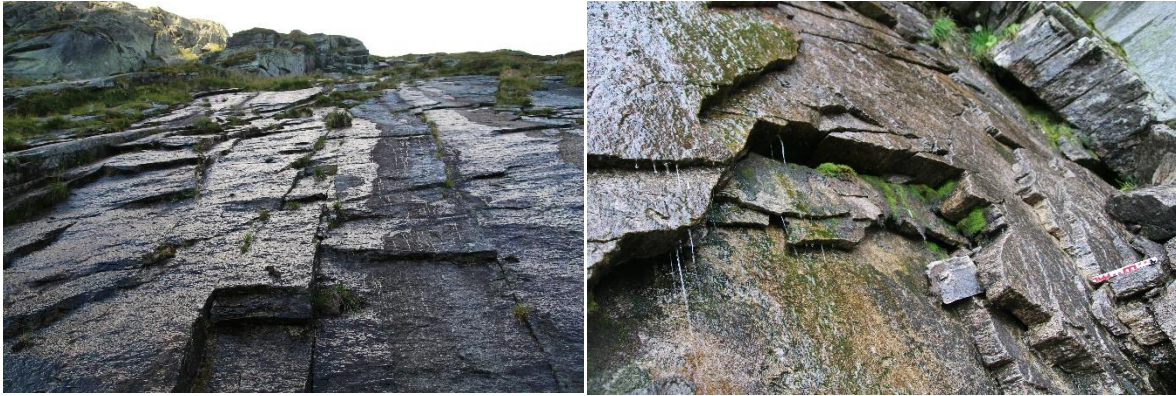
Figure 60 Water flow through very persistent joints. Left through JS1 (Outcrop 4) and right through JS2 (Outcrop 5).

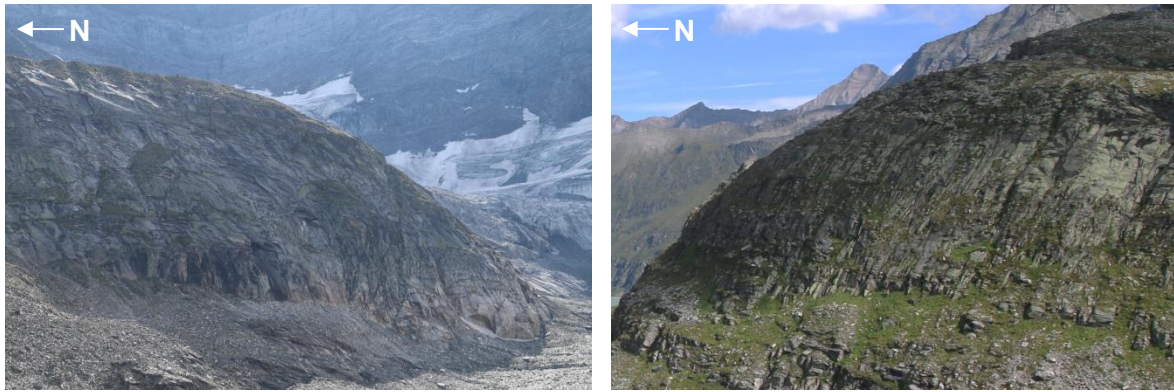
Figure 62 Photographs of the rock slope on the opposite side of the valley. (A) Left: The same slope parallel joints can be recognized. (B) Right: Steeply dipping joints that may be equivalent to JS2.

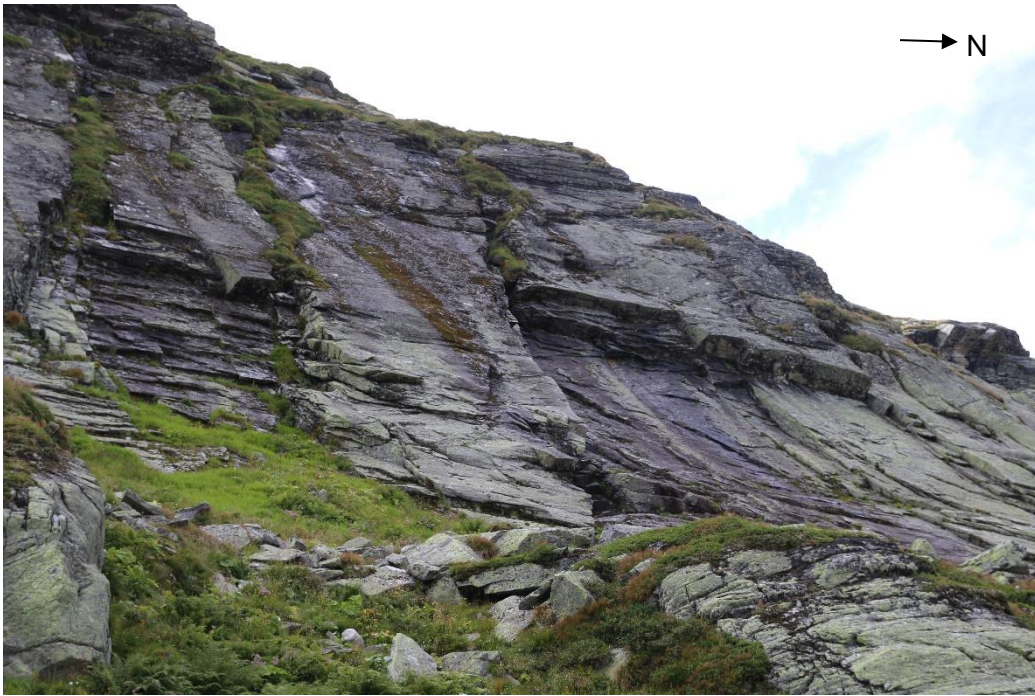
Figure 63 Planar sliding surface on JS1.

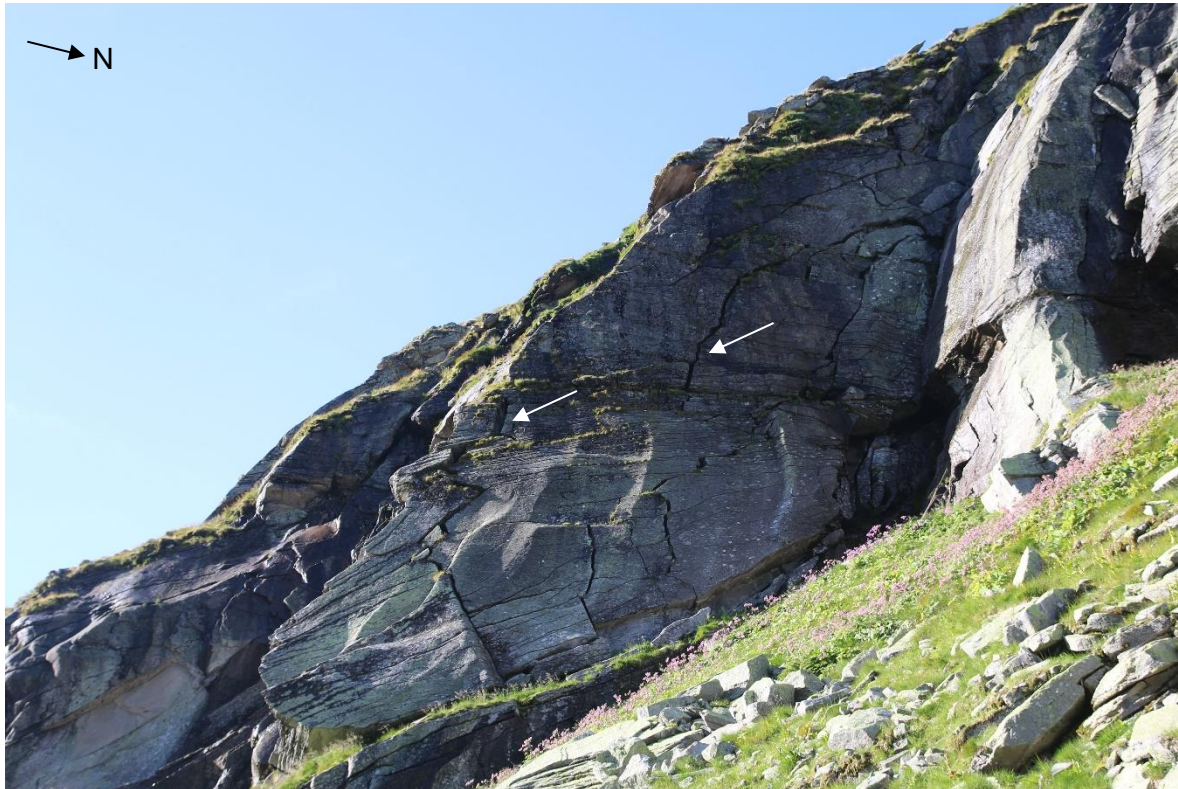
Figure 65 Rock mass prone to direct toppling.

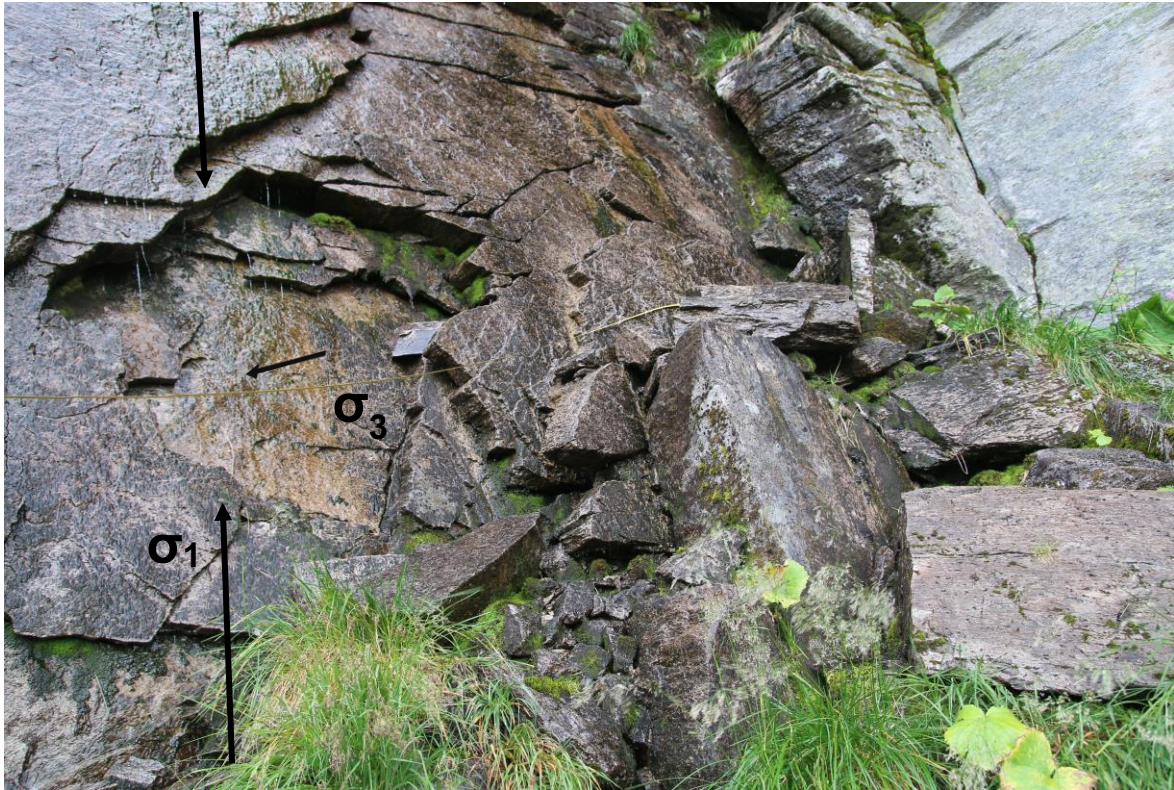
Figure 66 Buckling of rock slabs bounded by sheeting joints.

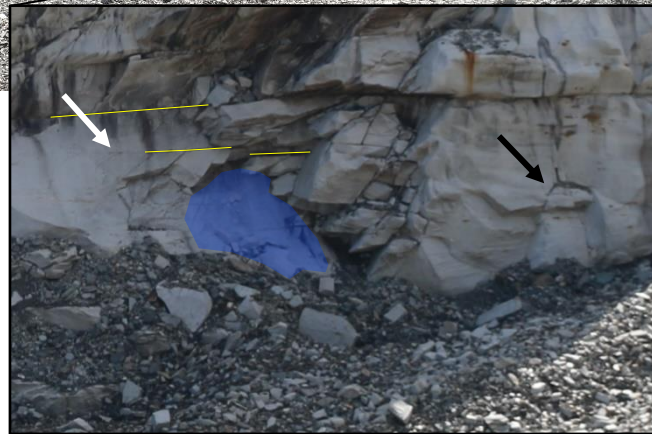
rock mass which formed parallel to the slope surface. These parallel discontinuities are marked with the blue area. The JS is less dominant. The rock mass in the bottom on the left side does not show any joints at the surface. Therefore, glacial marks are visible. It indicates that this part became ice-free during the last few years. In general, there are not as many slope parallel joints visible. In the rock mass in the bottom on the right side slope parallel joints may have just developed. Only a few associated joint surfaces are visible.
