Scotiabank Saddledome Roof Structure Monitoring Program

Vidya Limaye¹; Subharajit Roy¹; Mark Leblanc¹; Elizabeth Whittaker²; Atul Paranjape³; Lindsay Alleyne³

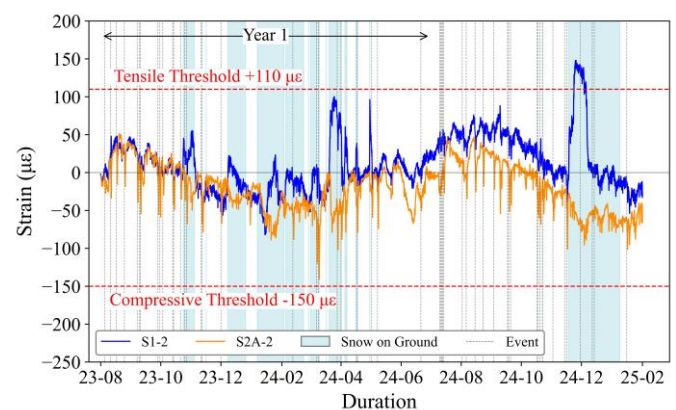
Figure 8. Strain Data from Different Zones

Analysis of the strain data revealed that the arena roof experiences event-specific changes in the strain levels both right before and after the events. These localized peak strain variations are primarily caused by the addition of event-specific mechanical and electrical fixture loads and their subsequent unloading from the arena roof. The strain levels are further increased due to snow accumulation and reduction in external temperatures. During these events, the internal temperature in the arena varied between 10°C and 22°C. The results also indicate that, during each scheduled event, the strain variations exhibited a similar pattern as the variation in the internal temperature inside the arena. The maximum tensile and compressive strain recorded by the strain gauge network is 148 µε and 140.5 µε, respectively against the threshold values of 110 µε and 150 µε. During this period, the absolute change in strain registered by a strain gauge was 230 µε.

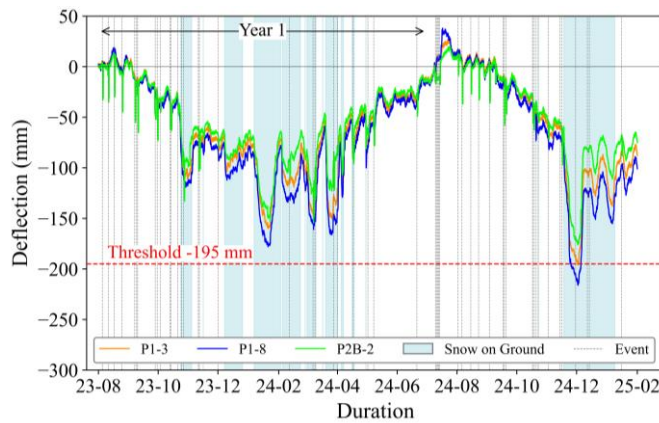
Figure 9. Deflection Data from Different Zones

The deflection levels recorded by target reflective prisms are compared with prisms symmetrically positioned about the orthogonal axis of the dome to detect any unbalanced deflection conditions. The comparative differential deflection results showed some localized behavioral patterns. A steep increase in downward deflection is observed during the day of each scheduled event in the arena. When accompanied by snowfall events higher levels of deflection are recorded. Figure 9 provides an overview of comparative differential deflection results from three different zones.

The prisms located within the central region of the roof experienced higher deflection levels compared to the rest of the prisms. This phenomenon can be directly attributed to the consistent and balanced loading from the Jumbotron digital display system. The peripheral prisms in the hogging direction encountered a sudden increase in deflection levels during each major event. These specific changes in deflection levels are the result of the additional suspended loading. The maximum upward and downward differential deflections recorded by the survey prism network were 39 mm and 216 mm, respectively against the threshold values of 50 mm and 195 mm. The central prism recorded a maximum change of 254 mm in overall roof deflection during this period. The upward movement of the arena roof occurred during the removal of the old Jumbotron and the installation of the new Jumbotron of similar weight. A few hours after lowering the Jumbotron to the arena floor, the central region of the arena roof lifted upwards by 39 mm. With the installation of the new jumbotron, the deflection levels at the central zone returned to their previous deflection levels.

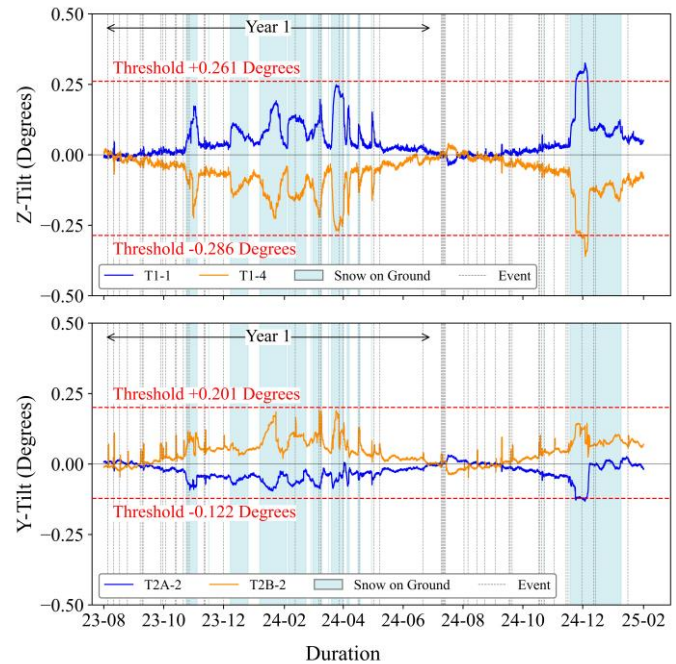
Figure 10. Tilt Data from Different Zones

The tilt levels are compared with respect to the in-plane and out-of-plane axes of the sensors at their symmetrical positions to infer any unbalanced rotation and its magnitude. The peripheral tiltmeters in both sagging and hogging directions recorded the maximum in-plane rotations. Steep changes in both the in-plane and out-of-plane tilt directions were observed mainly during the scheduled events. The maximum in-plane rotation for both high-to-high (sagging) and low-to-low (hogging) directional tiltmeters were 0.36 and 0.19 degrees, respectively. The absolute rotational range recorded by both high-to-high and low-to-low directional tiltmeters are 0.40 and 0.28 degrees, respectively. Similar to strain and deflection, the tilt is also influenced by event and environmental loading. Apart from the in-plane rotation, the Zone-2 tiltmeters experienced noticeable out-of-plane rotation during scheduled events, with the maximum rotation recorded at about 0.1 degrees. These out-of-plane rotations have primarily occurred due to the additional suspended loading and unloading during scheduled events. Figure 10 demonstrates the in-plane rotation in both the sagging and hogging directional tiltmeters. All the central tiltmeters showed a similar level of rotation on both planes when compared to the peripheral tiltmeters due to the consistent presence of Jumbotron loading. Similar to the deflection behavior, during the replacement of the Jumbotron,

the tiltmeters recorded a reverse angular shift but regained their normal levels after installation of the new Jumbotron.

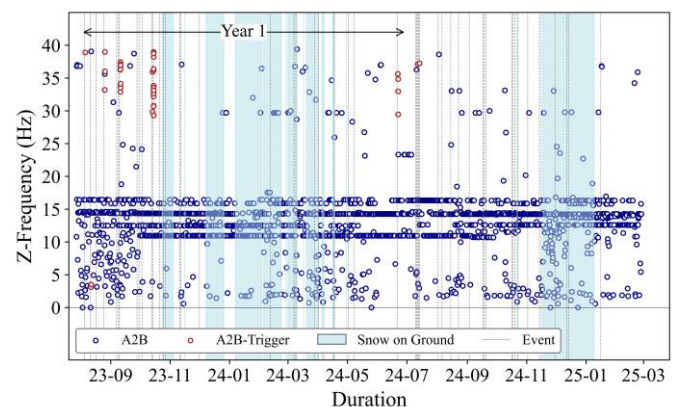
Figure 11. Typical Frequency Response of Arena Roof

The acceleration responses collected by triaxial accelerometers depending on two different acquisition modes: ambient and triggered, provided an understanding of the natural and induced frequency responses of the arena roof under different vibration levels and dynamic forces. The acceleration responses from different zonal accelerometers were analyzed using the Fast Fourier Transformation (FFT) and spectral density analysis. The peak frequencies were extracted and divided into four separate frequency bins based on their acquisition modes. Figure 11 presents the extracted ambient and induced frequency response from a Zone-2 accelerometer in the z-direction. Overall acceleration analysis showed that the natural frequency range of the arena roof is between 0 to 20 Hz. During an excited scenario, the frequency range of the arena roof lies primarily between 30 to 40 Hz.

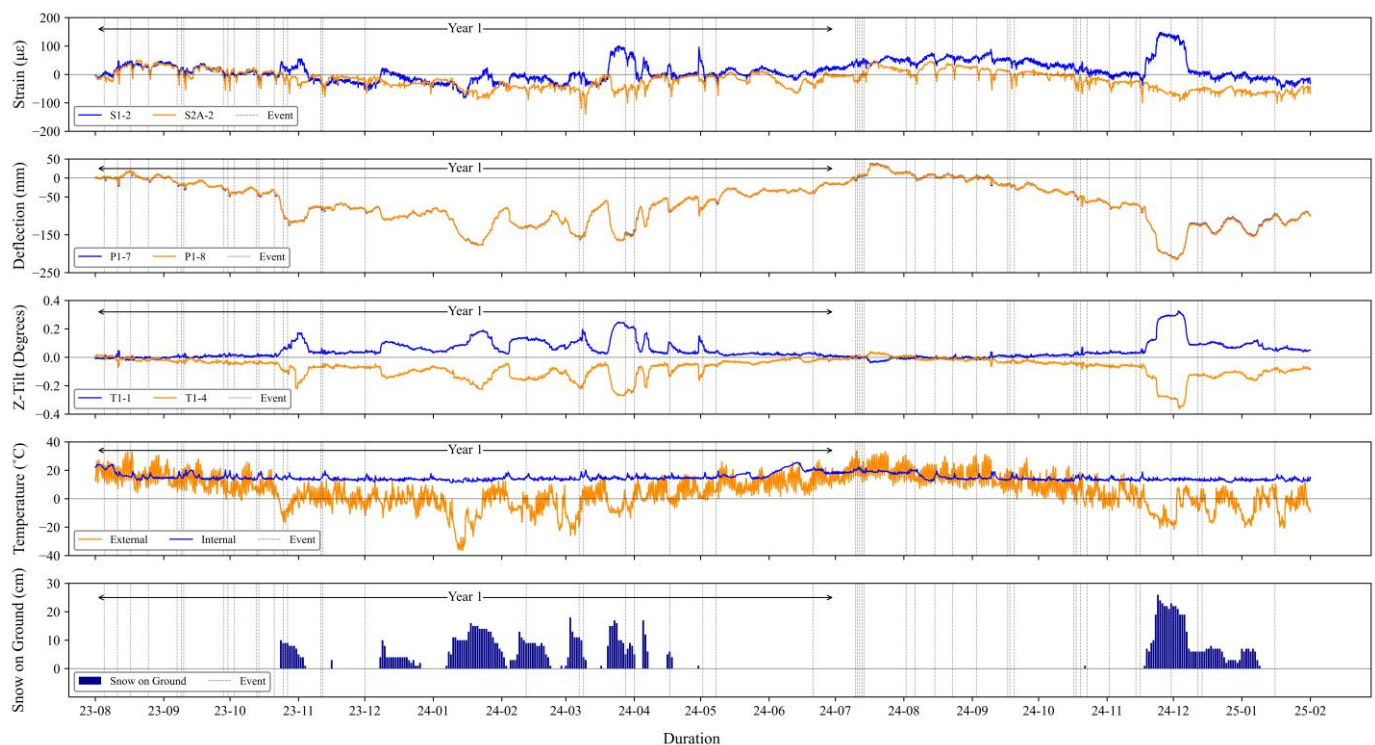
Figure 12. Monitoring Data Envelope for Strain, Deflection, Tilt, Temperature, Snow on the Ground

The global analysis shows that the arena roof experiences significant thermal-induced stresses and deformations, irrespective of their source being of internal or external origin. The changes in the concrete ribs' strain, the overall deflection profile, and the tilt variation at different locations in the arena are primarily driven by the external weather conditions (such as external temperature and snowfall) as seen in figure 9 and figure 10. However, the steep changes in the monitoring data are attributed to the internal conditions (such as event-related loadings and internal temperature of the arena).

The sagging concrete ribs in the arena roof are primary load-carrying members, and the tensile strain data recorded by those sensors installed on the sagging ribs showed elevated levels of strain. This period coincided with the increase in deflection and tilt levels observed by the central prisms and peripheral tiltmeters, respectively. In contrast strain gauges and tilt meters installed on the hogging ribs showed lower levels of strain and tilt respectively.

This behaviour can be attributed to movement in the arena roof caused by the temporary stretching of the sagging concrete ribs, the downward displacement of the central roof area, and the compressing of the hogging concrete ribs. In late 2024, accumulated heavy snowfall and additional event loading caused several deflection sensors to exceed their assigned thresholds, including a downward movement of up to 216 mm observed between November 25 and December 5. Upon clearing the accumulated snow, the roof rebounded to within acceptable threshold limits, indicating its elastic response to the loading conditions. The monitoring data indicate that changes related to external weather conditions are time-dependent rather than sudden. Additionally, the data analysis revealed a noticeable time lag between external weather changes and the corresponding monitoring data, likely due to the low thermal conductivity of the insulated concrete structure.

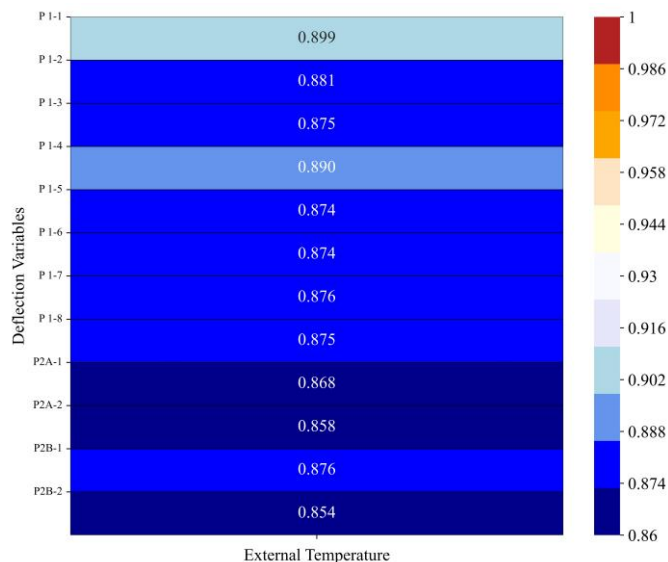
Figure 13. Relationship between Deflection and External Temperature

Figure 13 presents a Pearson correlation table between external temperature and deflection data from various reflective target prisms. Correlation analyses of other monitoring parameters not presented in this paper (strain and tilt) also show a high degree of correlation with external temperature.

The weather starts getting colder in October and remains cold until April of the following year. During the same period, starting in December, the City of Calgary experiences snowfall, which continues until the end of April. During Year 1 of the monitoring period, from August 2023 to July 2024, Calgary's lowest recorded temperature was -37°C , and the highest was 34°C . So far, during the current period of 2024-25, the temperature has ranged between -28°C and 31°C . However, the snow on the ground data for the current period shows that the city recorded higher levels of snow on the ground for consecutive days compared to the previous year. Due to the height of the arena roof, combined with heavy winds and adverse weather conditions, the snow removal process from the arena roof can be challenging. This becomes an important factor to consider, particularly when it coincides with an ongoing scheduled event or a concert.
