The Collapse of the Carola Bridge – Forensic Engineering and Palliative Monitoring

ABSTRACT: The events of September 11, 2024, will remain etched in the collective memory of Germany's bridge engineering community. The sudden and unannounced partial collapse of a prestressed concrete bridge rightfully reverberated across society at large. The structure in question was the Carola Bridge in Dresden. This architecturally refined and exceptionally slender bridge is, with good reason, regarded by professionals as an icon of its time's structural engineering. Even by today's standards, its design and construction would pose a considerable challenge. This paper presents the main findings from investigations undertaken to determine the cause of the collapse and attempts to reconstruct the failure process. Additionally, the acoustic monitoring system implemented to safeguard the remaining superstructures is also presented.

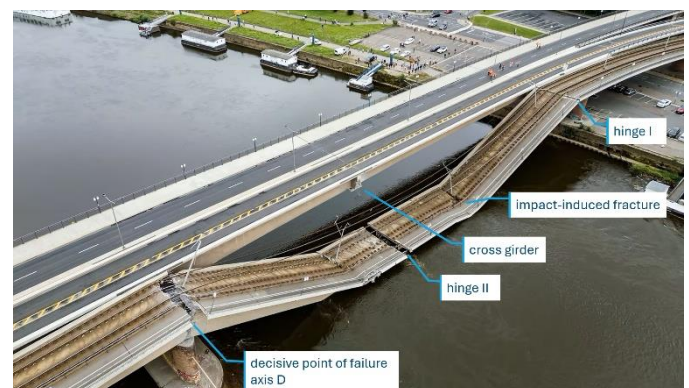
Figure 2. Building immediately after the collapse.

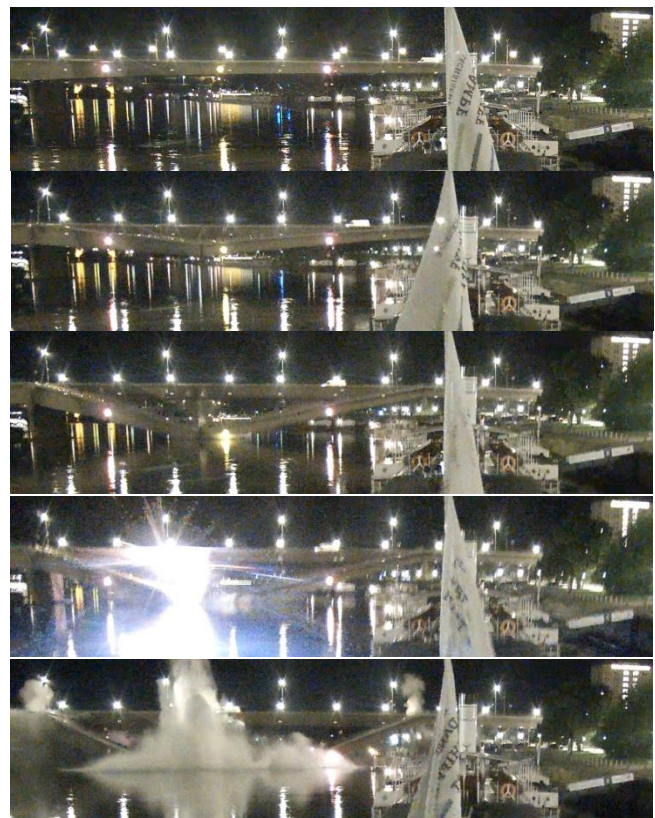
Figure 4. Recordings from a surveillance camera: initial state and moment of collapse.

captured the incident as it unfolded (Figure 4). Facing upstream, the camera recorded precisely the critical area—the river span between axes C and D.

A frame-by-frame analysis of the footage reveals the sequence of events: initially, the region around hinge II began to subside, while a crack opened at the support cross-section in axis D. Moments later, the overhead tram catenary came into contact with the river. A flash of light illuminated the night sky, accompanied by a column of spray erupting from the water's surface.

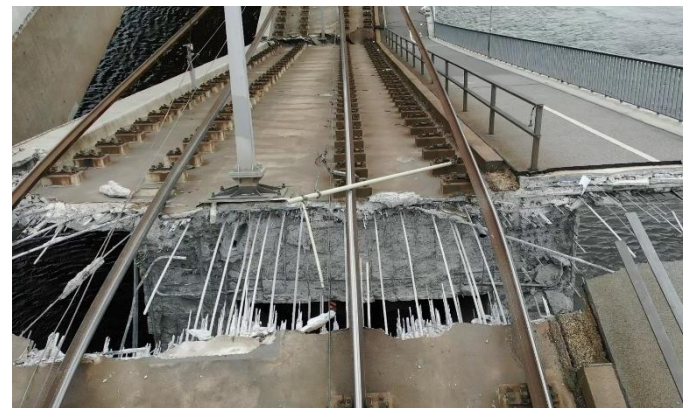
A characteristic feature of the fracture cross-section—beyond the failed prestressing tendons—was the presence of reinforcement bars that had been pulled out from the concrete section in the upper reinforcement layers (Figure 5). In several cases, the reinforcing bars exhibited no signs of fracture, necking, or cross-sectional loss. Only isolated and minimal indications of chloride-induced corrosion were visible externally (e.g. slight pitting corrosion at the ribs).

Subsequent analyses of concrete samples taken from the fracture zone confirmed that chloride-induced pitting corrosion did not play a relevant role in this area. The tightly spaced arrangement of tendons and reinforcement bars likely impaired the bond performance, which may have contributed to the complete pull-out of some reinforcing bars from the roadway slab.

Figure 5. Failed cross-section in axis D with pulled-out steel reinforcement.

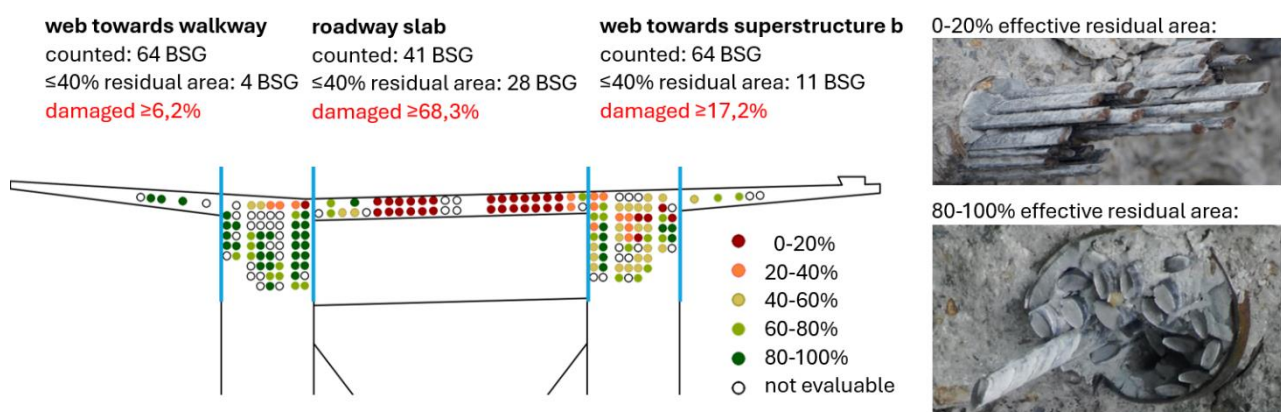
The condition of the prestressing tendons was evaluated visually and classified into damage categories. It became evident that the post-tensioned tendons in the roadway slab area, in particular, showed advanced pre-existing damage and had failed long before the collapse. These post-tensioned tendons had only been stressed after a time delay, following the installation of the suspended main-span beam; see also [2]. This conclusion was drawn from the almost black fracture surfaces of many tendons (top right in Figure 6), indicating an oxygen-deficient environment within the still-intact sheathing. As such, these wire fractures occurred either during construction or shortly thereafter, but in any case, a considerable amount of time ago.

Later microscopic investigations of fractured wires, conducted by the Federal Institute for Materials Research and Testing (BAM), Berlin, revealed mortar residues on some fracture surfaces—clear evidence that these fractures had occurred before or during the grouting process. Fresh fracture surfaces appeared metallic and glossy, without signs of corrosion, and also showed no ductile necking in the failure zone (bottom right in Figure 6). Even the prestressing steels without pronounced crack initiation lenses showed signs of embrittlement.

Figure 6. Results of photographic documentation of the condition of the broken prestressing wires at axis D of superstructure c, view direction Dresden-Neustadt (mid of December 2024).

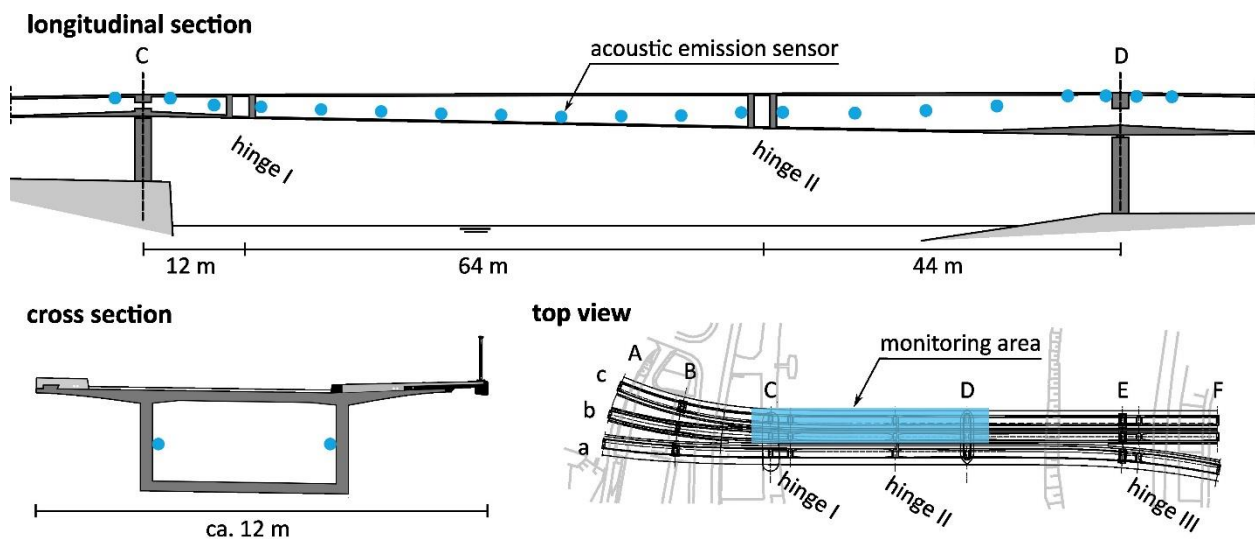
Figure 7. Overview of the monitoring area and the sensor layout for the acoustic emission monitoring system.

An evaluation of the structural safety could not be guaranteed solely through static analysis under the prevailing conditions. Therefore, a prerequisite for reopening the Elbe to ship traffic was the implementation of acoustic emission monitoring to detect new wire break events [6], [7]. Shortly after the partial collapse, a small number of sensors were installed in the roadway slab above pier D in superstructures a and b to ensure safety during on-site diagnostic investigations. In January 2025, this system was expanded to cover the entire main river span and the support regions at axis C (Figure 7 and Figure 8).

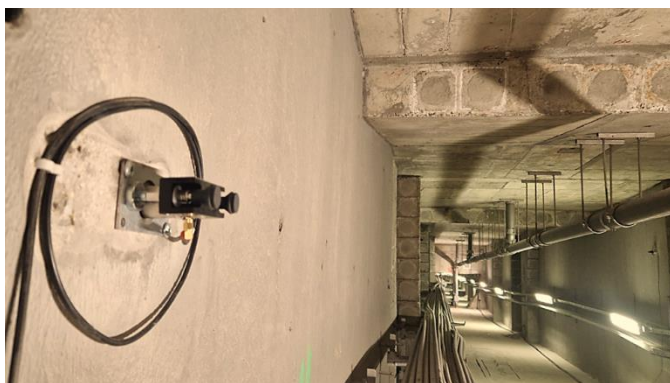
Figure 8. Acoustic emission sensor in superstructure b.

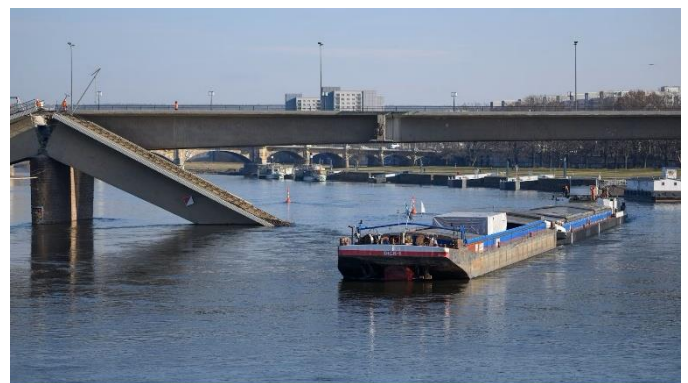
Figure 9. First ship passage after the collapse of the bridge and the installation of the monitoring system.

As of February 3, 2025, controlled ship passages were permitted based on real-time monitoring data, solely for operationally critical transit (Figure 9). Initially, a ship-specific clearance protocol was applied. From 18 February onward, clearance was planned to be issued daily, allowing navigation within predefined time windows. However, on the morning of 18 February at 04:50 a.m., the first wire break events were recorded. Several additional events followed within hours, concentrated on the axes and adjacent roadway slabs. At axis D, up to six spatially correlated events were detected within 24 hours. This sudden development was most likely triggered by pronounced temperature differentials compared to previous days.
