A damage screening method of the concrete slab focusing on correlation of mode shapes

KEY WORDS: Damage screening method; Mode shape; Concrete slab bridge; Maintenance.

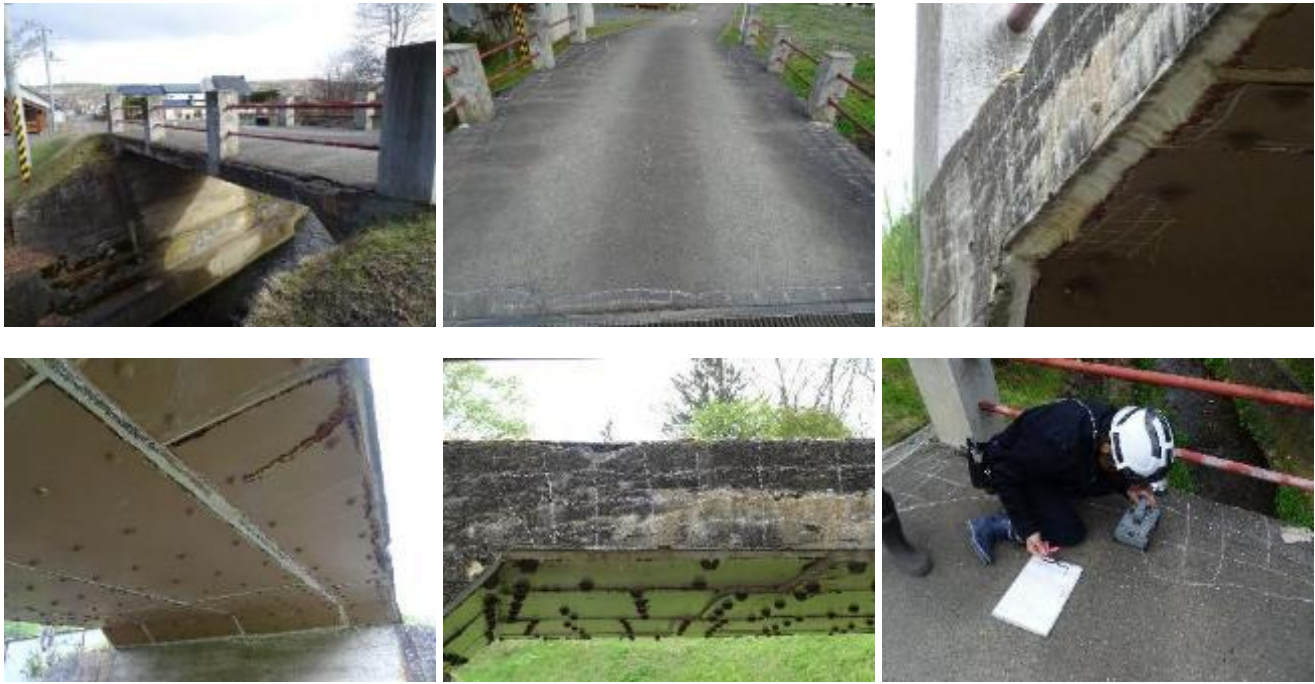
Figure 2. Inspection photos.

Visual inspection was conducted to grasp degree of damage of each component by our research group in 2023. As a result of this inspection, widespread flaking has been found at the pavement on both sides, and corrosion and free lime can be seen on the reinforcement steel plates underside of the slab. Especially, icicle-like free lime has been found upstream side on the A2 abutment. Since this bridge does not have a waterproof layer on the concrete slab, it was suspected that segregation of the slab surface occurred more than in other areas. However, the pavement and steel plates make it difficult to see damage directly. A non-destructive survey by using electromagnetic waves was conducted on the pavement, but it did not obtain a clear waveform from the surface of the slab. Inspection status and results are shown in Figure 2 and Figure 3.

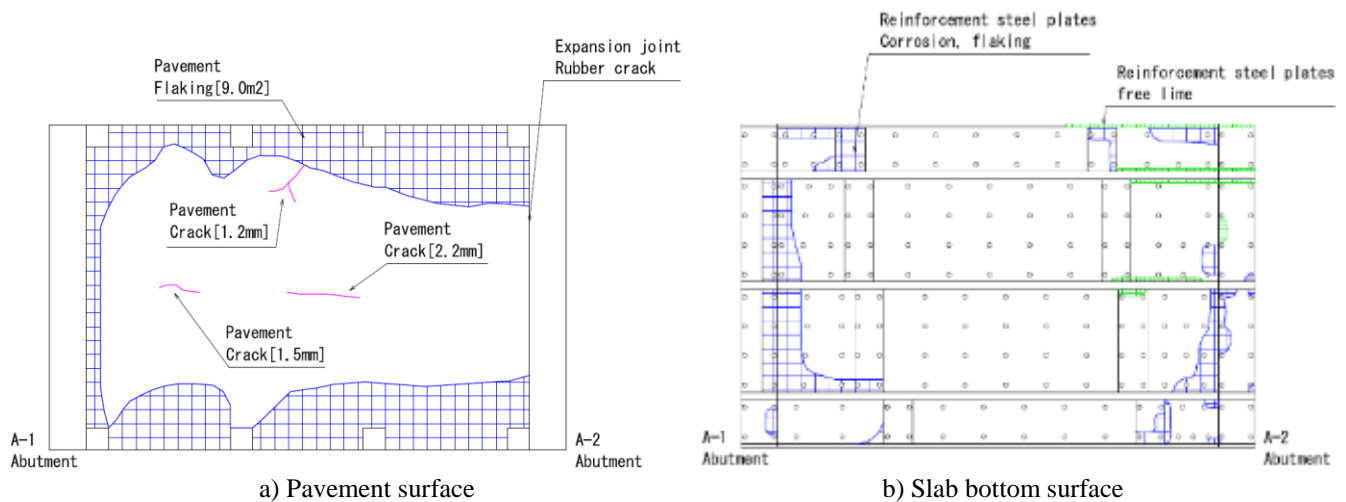
Figure 3. Inspection results.

As a result of the inspection shown in Figure 3, icicle-like free lime has occurred upstream side on the A2 abutment, then it is thought the segregation has progressed more than in other areas. At the relationship between sensor position and icicles position shown in Figure 7, it shows that the icicle-like free lime is near the sensor number 3. In this study, the COMAC (Coordinate Modal Assurance Criterion) [6] technique is adopted to try to

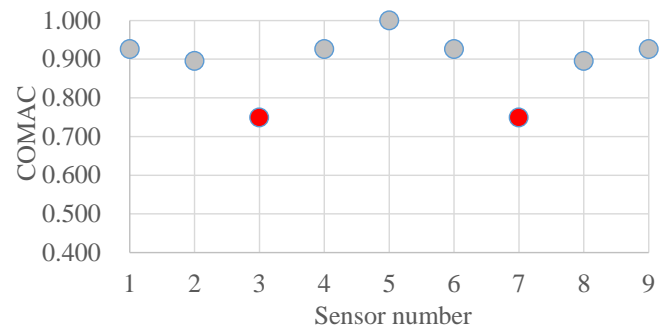
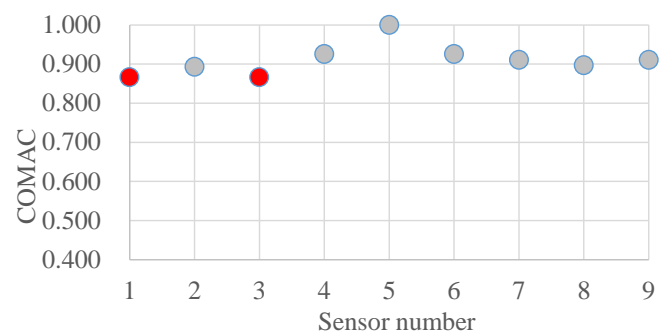
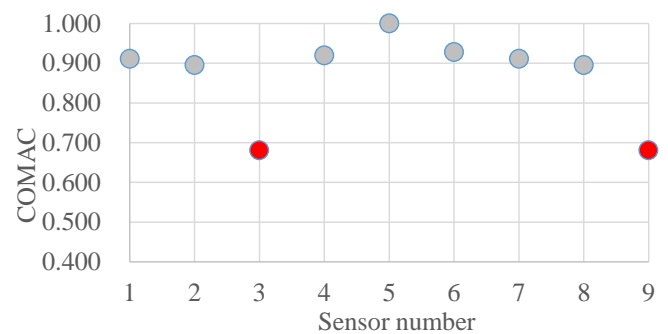
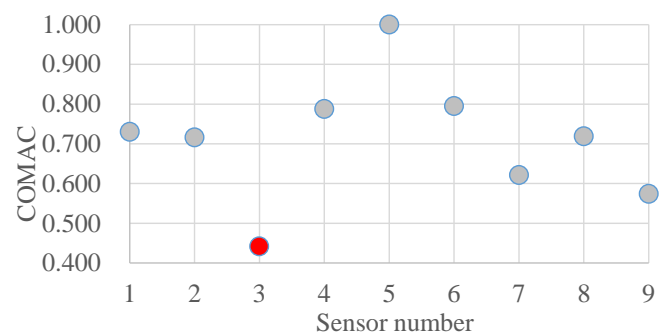
Figure 9. COMAC results.

In the COMAC comparison between patterns 1 and 2, it shows the values at sensors 3 and 7 are relatively low. Also, in the COMAC comparison between patterns 1 and 4, it shows the values at the sensor number 3 and 9 are more clearly lower. On the other hand, the COMAC result between patterns 1 and 3 is less clear than the others, it barely lowered sensors 1 and 3. From these results, the COMAC value at sensor number 3 is generally low. Here, a graph of the three results multiplied together is shown in Figure 8d) in order to clarify the difference in the COMAC values for each sensor. The correlation at the sensor number 3 was the single lowest.

As a result of the above, it was considered that the COMAC value of sensor number 3 which was located near the icicle-like free lime was the lowest, the rigidity of the concrete slab may have been reduced by the pooled water at the invisible inside, it affected the mode shape of the sensor number 3. It was also shown that even without initial structural values or historical measurement data, it is possible to screen for the damaged locations by swapping vibration mode vectors, even the locations are limited.
