## Icelandic turf houses: A one-year monitoring overview

This paper provides a one-year overview of monitoring at two sites: Keldur farm in southern Iceland and Laufás in the north. The study details the monitoring strategy, system design, installation, and operation, presenting results such as 3D point scans, hygrothermal data, and comparative analyses between the two sites. Findings from the study contribute to understanding the behavior of Icelandic turf houses, offering insights for their long-term conservation and ongoing management.

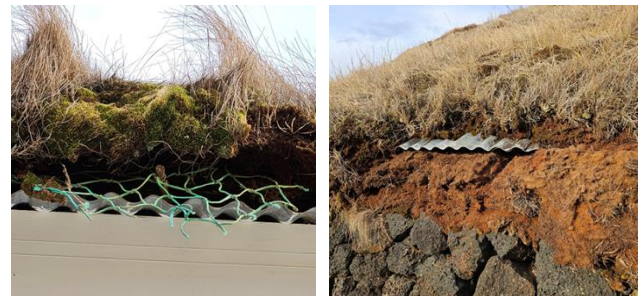
Figure 3: Examples of corrugated steel in turf roofs. A fishing net has also been added likely because the turf slides on the corrugated steel.

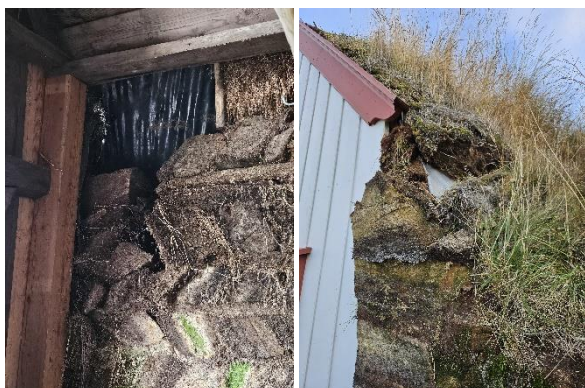
When constructing a turf roof today, the ideal thickness ranges from 40-70 cm (Sigurðsson, 2025). We have not yet seen a roof with this thickness in any of the buildings we are monitoring. Additionally, many of the roofs have holes or chunks of turf missing.

Figure 4: Examples of plastic membranes in turf roofs. Left: membrane visible from the inside. Right: membrane visible from the outside.

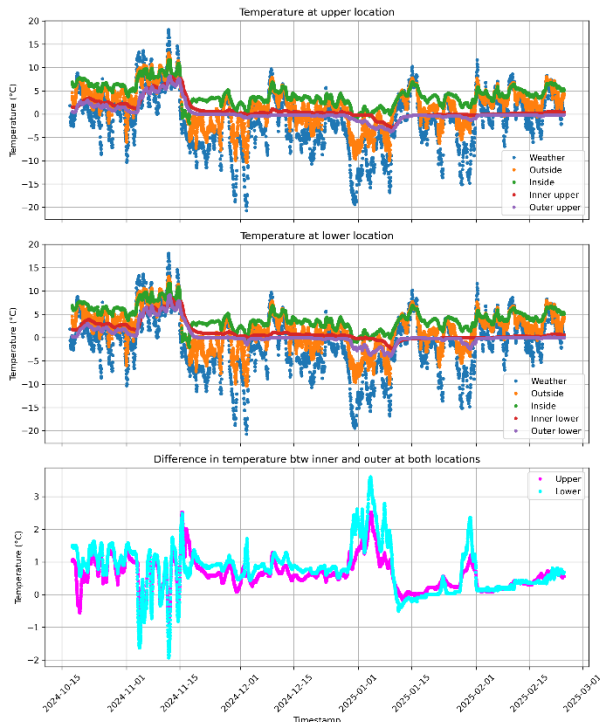
The temperature in the turf shows less fluctuations than the air temperature outside and inside the house. The difference between the outer and inner sensor is remarkably low, only 1-3°C, as shown in the lowest plot in Figure 14.

Figure 14: Temperature measurements in Laufás. Note: Weather refers to temperature from nearest weather station, Végeirsstaðir.

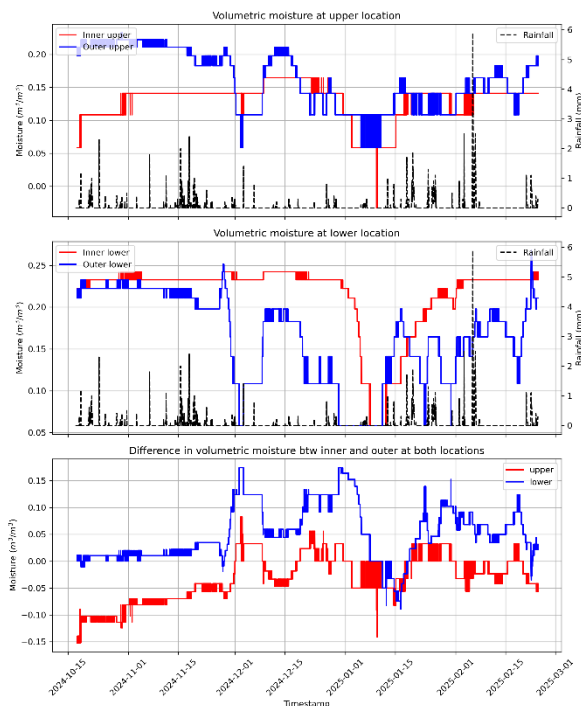
Figure 15 shows the turf moisture measurements in Laufás. In this first analysis the manufacturer calibration of the moisture sensor was used. That can have an effect on the absolute values but does not affect the trends. The moisture is plotted together with rainfall measurements from the weather station in Akureyri, 20 km from Laufás. Heavier rain can be correlated with higher moisture content.

Generally higher moisture content is measured in the lower location than in the upper location. This observation is consistent with that rainfall and moisture within the turf seeps downwards.

Figure 15: Turf moisture measurements in Laufás. Note: Rainfall measurements from weather station in Akureyri.

Moreover, the inner sensor at the upper location is drier than the outer sensor, also consistent with expected behavior. However, at the lower location the outer sensor is drier than the

inner. More investigation is necessary to fully explain this observation.

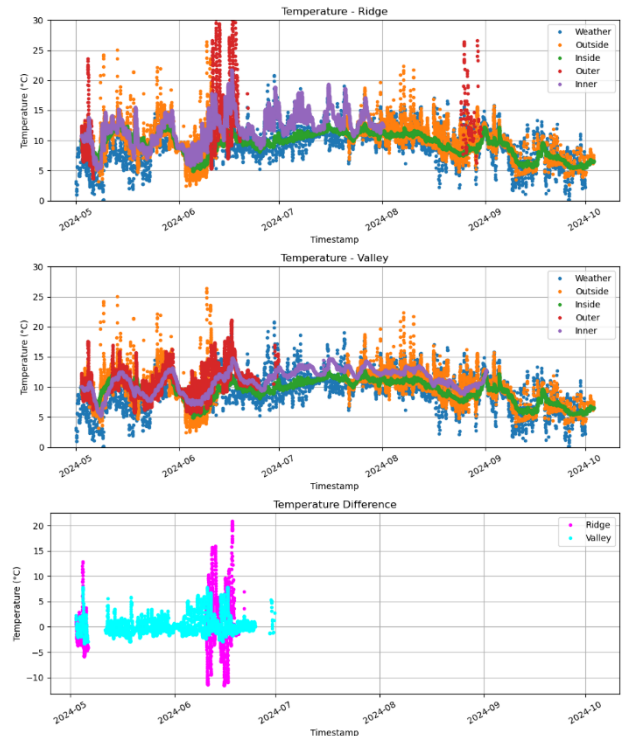
In general, the temperature close to the surface (red) fluctuates more than the temperature deeper in the turf close to the plastic (purple). The temperature inside is more stable than outside. Close to the ridge the temperature increases significantly, even higher than the air temperature. This is most likely because this part of the roof is facing south and highly affected by the sun radiation.

In the valley, which has more shadow, the outer sensor measures higher temperatures than the inner. The lowest plot in the figure shows the temperature difference between the outer and inner sensor at both locations. The temperature difference is higher at the ridge than at the valley, showing that the surface of the turf is very prone to temperature fluctuations. It even indicates that the turf, albeit thin, exhibits good insulation properties and/or high thermal inertia.

Note that for less extreme temperatures, between 5°C and 10°C, the difference between the outer and inner measurements is not as pronounced.

Figure 16: Temperature measurements in Keldur. Note: Weather refers to temperature from nearest weather station, Sámstaðir.
