Redundant Monitoring Strategies for Structural and Geohazard Assessment Using Wireless Tiltmeters and LiDAR on Linked Highway Bridges in Colombia

ABSTRACT: The bridge system composed of Los Grillos, Puente Nuevo, and Chorro Blanco, located along the roadway connecting Sogamoso and Aguazul, near the municipality of Pajarito (Colombia), is founded on an active large-scale landslide in shale bedrock. This mass movement exhibits variable displacement rates depending on rainfall frequency over time. On August 20, 2023, the Los Grillos Bridge collapsed as a result of cumulative ground displacements that compromised its foundations and piers. Between July and December 2024, an integrated monitoring system was implemented, combining observations from an Automated Total Station (ATS), distance measurements using LiDAR, and tilt data obtained from inclinometers. The primary objective of this system is to establish correlations and track both ground and structural displacements, thereby supporting local stakeholders and decision-makers in the operational management of the remaining bridges still in service for civilian traffic. This paper presents the principal findings and illustrates how t

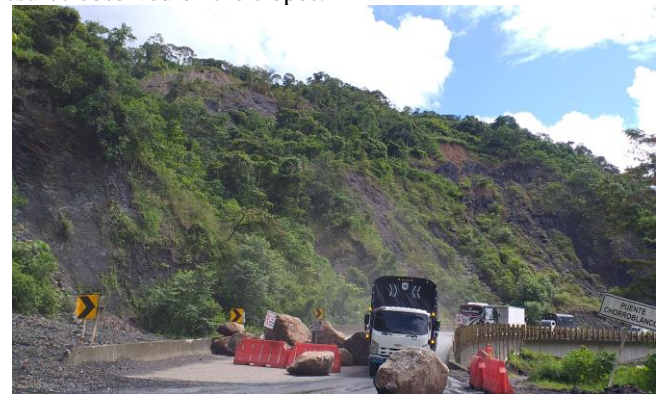
Figure 4. Evidence of geomorphological processes in sector PR81

For years, the area has exhibited significant and progressive mass movement processes, particularly near the Chorro Blanco stream and along the slopes leading to the Cusiana River channel. This suggests that torrential flows from these tributaries may act as a triggering factor for the landslides and fissures observed on the slopes.

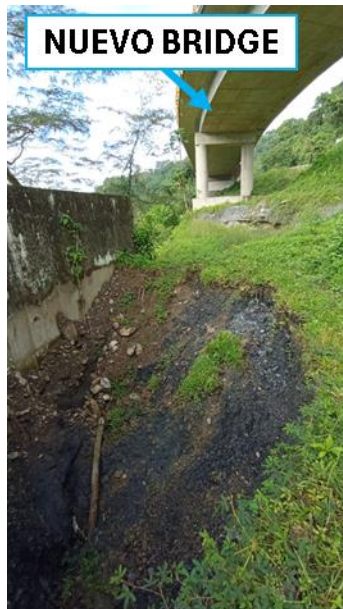
Figure 5. Evidence of mass wasting processes near the foundations of the PR81 corridor bridges

Due to the previously mentioned geodynamic conditions, among the three structures that comprise the viaduct, the Los Grillos Bridge exhibited the most significant deterioration. This was primarily attributed to its structural typology in conjunction with the landslides occurring in the area.

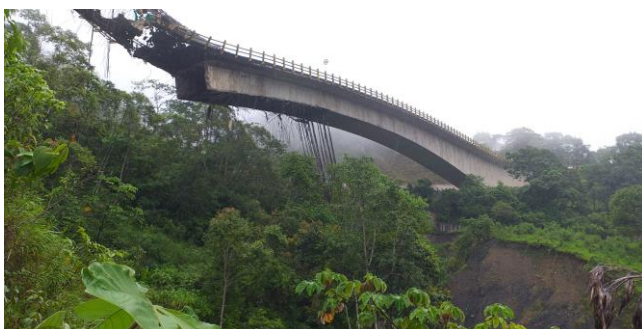
Figure 6. Los Grillos bridge structural collapse.

In 2023, following a series of seismic events with magnitudes ranging from 0.70 to 6.10, a collapse occurred on August 20 in a central section of the Los Grillos Bridge deck, located at the midpoint of the main span. This failure may have been influenced by a combination of factors, including material fatigue and cumulative effects of regional seismic activity.

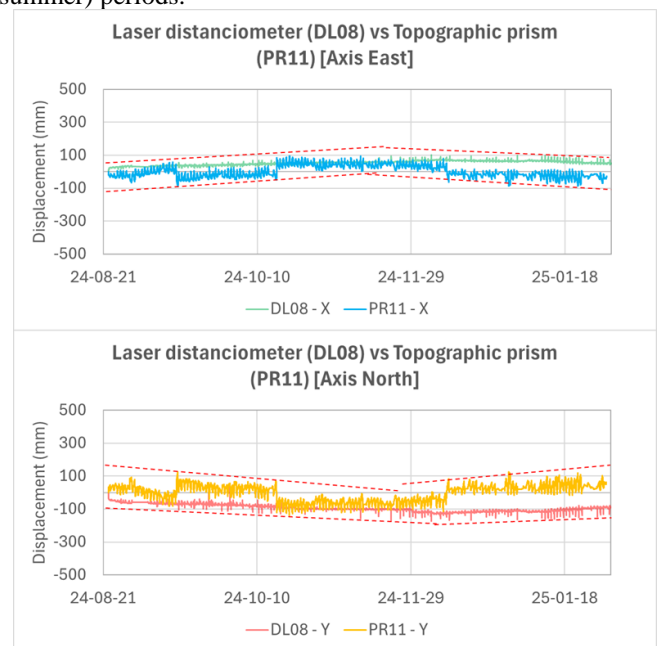
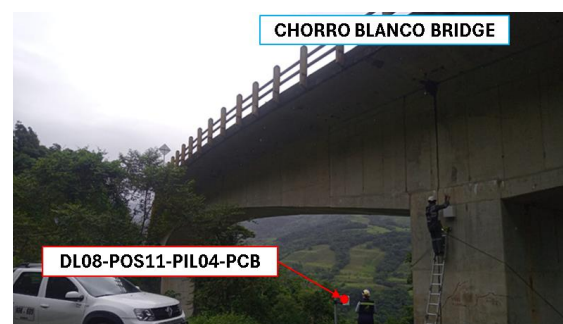
Figure 13. Location and historical record of horizontal displacements for Sector 1

For Zones 1 and 2, based on the data obtained from the dual monitoring system (GMS and sensor network), an initially positive incremental trend is observed along the X-axis (East), which subsequently tends to stabilize.

Similarly, although with an opposite pattern, the Y-axis (North) shows an initially negative incremental trend, also followed by a stabilization phase.

The global displacements recorded along both axes remain below 20 cm in magnitude, which aligns with field observations and with the presence of geomorphological indicators of slow-moving processes.

These behavioral patterns suggest a process of progressive deformation, followed by a decrease in displacement rates (as evidenced toward the end of the monitoring period), possibly associated with the seasonal transition from wet (winter) to dry (summer) periods.

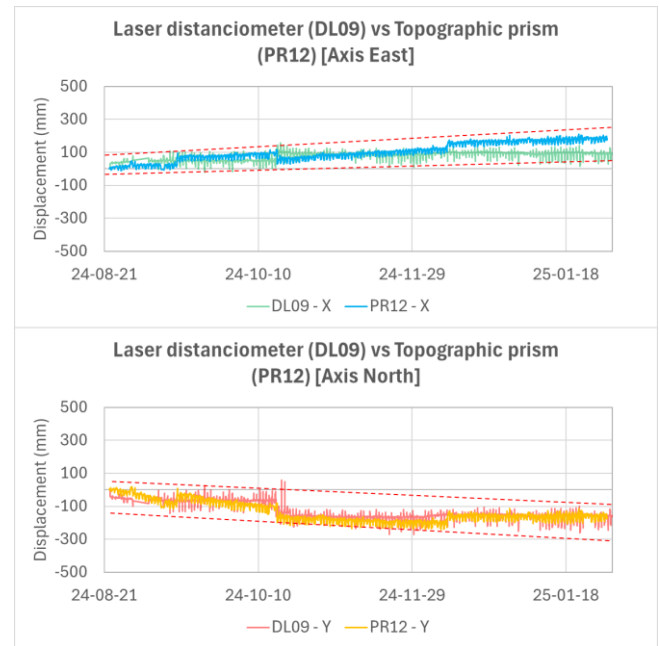
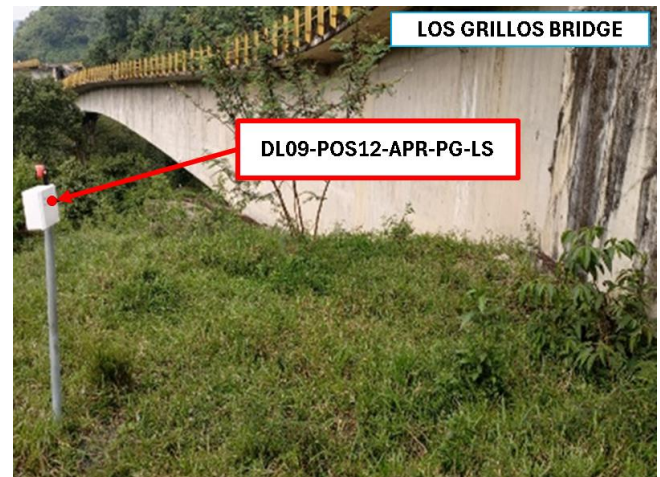
Figure 15. Location and historical record of horizontal displacements for Sector 3

On the other hand, for Zones 3 and 4, based on the information obtained during the monitoring period, mainly incremental displacement trends were identified, with more pronounced movement along the X-axis (East).

In contrast, the behavior along the Y-axis (North) tends to be more stable, exhibiting only minor variations.

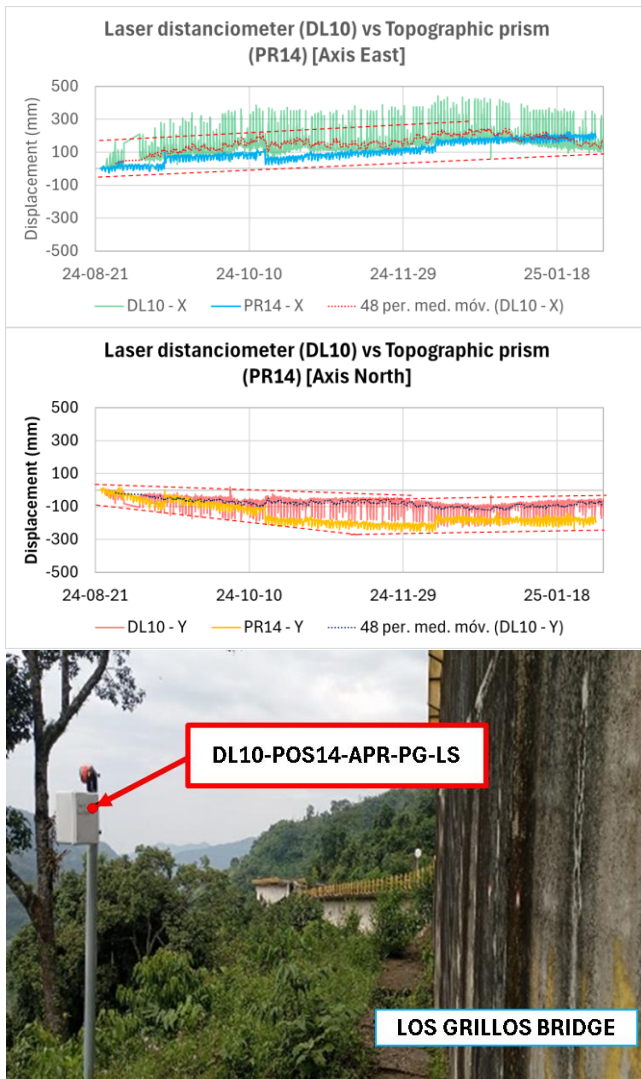
Figure 16. Location and historical record of horizontal displacements for Sector 4

The recorded displacements remained below 20 cm along the X-axis and below 25 cm along the Y-axis, values that are consistent with field observations and the documented surface morphological evolution in the area.

This behavior suggests a more active movement dynamic in the X-direction (East), possibly associated with the slope geometry, the orientation of the fracturing system, or the direction of the principal stress in the ground.

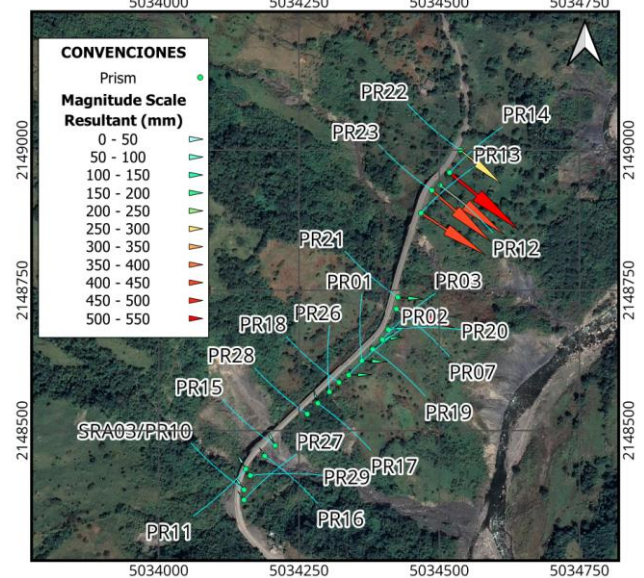
Figure 17. Principal Displacement Directions Identified Based on Measurements from Wireless Sensors

Regarding the displacement directions derived from the wireless sensors, it was observed that, as expected, movements recorded by devices installed directly on the ground exhibit greater magnitudes compared to those mounted on concrete structures.

This difference is primarily attributed to the foundation conditions of the structures, which tend to dissipate part of the deformation, as well as to the geological characteristics of the adjacent slopes, which favor greater displacement in the superficial soil layers.

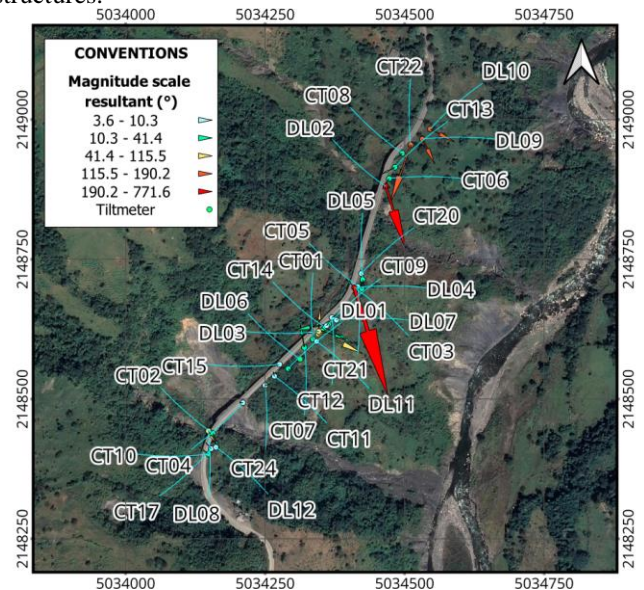
Figure 18. Principal Displacement Directions Identified Based on Measurements from topographic prism

The predominant displacement trends appear to be strongly influenced by the geomorphological characteristics of the area, which are generally aligned with the direction of the ongoing mass movement process occurring near the bridge foundation structures.

The largest displacement magnitudes are concentrated around the abutment areas of the Los Grillos Bridge. It is important to highlight that, despite these observed similarities, the two monitoring systems are based on fundamentally different methodologies, each with its own limitations and advantages.
