Laboratory Testing of Old Bridge Girders: Preliminary Results

Maja Kreslin¹, Mirko Kosič¹, Aljoša Šajna¹, Andrej Anžlin¹, Doron Hekič¹, Vladimir Požonec¹, Petra Triller¹

¹Slovenian National Building and Civil Engineering Institute, Dimičeva ulica 12, 1000 Ljubljana, Slovenia
email: maja.kreslin@zag.si, mirko.kosic@zag.si, aljosa.sajna@zag.si, andrej.anzlin@zag.si, doron.hekic@zag.si,
vladimir.pozonec@zag.si, petra.triller@zag.si

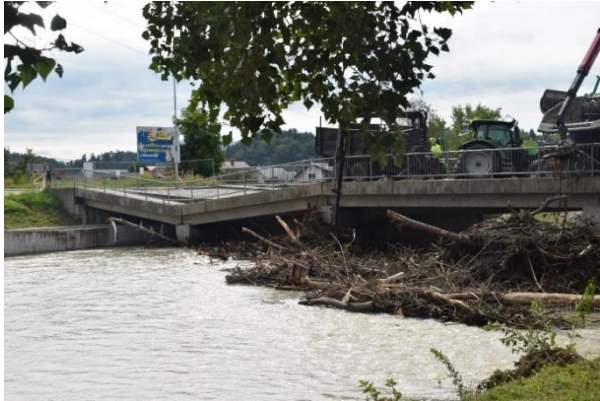
Following the catastrophic 2023 floods in Slovenia, the bridge partially collapsed, as shown in Figure 2 from the downstream side. While the intermediate supports were damaged, an inspection confirmed that the longitudinal girders remained in good condition. In agreement with the infrastructure manager and demolition contractor, selected girders were salvaged for laboratory testing (Figure 3).

Figure 2. Partly collapsed bridge after floods (upstream).

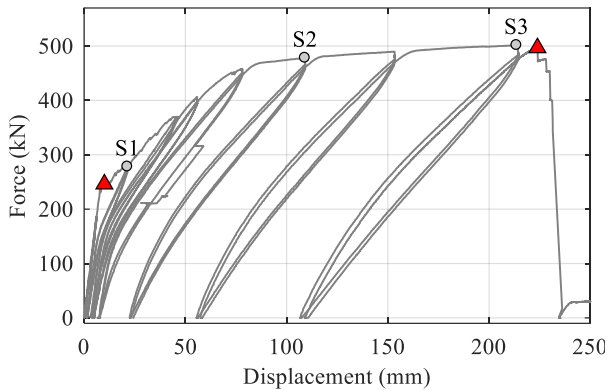
The flexural behaviour of the girder is represented by the hysteretic curve, which shows the relationship between applied force and mid-span displacement, as illustrated in Figure 5. The triangles indicate the state at initial cracking and the state just before failure. The labels S1, S2, and S3 denote engineering-

Figure 5. Hysteretic response of the girder at the middle.

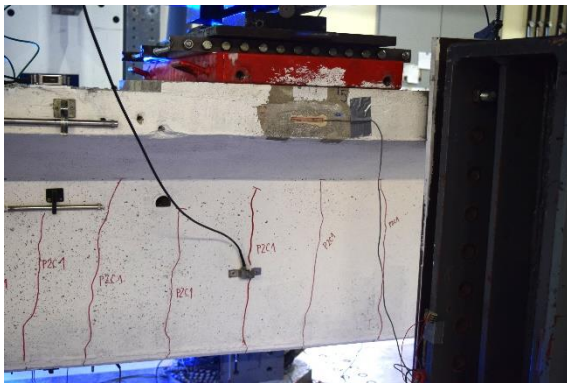
The initial cracks appeared during the second loading phase, forming in the load application area with an initial width of approximately 0.1 mm (Figure 6). Cracking began at an applied force of 246.1 kN and a corresponding displacement of 10 mm. These cracks closed completely upon unloading. As the loading progressed through subsequent phases, the cracks widened and propagated, increasing both in number and extent. Inclined (shear) cracks also began to appear in supports' region.

Figure 6. Damage state at the peak of the cycle when the first cracks appeared.

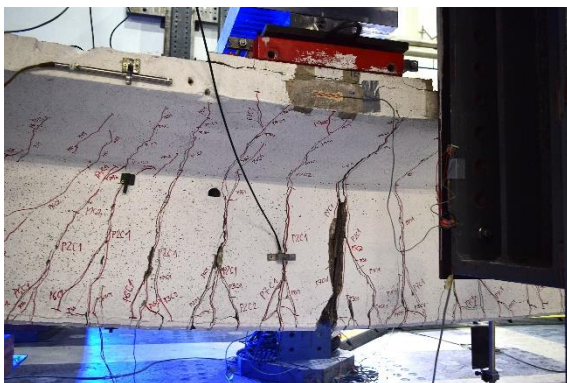
Figure 7. Damaged girder in the failure stage.

In the phase immediately preceding failure, the maximum observed crack width reached 4.5 mm, with a residual width of 3.0 mm after unloading. In the following phase at displacement of 22,4 mm and force 497 kN, the girder experienced flexural

failure, accompanied by the rupture of the prestressing tendons in the load application zone (Figure 7).

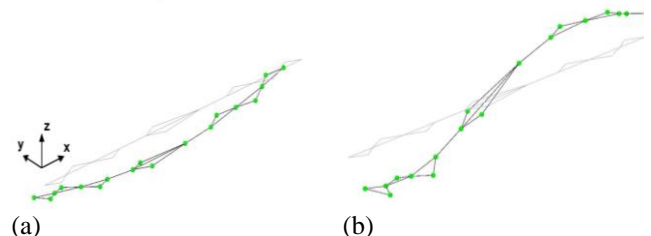
The reference natural frequencies of the first and second vertical bending modes amounted to 12.38 Hz and 45.81 Hz, respectively. As damage accumulates during load cycles, the girder's stiffness diminishes, which is reflected in the corresponding reduction of natural frequencies in Table 1. A reduction of 3% to 36% in the first natural frequency was observed as the damage evolved from cracking (S1) to near-collapse limit state (S3). Smaller decrease was obtained for the second vertical bending mode (1% to 11%), which is due to the applied load causing more damage near mid-span, where the amplitude of the second mode is nearly zero (see Figure 8b).

Figure 8. First (a) and second (b) vertical bending modes of B4 girder.

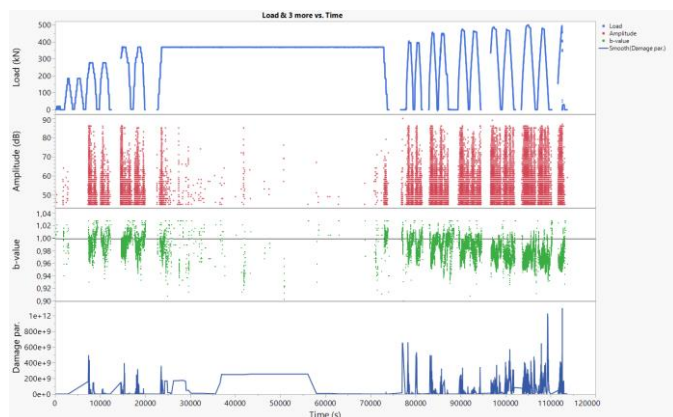
General acoustic emission activity, represented by the amplitude of each hit, the applied load, are time-dependent and presented in Figure 9. Nevertheless, The AE activity, i.e. damage evolution during loading and unloading phases, is visible. In addition, the b-value and the damage parameter as used by Vidya Sagar and Raghu Prasad [6] and Elbatanouny et al. [7] in similar investigations were calculated to evaluate the damage evaluation. The decrease of b-value and the increase of damage parameter with increased load are clearly visible.

Figure 9: Load and amplitude of individual hits, and b-value and damage parameter as a measure of damage evolution and propagation.

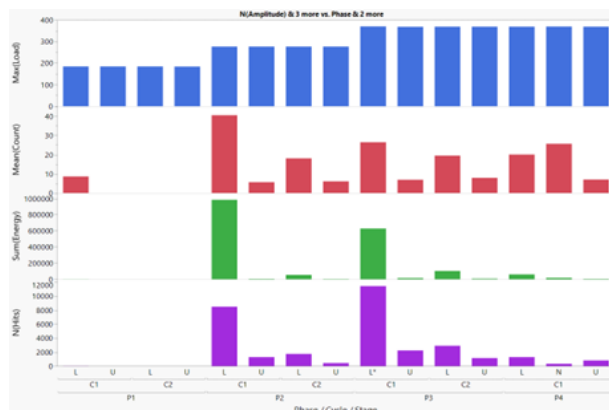
Figure 10: Maximum loads (Max - blue), and number of hits (N - purple), total energy (Sum - red) and mean count (Mean - green) of the hits for individual phases (P1, P2, P3), cycles (C1, C2) and stages (loading L and unloading U).

As an example of a more detailed analysis the number of hits, total energy and mean counts of the first three phases are presented in Figure 10. Each phase consists of two cycles of loading and unloading. A significant difference in AE activity between different phases, cycles within individual phases and

loading/unloading stage was recorded. A more detailed analysis is foreseen. It must be noted that some data of the phase 3, cycle 1, loading stage (marked L* on graph), was unfortunately lost.
