Investigation of the causes of the unusual gap between the bridge and abutment using long-term monitoring

KEY WORDS: Unusual expansion gap; Expansion-Gap Measurement System; Long-term monitoring; Girder bridge.

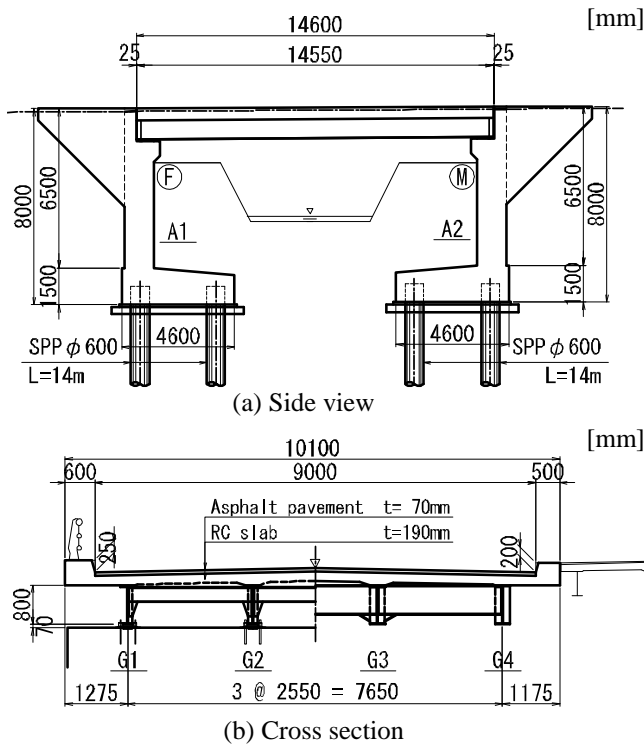
Figure 3. Overview of the target bridge.

Figure 3 provides an overview of the bridge investigated in this study. The target bridge is a simply supported non-composite H-shaped steel girder bridge in Hokkaido, Japan, with a total length of 14.6 meters. Each of the four main girders has the dimensions of $\text{H}800 \times 300 \times 14 \times 26$ mm. The deck is a 19 cm-thick reinforced concrete slab with a 70 mm-thick asphalt pavement. The abutments are of the reversed T type and are

The bridge was completed in 1971, but a periodic inspection in 2012 found the gap at both abutments to be 0 mm. However, there were no indications of lateral movement, and the cause of the unusual gap remained unknown, posing challenges to the selection of appropriate remedial measures.

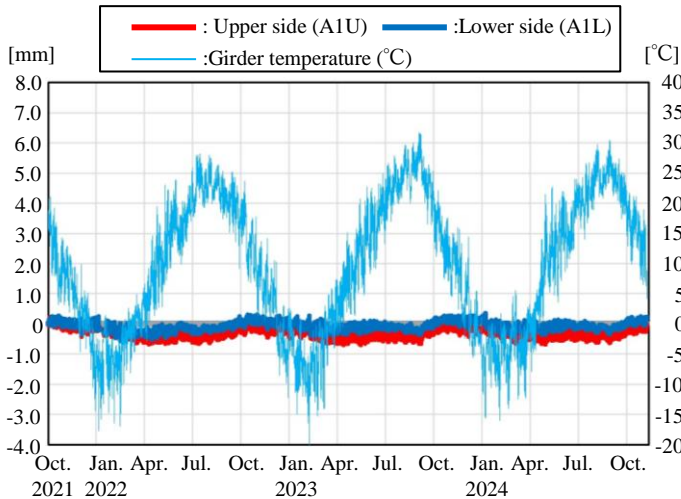
Figure 6. Variation in clearance (A1 abutment).

Figure 6 shows the measured gap distance at the A1 abutment, which serves as the fixed bearing. The gap distance is displayed with the initial measurement value set to 0 mm. Figure 6 also includes the temperature of the main girder for reference.

At the fixed bearing, the variation in gap distance was minimal, remaining within the range of ± 0.7 mm. Since the bearing at the fixed support has a 2 mm clearance, it is presumed that movement within this range occurred at the bearing. This confirms that the fixed bearing is functioning properly.

On the other hand, a difference in gap distance between the upper and lower sections of the main girder was observed over time. This discrepancy suggests that the abutment may have tilted. Therefore, a more detailed investigation of this issue is conducted in Section 4.5.

Referring to Figure 6, while the lower gap distance of the main girder remained around 0 mm, the upper gap distance showed a decreasing trend. This indicates that the increase in negative difference is caused by a decrease in the upper gap distance. Since the lower gap distance remained unchanged while the upper gap distance decreased, it is assumed that the A1 abutment is tilting toward the main girder. Therefore, it is presumed that the cause of the unusual gap lies in the A1 abutment.

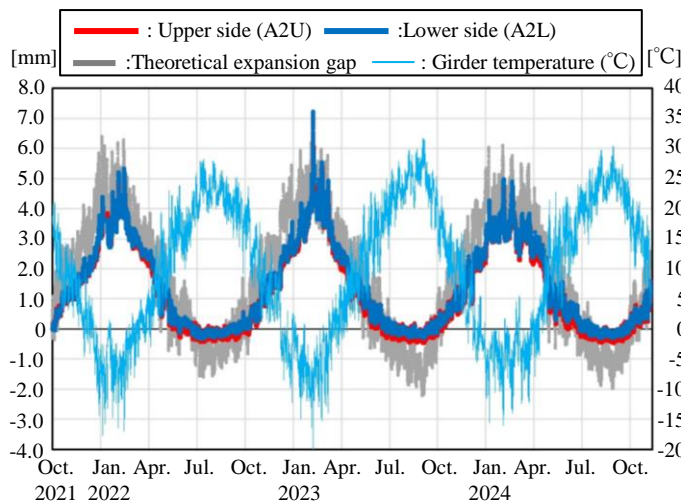
Figure 7. Variation in clearance (A2 abutment).

Figure 7 shows the measured gap distance at the A2 abutment, which serves as the movable bearing. As for the A1 side, the gap size is displayed with the initial measurement value set to 0 mm. The temperature of the main girder is shown as a blue line, while the theoretical gap distance, calculated based on the girder temperature, is indicated in gray.

At the movable bearing, significant variations in the gap distance are observed in response to temperature changes. During the winter, when temperatures were low, the main girder contracted, and the measured gap distance closely

matched the theoretical gap distance. In the summer, when the temperatures were high, the gap distance decreased. However, the gap reduction was less than the theoretical value. Onsite inspection confirmed that the main girder was in contact with the abutment parapet. A more detailed investigation into the gap distance behavior during warmer periods is discussed in Section 4.6.

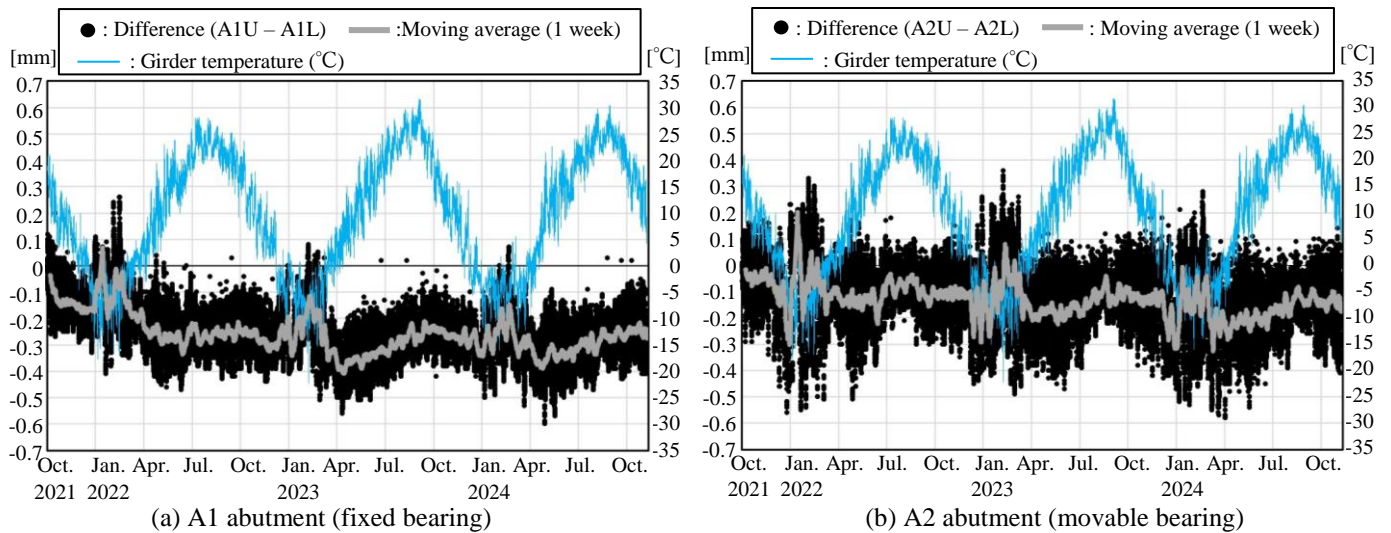
Figure 10. Variation in the difference of clearance between the upper and lower parts of the main girder.

To investigate the cause of the difference in gap distance between the upper and lower segments of the main girder at the fixed bearing over time, Figure 10 illustrates the transition of that difference for each abutment.

As shown in Figure 10a, at the A1 abutment (the fixed bearing), the difference became negative and that negative difference continued to increase over time. It is noted that the difference fluctuated significantly during the cold winter season, likely due to girder deflection caused by snow accumulation and the impact of snow removal. In contrast, the change in the difference at the A2 abutment (the movable bearing) remained minimal.

However, since the decrease in the upper gap measurement was approximately 0.5 mm over three years, it is considered to have no immediate impact on the safety of the bridge.

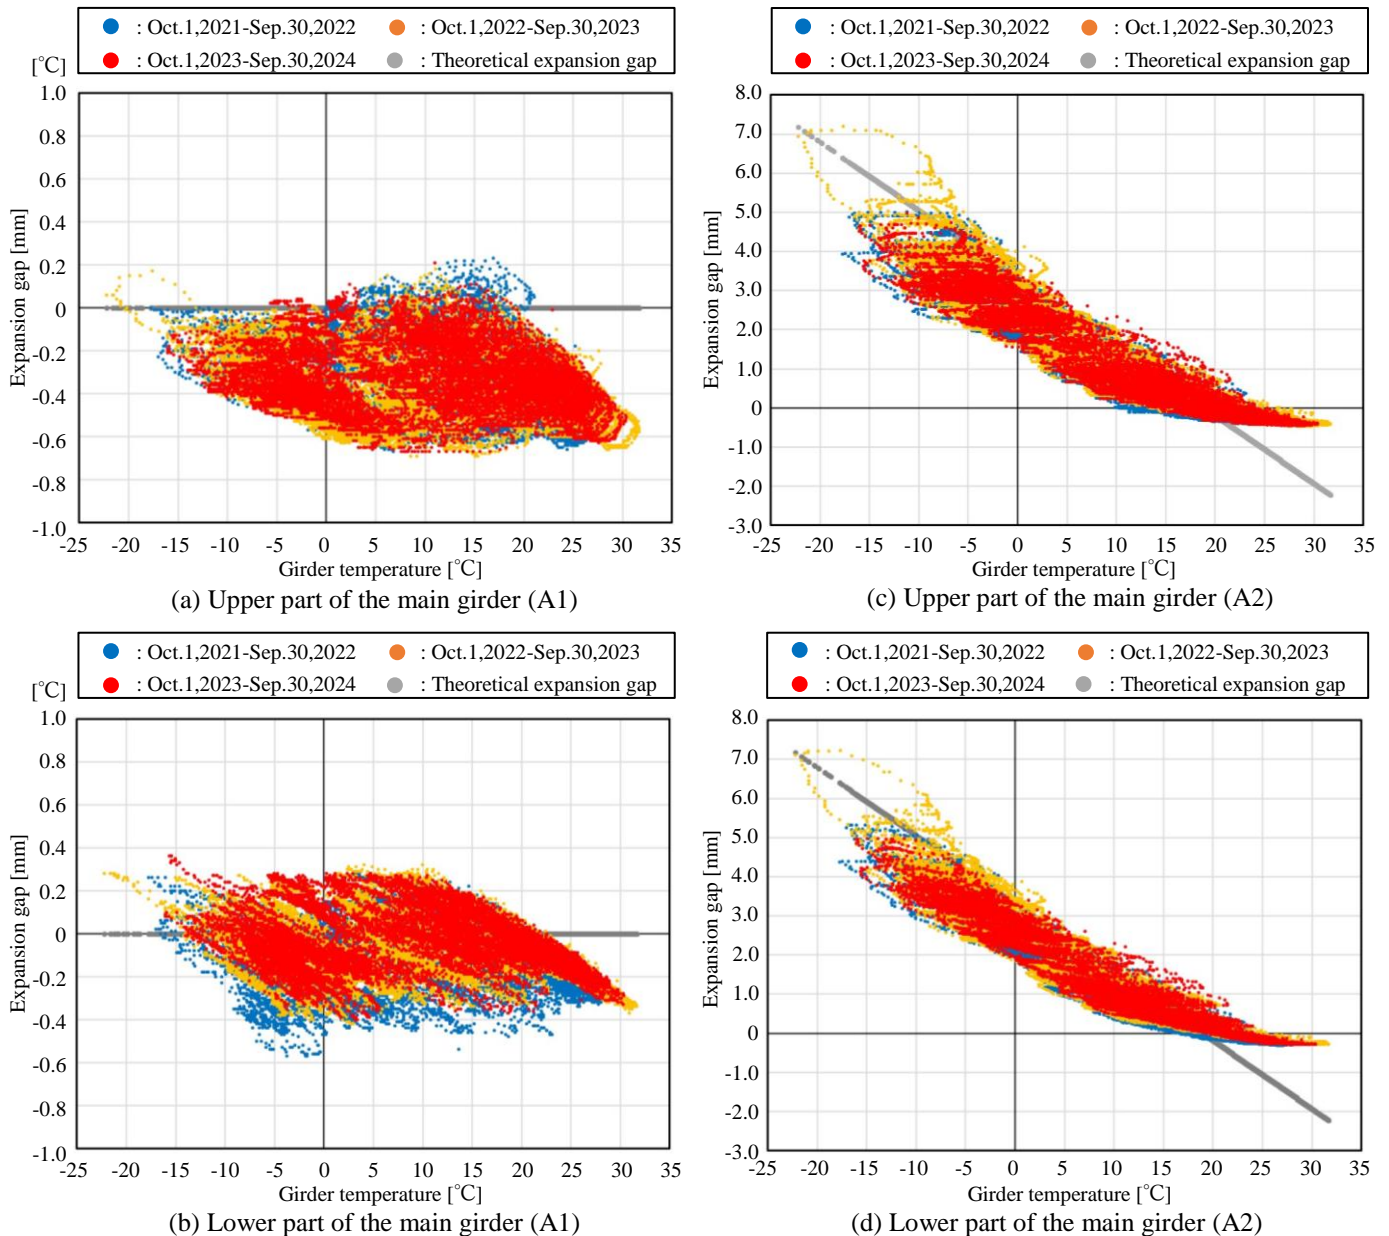
Figure 11. Relationship between temperature variation and clearance.

At the A1 abutment (the fixed bearing) (Figures 11a and 11b), the gap distance fluctuates within the range of ± 0.4 mm regardless of temperature. Additionally, while the gap distance of the lower segment of the girder changes linearly with temperature, no distinct trend is observed in the upper segment. This is likely because the lower segment primarily undergoes thermal expansion and contraction due to the steel material of the girder, whereas the upper segment is constrained by the concrete deck, which has a different specific heat capacity. However, since the overall variation in displacement is small, it is confirmed that the A1 abutment is functioning as a fixed bearing.

At the A2 abutment (the movable bearing), it is observed that the gap distance increases as the temperature decreases. However, when the temperature exceeds 15°C , the decrease in displacement plateaus. The difference between the theoretical and measured gap distances increases, and at 30°C , this discrepancy reaches approximately 2 mm.

Since gap distance is maintained during periods of temperature decrease at the A2 abutment, it is unlikely that the abutment is consistently leaning against the girder. In contrast, as noted in Section 4.5, a slight tilt was observed at the A1 abutment. This suggests that one possible cause of the unusual gap is the gradual tilting of the A1 abutment after the bridge was completed. However, since no significant inclination is visible on the front of the abutment, another potential cause could be past abutment movement or an insufficient distance between abutments during construction.

In any case, since no ongoing horizontal displacement of the abutments was detected and the average annual tilt of the upper part of the A1 abutment is approximately 0.1 mm, cutting off the girder ends is expected to be effective in preventing axial force from being input into the main girder.
