The area around Landeck in the Tyrol Upland, Austria, features a significant density of deep-seated landslides. In the course of the present thesis the failure mechanisms and kinematics of the slope instability at the area of Perfuchsberg, in the west of Landeck, get investigated and determined. To support these analyses, detailed geological and geomorphological field mapping, rock sampling, laboratory investigations and engineering geological analysis are performed.

This master thesis is concerned with the landslide Perfuchsberg. The aim is, to determine the geological conditions, the failure mechanisms, causes and kinematics of the slope instability and to document the influence of the slope deformation on infrastructure and buildings.

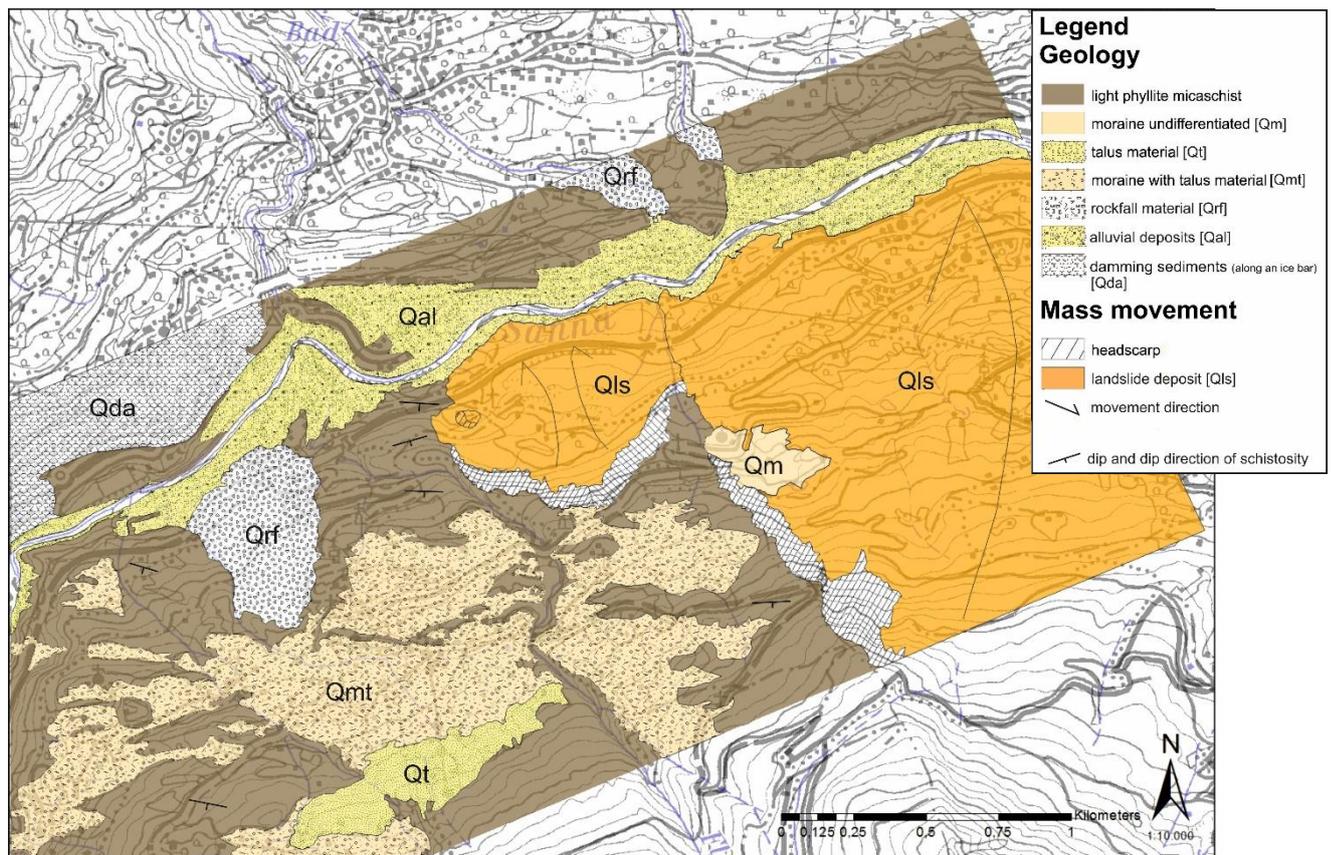
Figure 9: Geological and geomorphological map of the study area [base map from BEV, 2013].

Figure 9 shows the detailed map of the project area at a scale of 1:10,000. The lithological units and quaternary deposits are explained in detail in the following chapter. As a base for the field mapping topographical (ÖK 1:50,000) and geological (“Geologische Karte der Republik Österreich” 1:50,000, 2004, Kartenblatt 144 Landeck) maps of the area around Perfuchsberg are used.

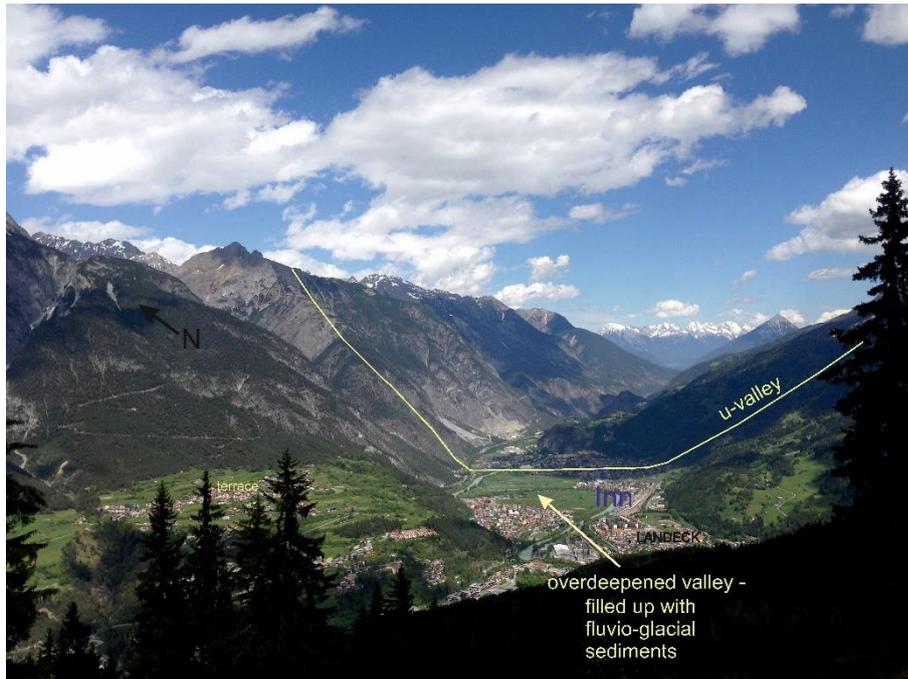
Figure 12: View toward east: typical u-shaped valley, with characteristic terraces, e.g. in the north of Landeck.

During the last glacial epoch (Würm, approx. 14.000 years ago) the whole project area was covered by the glacier. The erosional activity of the ice formed the existing, rounded morphology with the typical u-shaped-valley. Good examples for the smooth and slightly curved physiography are shown at the grasslands in Tobadill and on the terrace in Pians and Grins, where sheepback rocks and glacial polish are found.

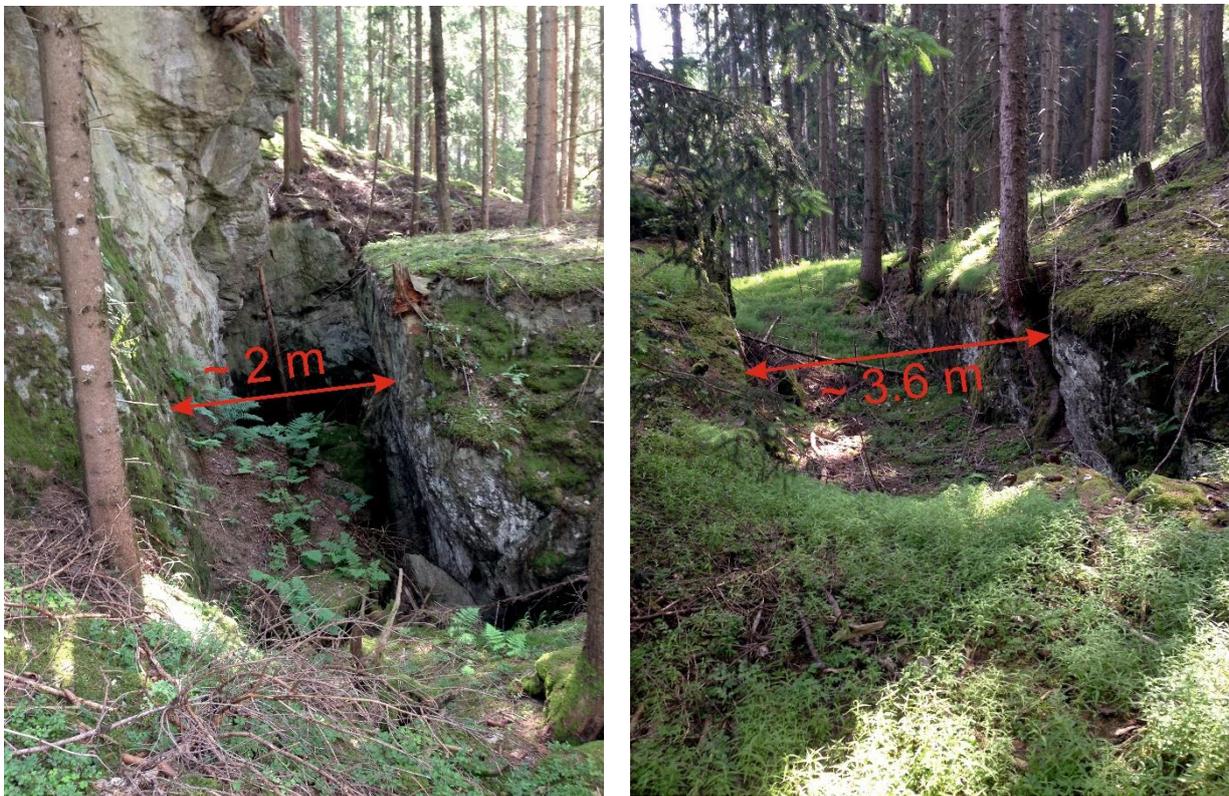
Figure 14: Dimension of breaks in the slope under the church of Tobadill.

At the street, downhill from the church of Tobadill, large breaks, cracks and fractures are documented. They have a dimension of several meters and are distributed all over this area, also on the very front of the slope (Figure 14).

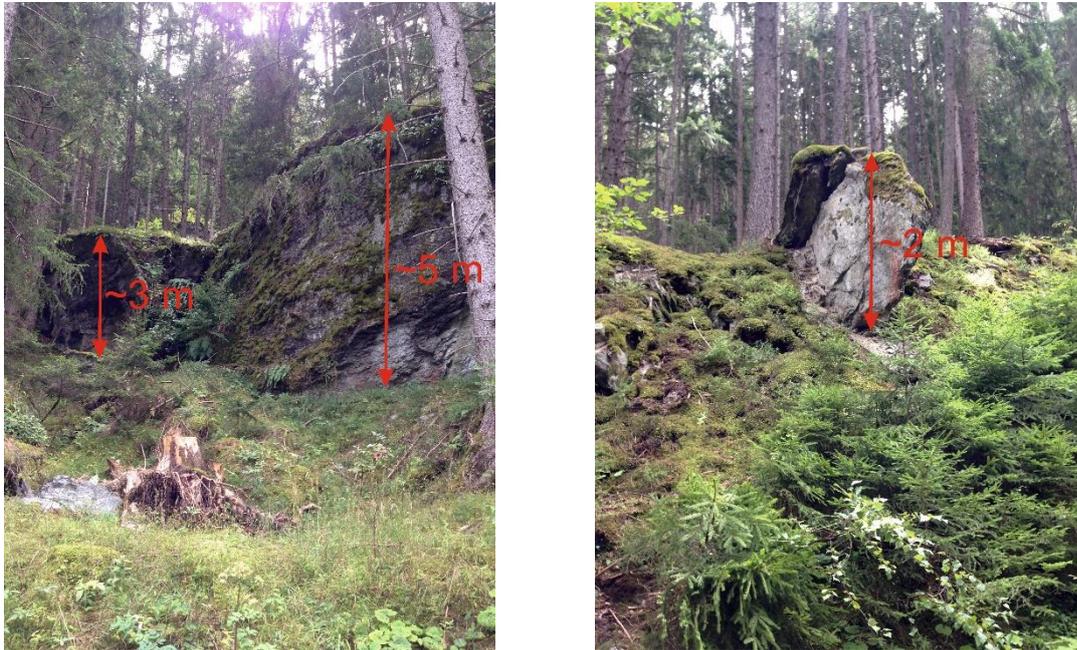
Figure 15: Rockfall material northwestward of Tobadill.

The rockfall material, west- and northward the large cracks, are characterized by a rough and uneven morphology due to the existence of boulders and large rock fragments. The slope inclination is rather steep and about 35 – 40°.

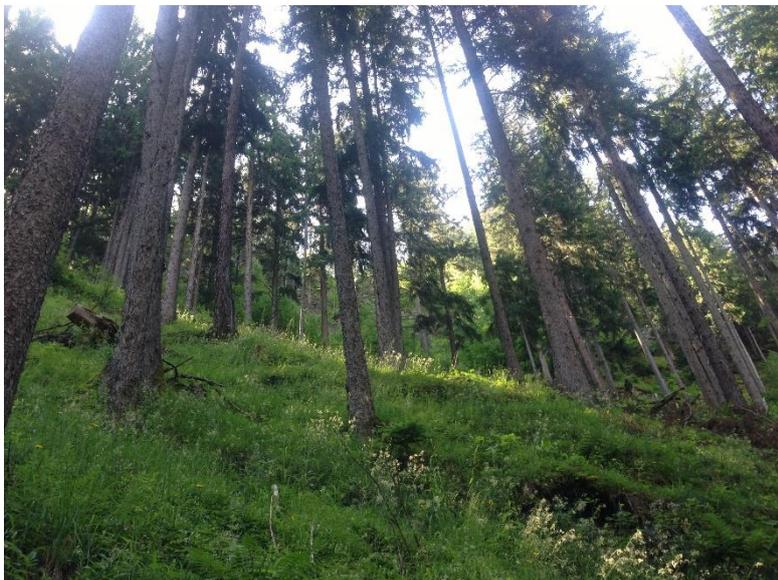
Figure 16: Steep headscarp area.

Near the street to Tobadill, one kilometer eastward from Tobadill, a very steep part, with an approx. height of 70 meters and an extension of 800 meters is mapped (Figure 16). At this part the morphology is irregular and rough, destroyed rocks, boulders and trees are laying around and block of rocks are crumbling down from time to time. Below the steep slope a small flattened area with a smoother surface is located and then it goes again steep downward to the Sanna. On the way down small, about three metres high, “horst and graben” structures one after another are found.

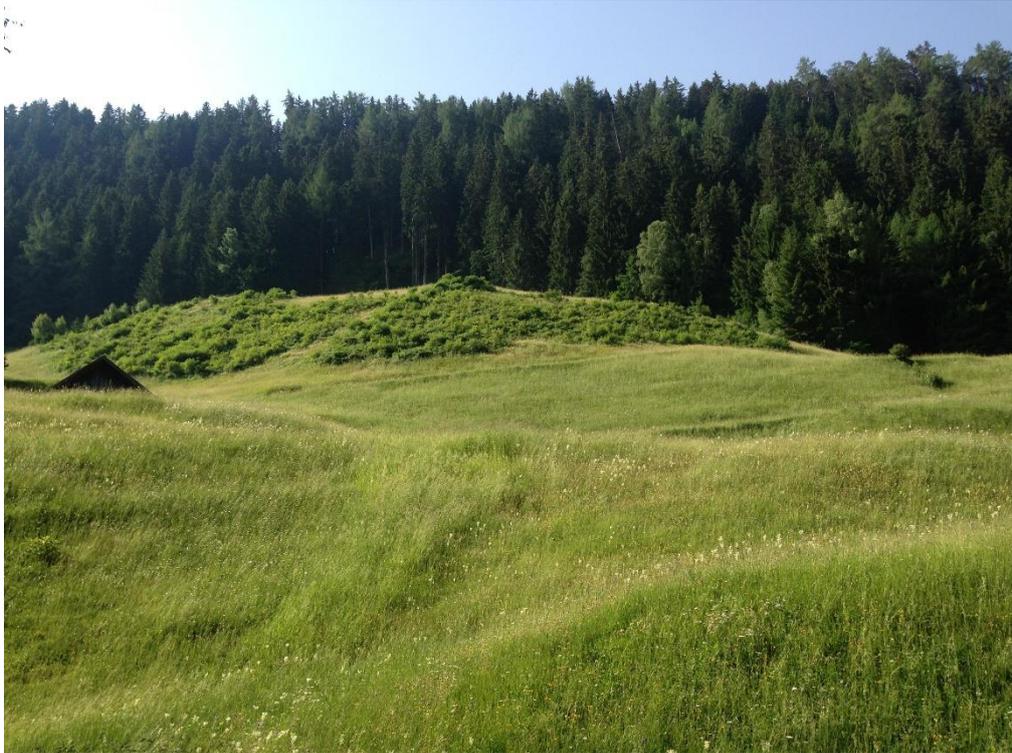
Figure 17: Small flattened area with a smoother surface NNE of the headscarp. Behind the forest the headscarp area is located.

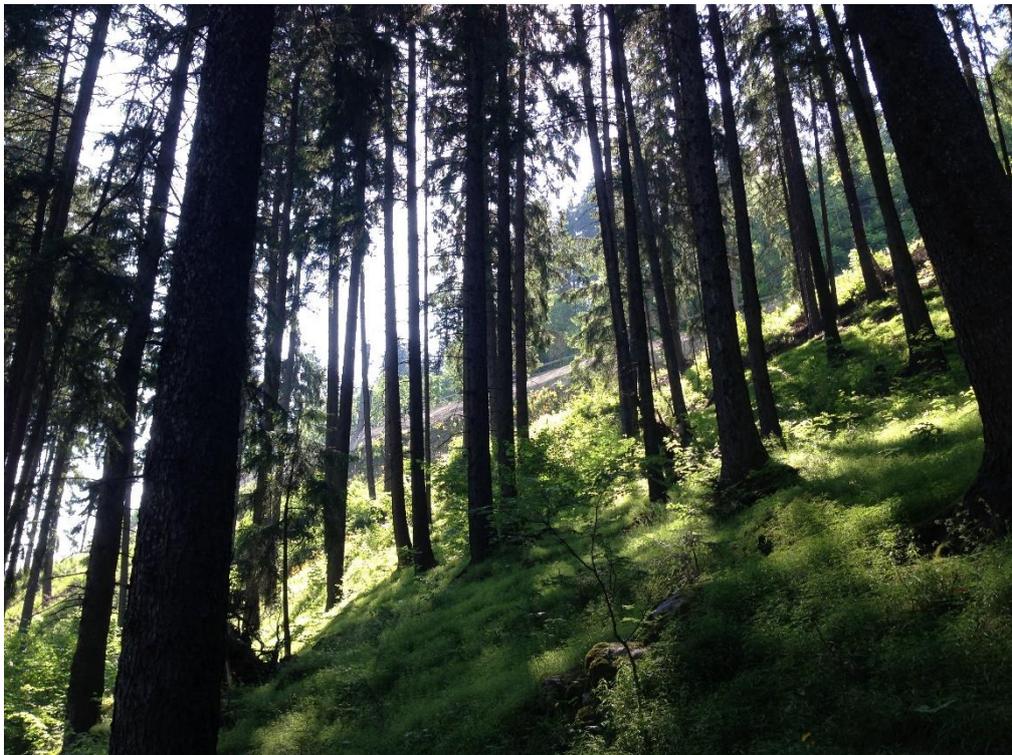
Figure 18: Steep toe of the slope downward to the Sanna River with the railway track.

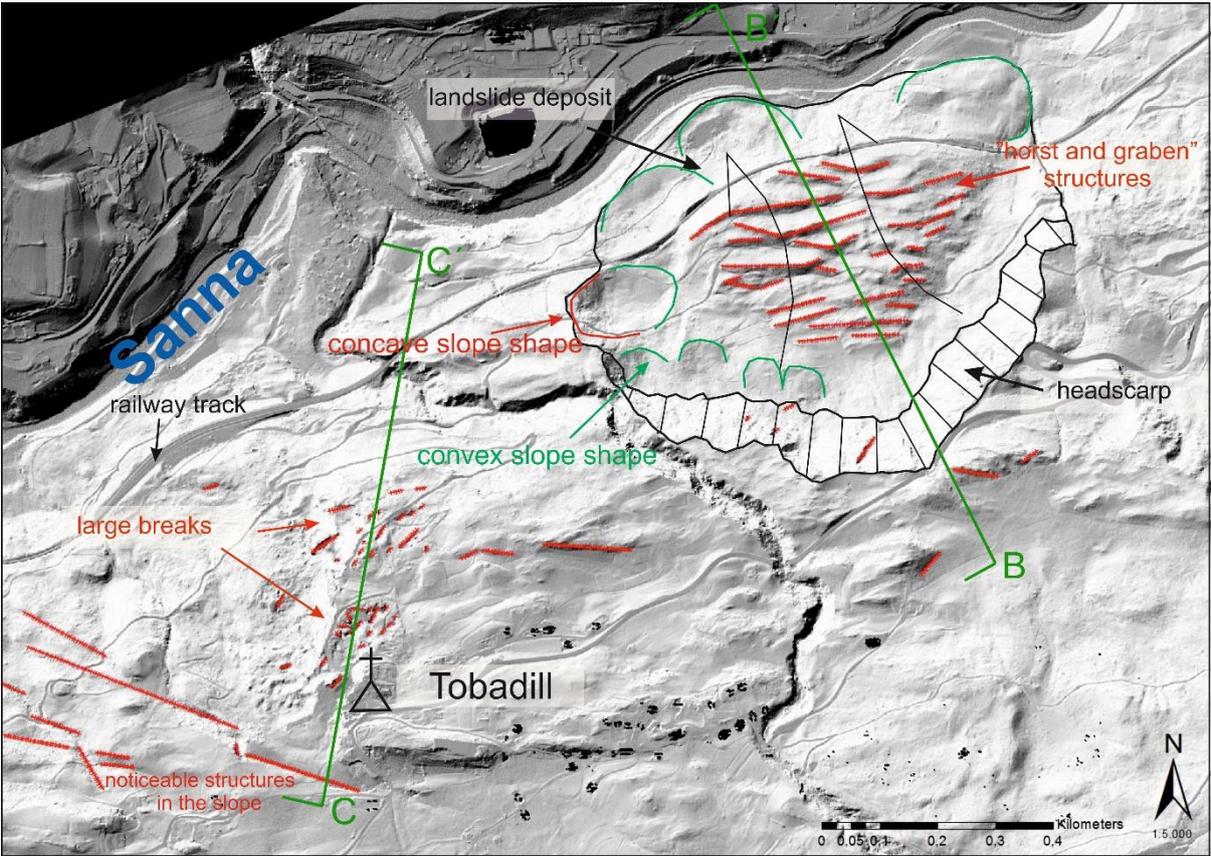
Figure 19: Detailed geomorphic map of the study area based on the laserscan data [modified after TIRIS, 2015]. The green lines represent the location of the cross sections (c.f. chapter 4).

Based on desk study and detailed field mapping Figure 19 shows the before mentioned geomorphic features on the laserscan data. The geomorphic map illustrates the exact location of the large breaks, cracks and fractures under the church of Tobadill. In the southeast noticeable structures of the slope get observed during laserscan evaluation and field investigations. Southward the steep headscarp areas small convex morphologies are found more frequently than concave slope structures. The two green lines are representing the location of the cross sections, which get analysed in the course of this thesis.

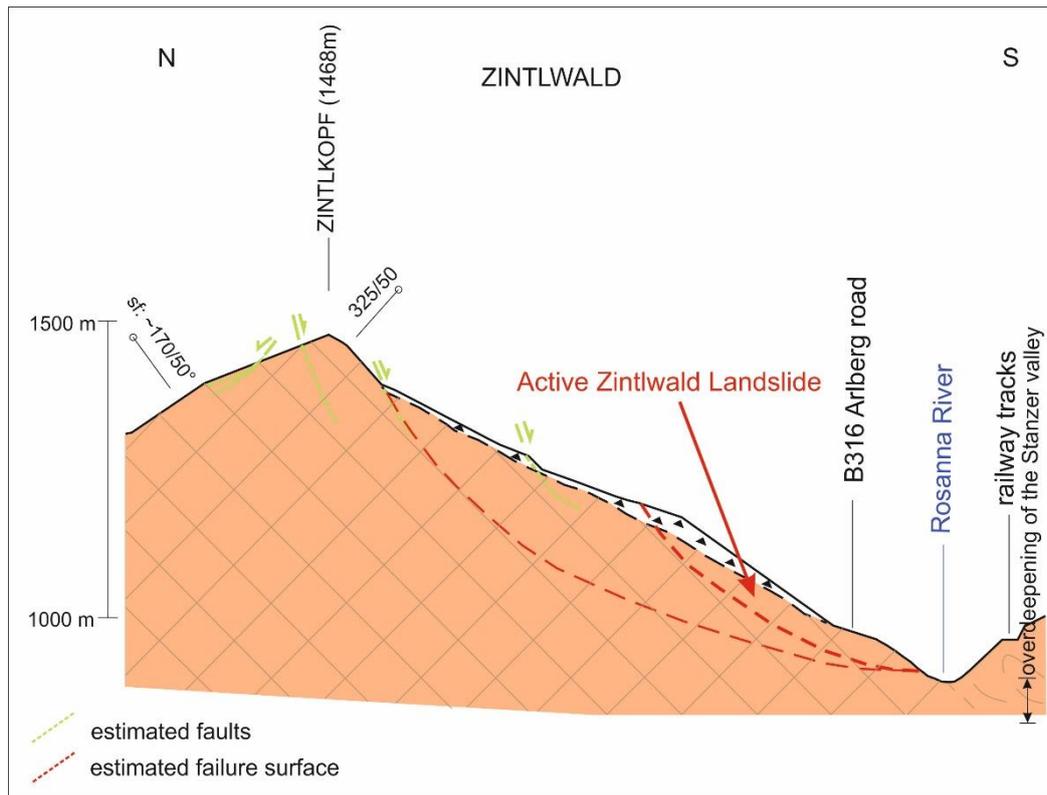
Figure 22: Profile of the landslide Zintlwald [modified after Henzinger et al., 2008].

Extensive investigation methods (field investigations, geodetic monitoring, reflection and refraction seismic, core borings with inclinometers and piezometers) enabled to design a geologic model: The bedrock is fragmented into slabs, which are floating in a more fragmented fine grained matrix (Figure 22). Those slabs have a higher seismic velocity than the matrix. The changeable subsurface conditions are also responsible for different groundwater situations when the groundwater level was rising due to the heavy rainfall. Furthermore, the valley is glacial overdeepened. It had a deeper and wider morphology before and has been filled up with loose material sediments, which are representing a perfect sliding underground. [Henzinger, 2008]

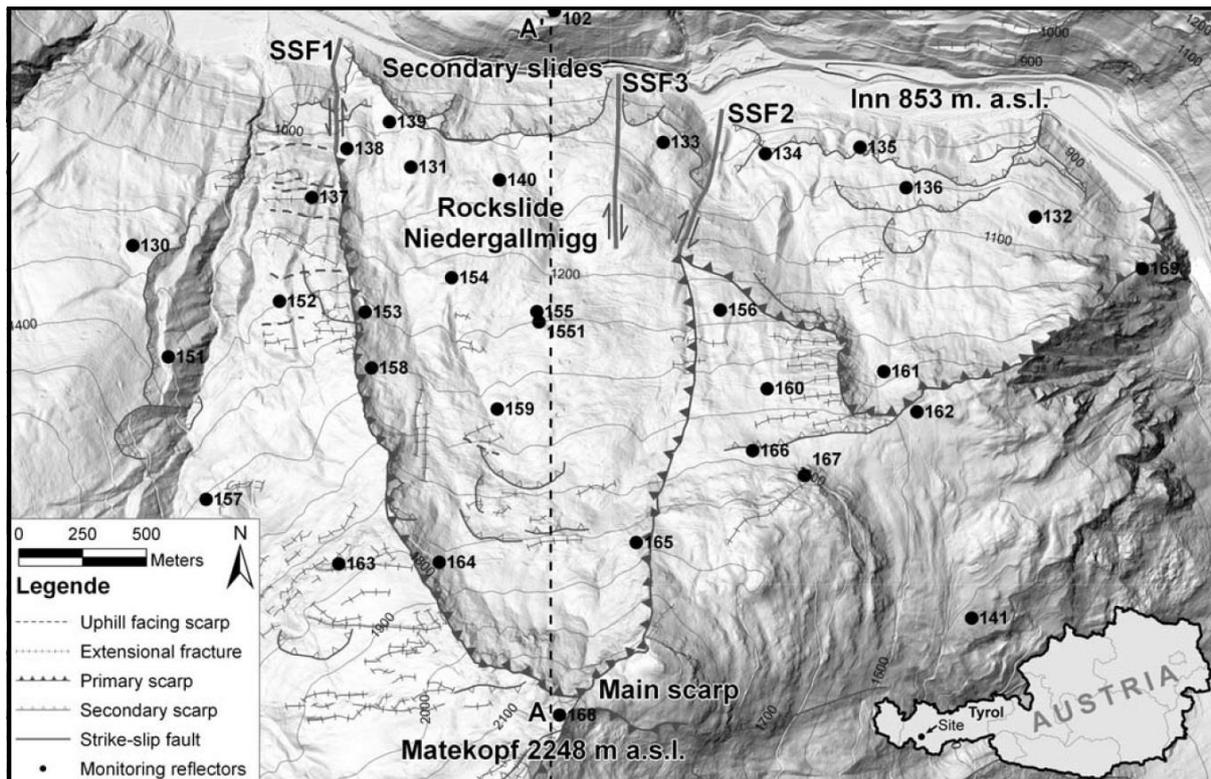
Figure 23: Hillshade map of the deep-seated rock slide system Niedergallmigg showing primary and secondary scarps, strike-slip faults (SSF1, SSF2, SSF3), geodetic monitoring targets and the trace of the cross section A-A' [after Zangerl et al., 2012].

Geologically the landslide is located in the Silvretta nappe: The upper area (headscarp area) belongs to the Silvretta complex, consisting of biotite-muscovite schists and paragneisses, and the middle and lower part build up by phyllonitic micaschists, paragneisses and amphibolites of the Venet complex. The foliation is dipping to the southeast / south with rather flat dip angles. Due to the folding the dip direction can also vary to northwest and steeply dipping brittle faults that strike E-W also occur. Occasionally the bedrock is covered with quaternary deposits (e.g. moraine deposits, rockfall blocks). [Zangerl et al., 2012]

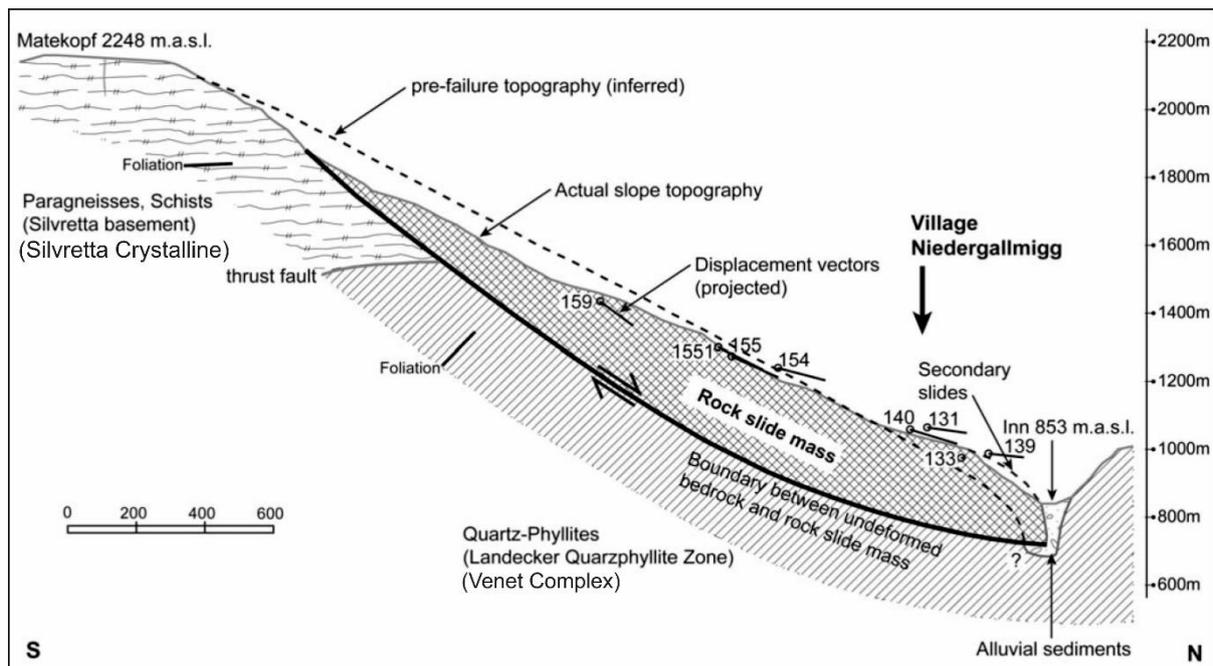
Figure 24: N-S cross section along A-A' showing the rock slide geometry, the actual and pre-failure topography, displacement vectors of geodetic targets and geological setting [after Zangerl et al., 2012].

Changes in the slope topography, due to slope undercutting, or at the mechanical and hydrogeological conditions were leading to secondary slides at the toe of the slope (Figure 24). The composition is more like a soil, compared to the total landslide which is classified as rockslide. [Zangerl et al., 2012]

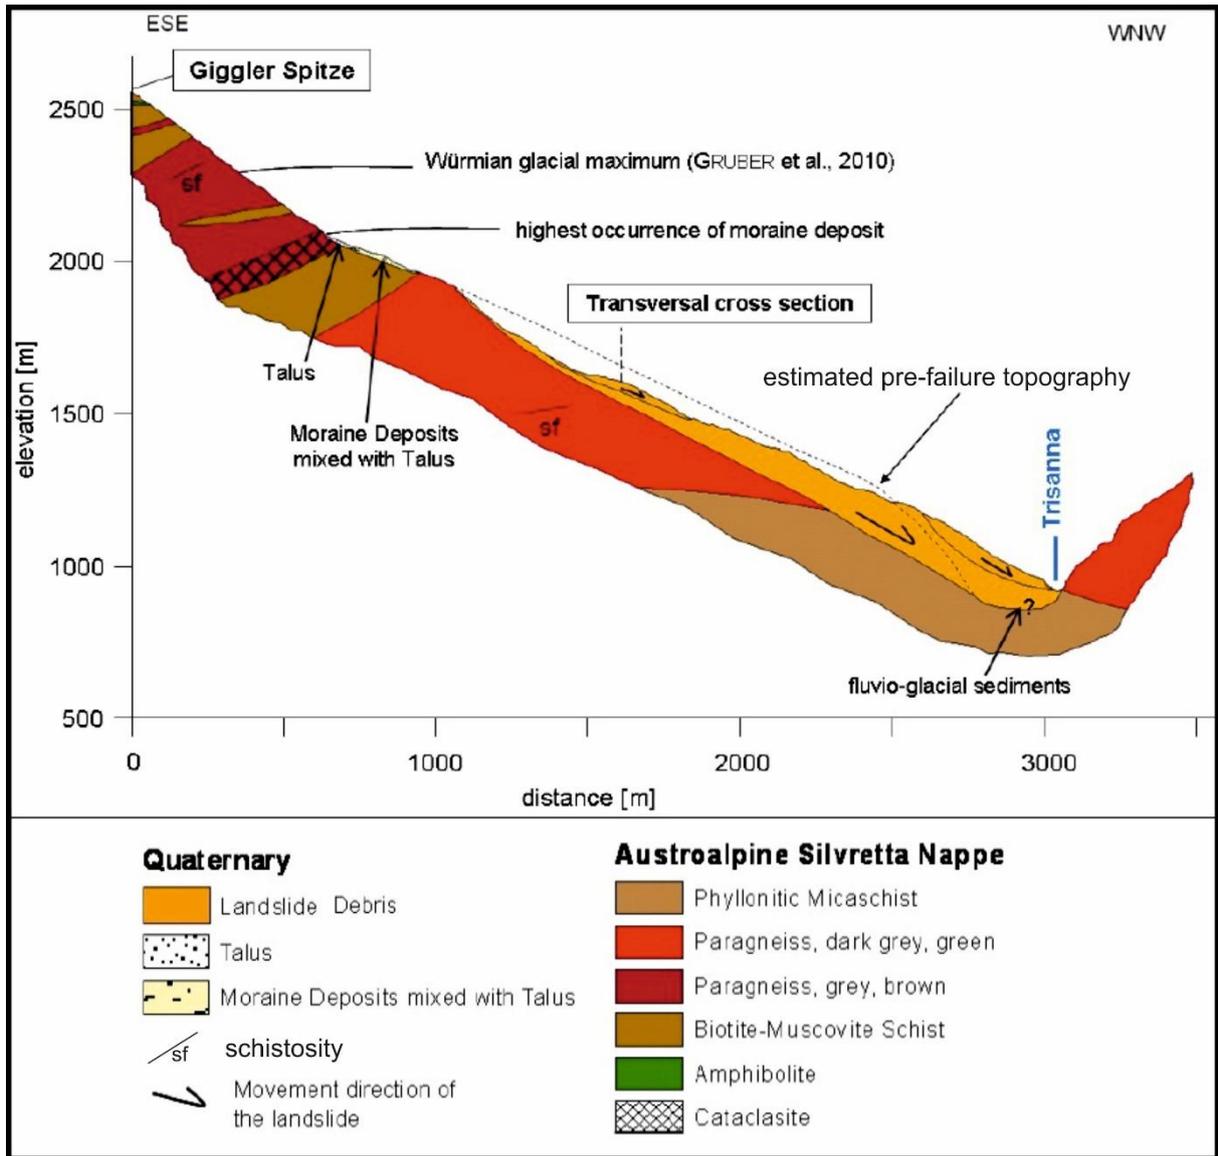
Figure 26: Detailed Profile of the landslide Gfäll [modified after Strobl, 2015].

During the floodwater event in August 2005 parts of the slope got unstable and disturbed the street and the bridge in the valley. After this event field investigations, the monitoring and further analysis were initiated. According to *Strobl (2015)* two joint sets, striking approx. NE-SW and NW-SE, are forming the headscarp of the entire landslide Gfäll. "...On the basis of engineering geological investigations performed, it is suggested that the landslide initiated as wedge-shaped blocks sliding along a stepped failure surface. With continued displacements these steps (or asperities) were subsequently sheared during progressive movement of the landslide. A basal shear zone consisting of sheared rock material (kakirites) is then suggested to have developed. ..." [*Strobl, 2015*] The estimated depth of the landslide is about 200 m. Based on engineering geological analysis the classified deep-seated rockslide Gfäll shows, with increasing distance to the headscarp area, an increasing disintegration of the landslide debris, which results in secondary (soil-like) slides at the toe of the slope (Figure 26). Actual these secondary slides are active. It is assumed that the erosion of the Trisanna River at the toe and changes at the groundwater situation (e.g. heavy rainfalls, snowmelts) have significant influence on the current movement of the landslide Gfäll.

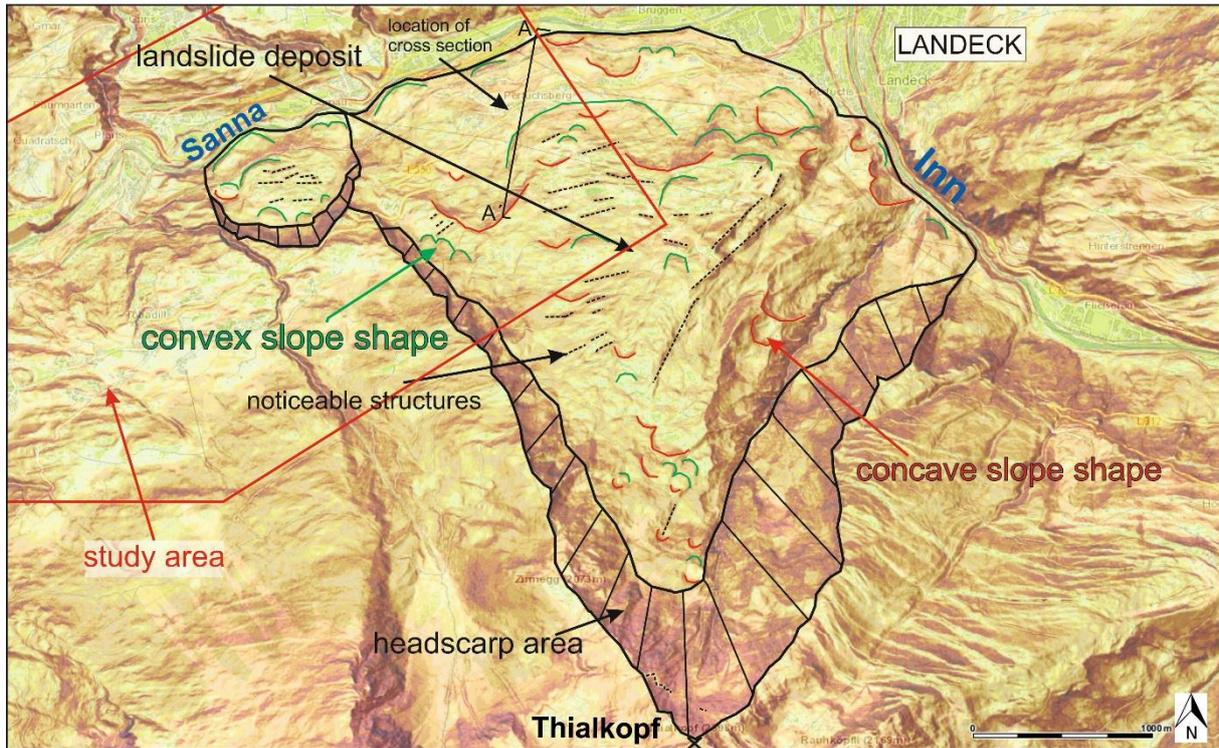
Figure 27: Morphologic map of the landslide Perfuchsberg with its most noticeable structures based on laserscan data evaluation and the location of the cross section at the toe area [modified after TIRIS, 2015].

The entire landslide Perfuchsberg is located on the orographic right side of the confluence of the Stanzer valley and the Upper Inn valley, directly southwest of the town Landeck. The landslide extends from the mountain Thialkopf (2398 m a.s.l.) down to the Sanna (northward) and the Inn River (northeastward) (Figure 27). [Gruber et al., 2010]

The rock mass consists mostly of phyllonitic micaschists, generally striking E-W and dipping to the south, which are belonging to the Venet complex of the Silvretta nappe. The headscarp show a distinctive concave shape and behind the headscarp area (southward) mountain splitting phenomena, like tension cracks and trenches, occur. The convex shaped landslide deposit toward north has an area of approx. six to seven km². Secondary scarps at lower areas of the deposit indicate that parts of the entire landslide are still active or moving as separate slides. [Gruber et al., 2010]

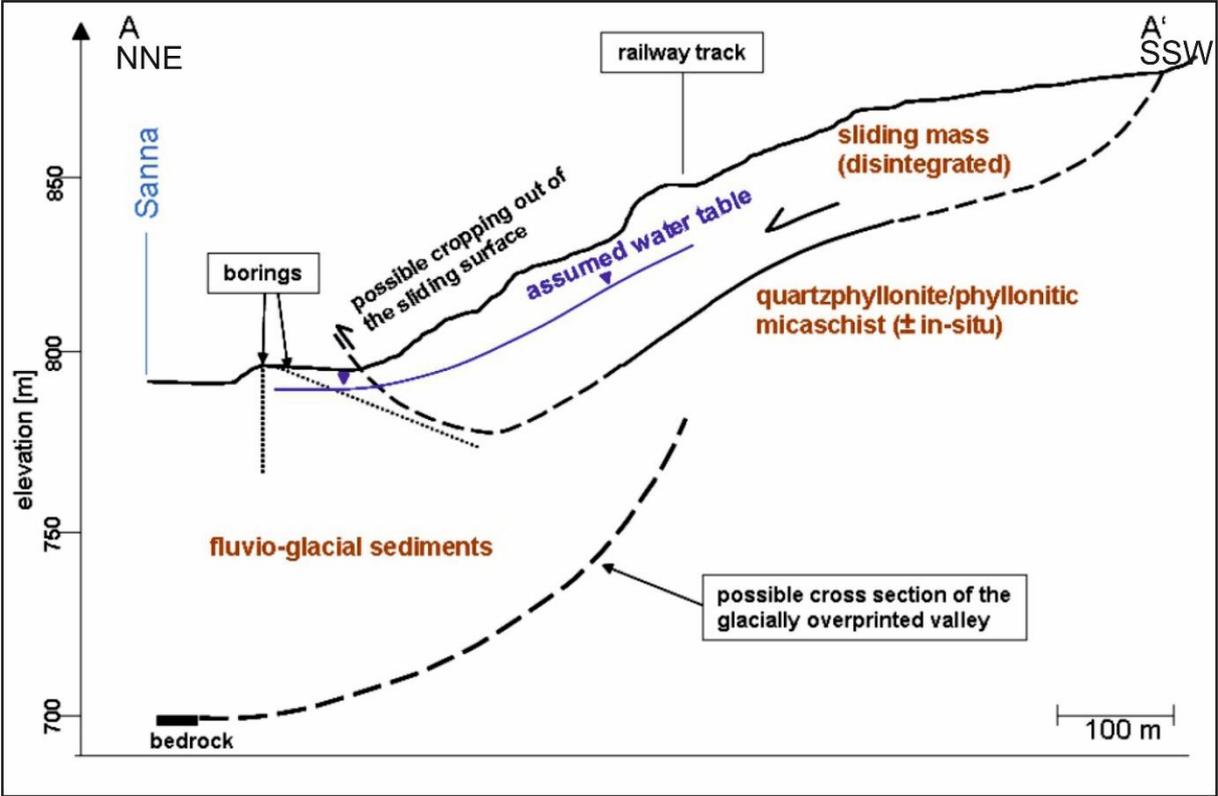
Figure 28: Cross section of the toe area of the landslide Perfuchsberg [modified after Poscher, 1993].

From previous investigations (borings, refraction seismic), at the toe of the slope, it could be assumed that the landslide was sliding on the glacial overdeepened valley, which was filled up with fluvio-glacial deposits after the glaciation (Figure 28). The glacial overdeepening at this area get suggest with 100 m. [Poscher, 1993]

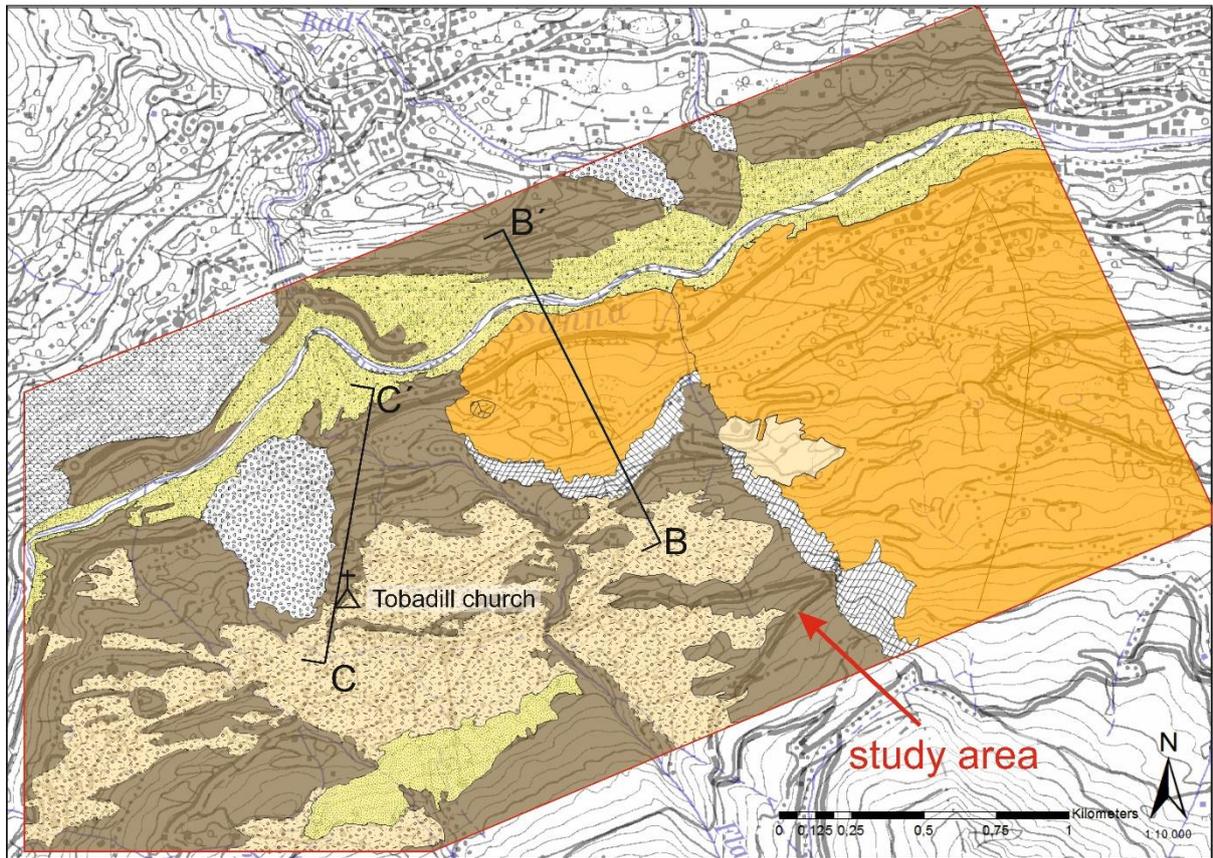
Figure 30: Exact position of the cross sections in the study area.

The exact position of the cross sections in the study area is shown in Figure 30 and the reconstructed pre-failure cross section after glaciation is shown in Figure 31.

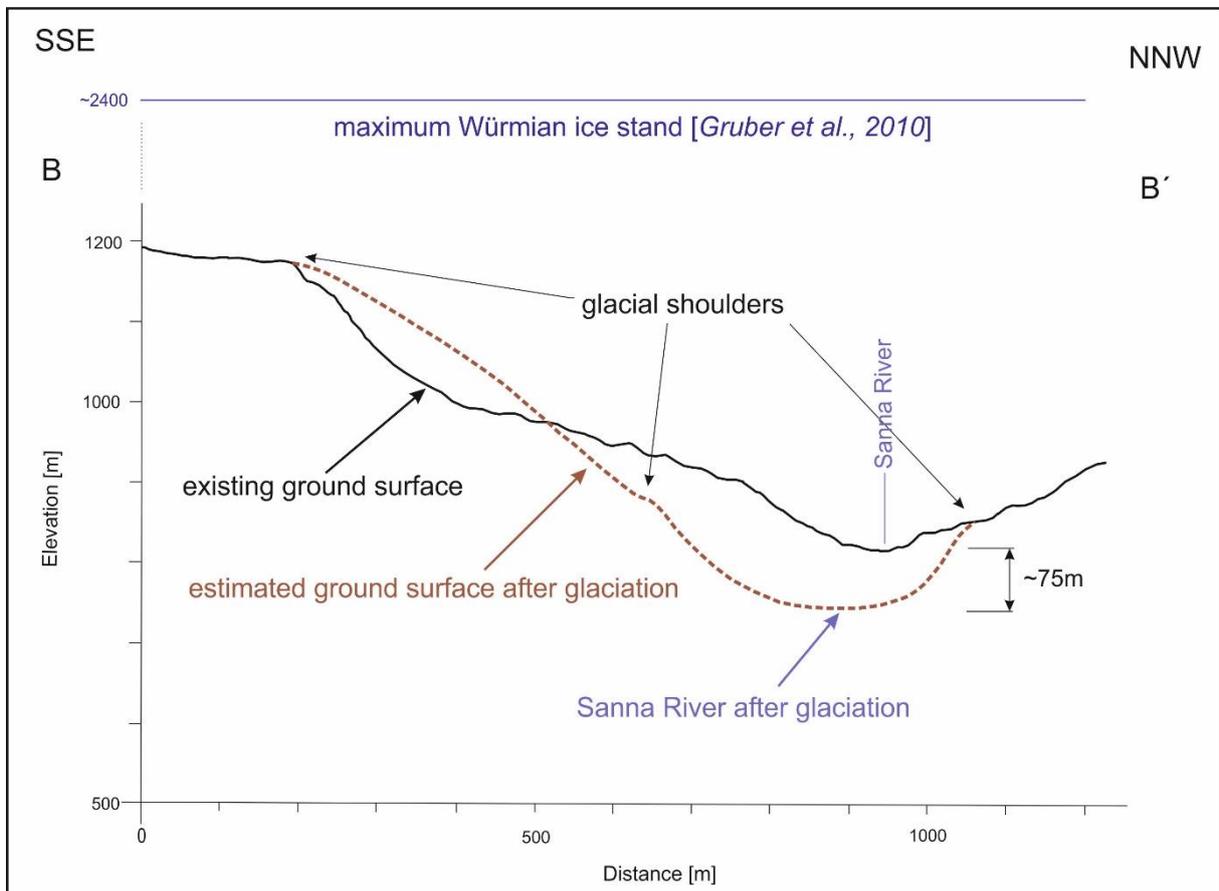
Figure 31: Estimated cross section after glaciation.

The first step for constructing a detailed slope profile is to get to know the development of the slope and the valley. Together with different information and assumptions the pre-failure topography of the valley can be reconstructed:

- Based on desk study, analysis of remote sensing data and field observations it gets assumed that the exact opposite site of the study area was not influenced by large landslides. Therefore and according to the system of mass balance, meaning that the loss of rock mass volume in the upper headscarp area equals the volume increase at the toe area of the slope, the pre-failure profile line can get reconstructed approx. symmetrically to the exact opposite site.

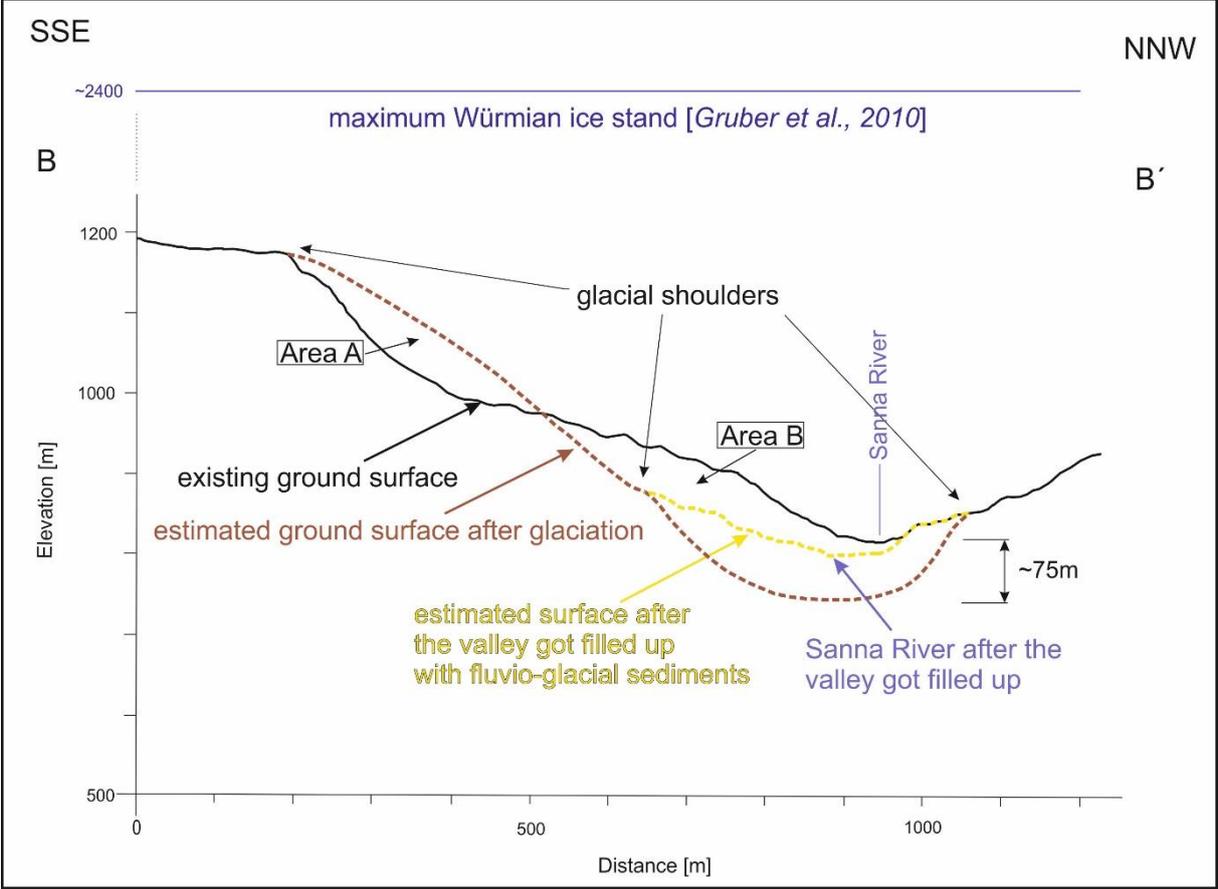
Figure 32 Estimated cross section after the valley got filled up with fluvio-glacial sediments and shortly before the landslide happened.

Borings and geophysical measurements at the level of the Sanna River in the area of Landeck [Poscher, 1993] detected both above and below the landslide mass alluvial Sanna deposits. Based on this it is expected that the Stanzer valley got filled up for a great part with fluvio-glacial sediments before the landslide has occurred. Figure 32 illustrates an estimated cross section shortly before the landslide happened.

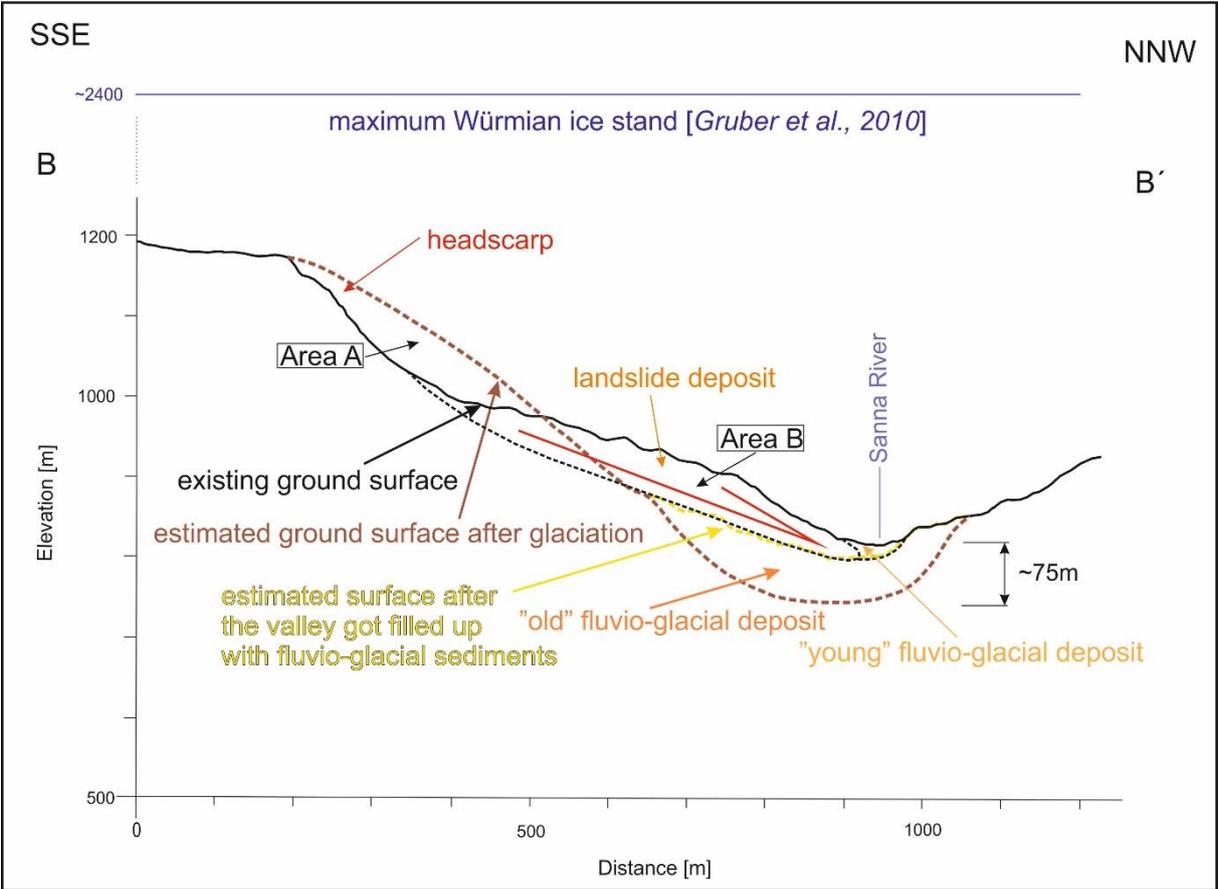
Figure 33: Present day cross section.

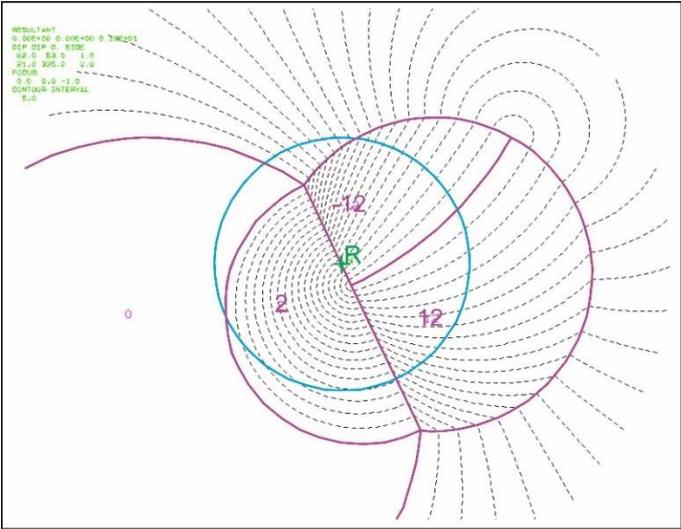
Figure 37: Stability analysis for the key block 110101. The blue circle represents the reference circle and R marks the resultant force vector.

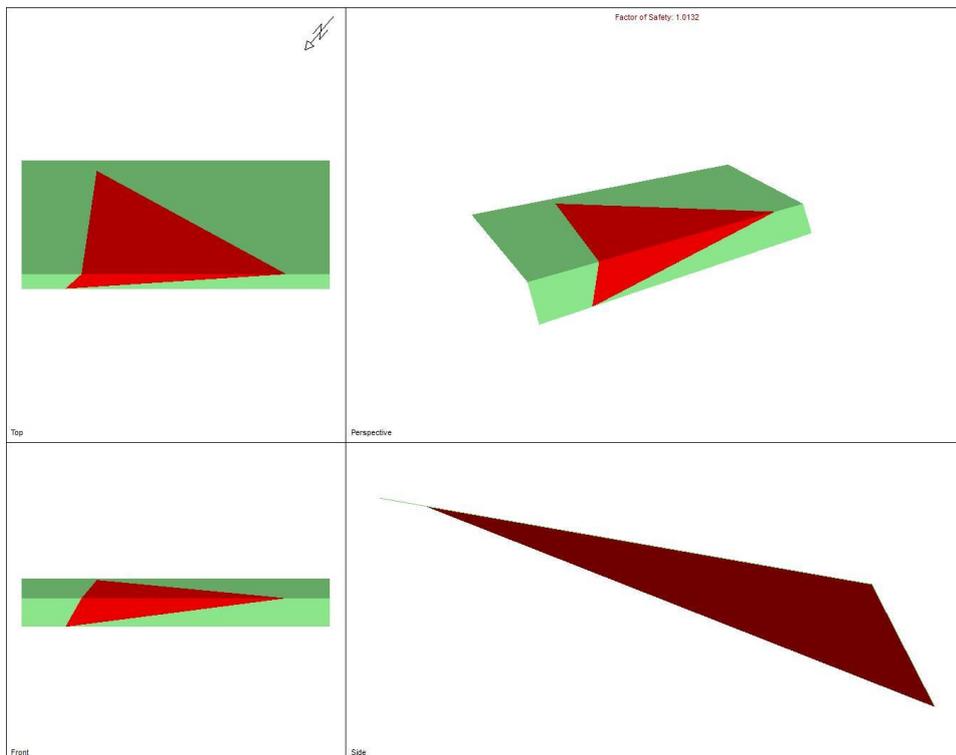
Figure 38: SWedge analysis for the key block 110101 in different perspectives.

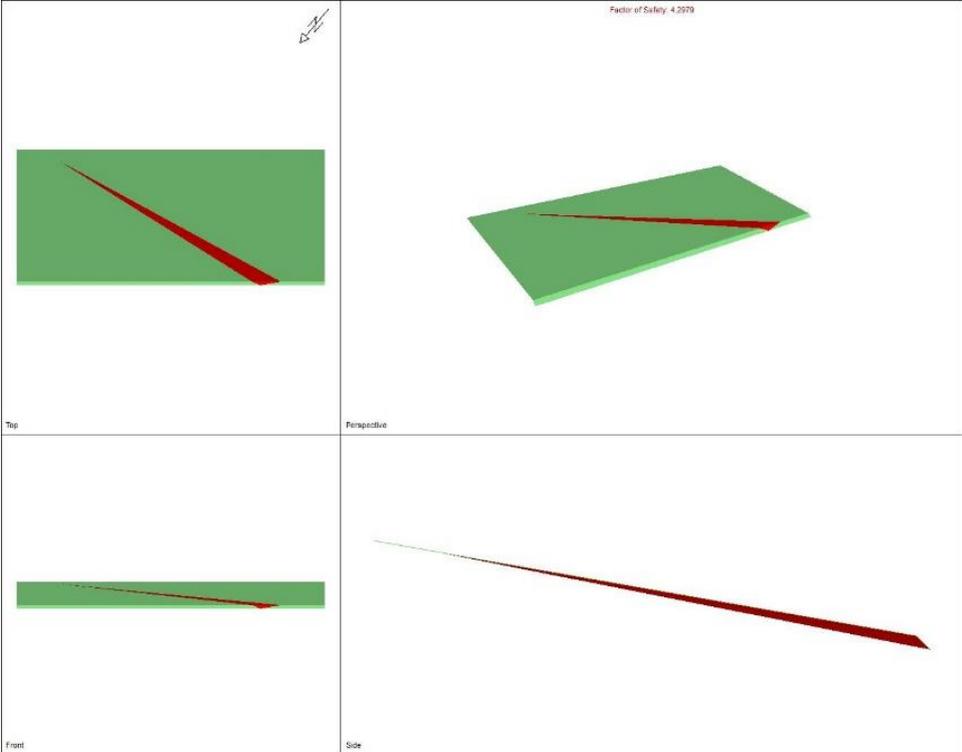
Figure 39: SWedge analysis for the key block 100100 in different perspectives.

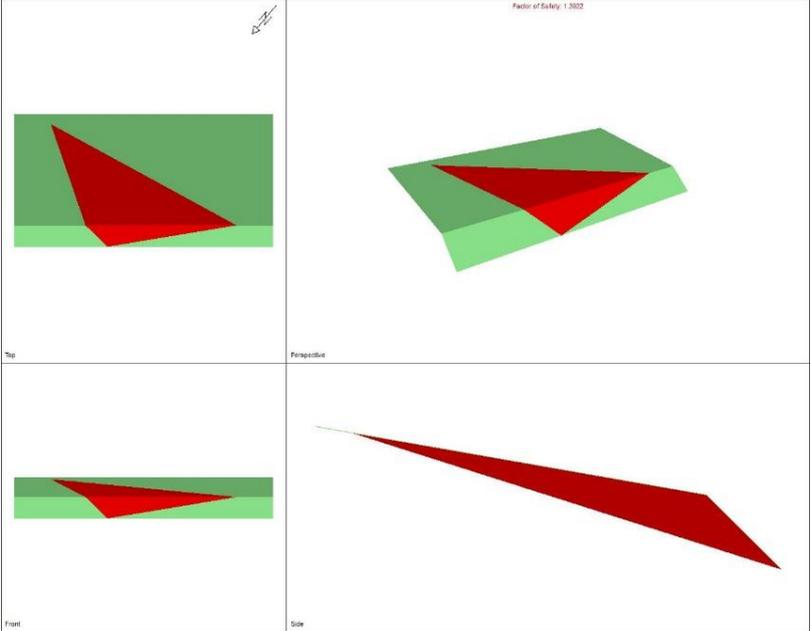
Figure 40: SWedge analysis for the key block 100101 in different perspectives.

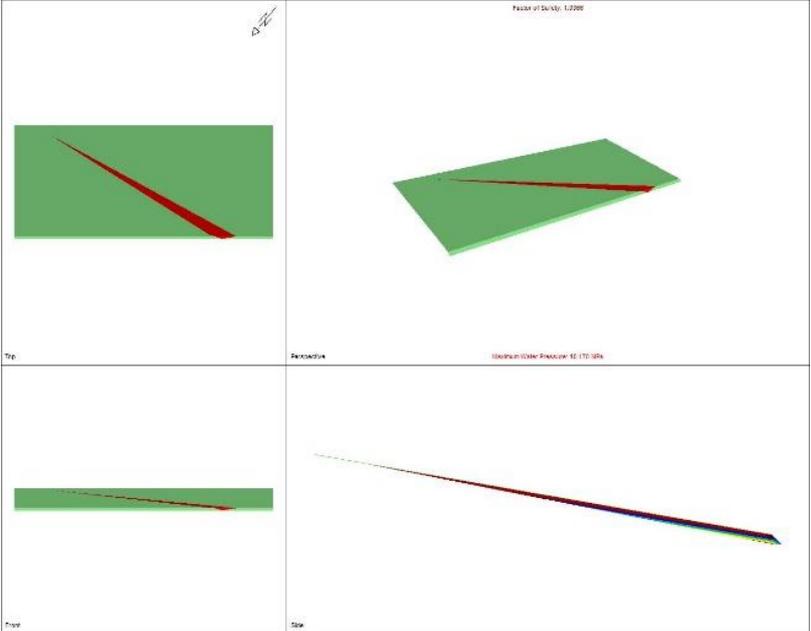
Figure 41: Graphic of the potential key block 101100.
