The area around Landeck in the Tyrol Upland, Austria, features a significant density of deep-seated landslides. In the course of the present thesis the failure mechanisms and kinematics of the slope instability at the area of Perfuchsberg, in the west of Landeck, get investigated and determined. To support these analyses, detailed geological and geomorphological field mapping, rock sampling, laboratory investigations and engineering geological analysis are performed.

This master thesis is concerned with the landslide Perfuchsberg. The aim is, to determine the geological conditions, the failure mechanisms, causes and kinematics of the slope instability and to document the influence of the slope deformation on infrastructure and buildings.

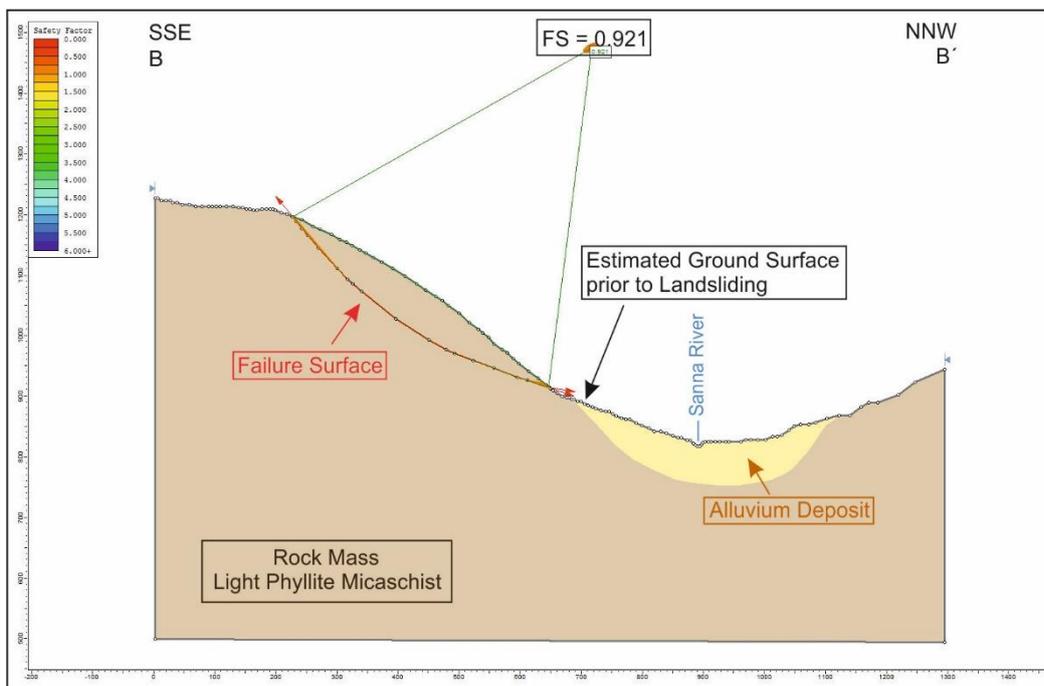
Figure 42: Slide profile under dry conditions with the most likely failure plane.

Under approximately dry conditions the most likely failure plane is shown in Figure 42.

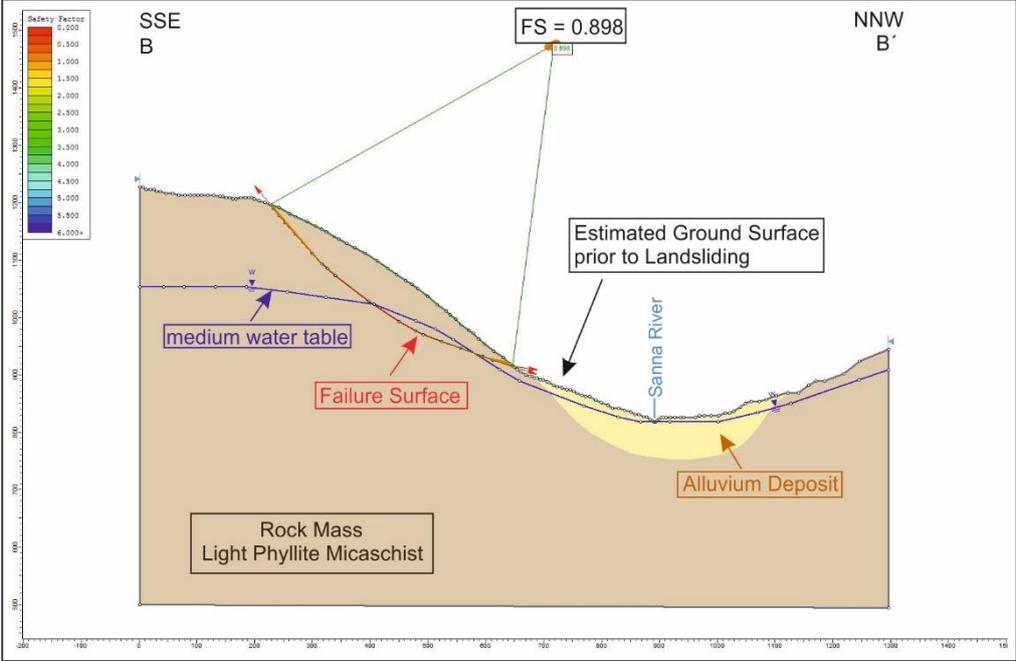
Figure 43: Slide profile under medium water table conditions with the most likely failure plane.

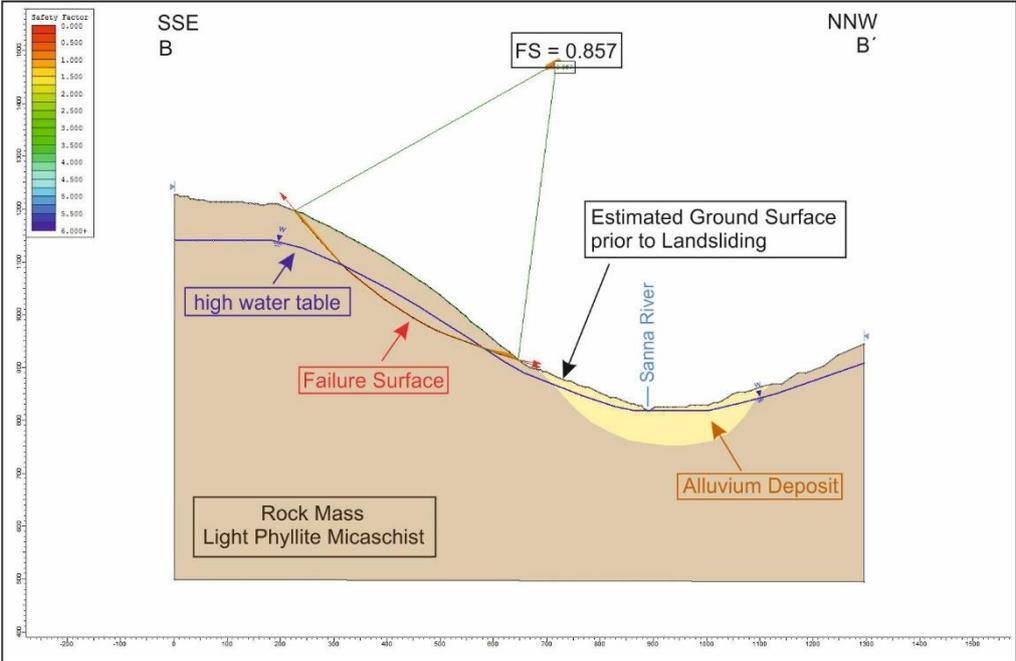
Figure 44: Slide profile under high water table conditions with the most likely failure plane.

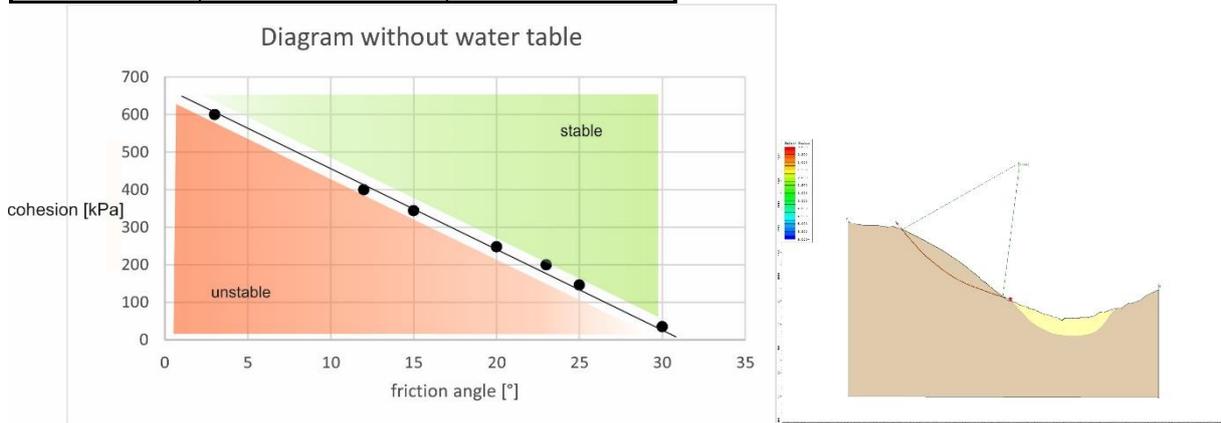
Figure 45: Material properties which lead to FS = 1 charted at the left diagram. The trend line indicates limit equilibrium conditions. The red sector represents the unstable parameter conditions and the green sector the stable conditions.

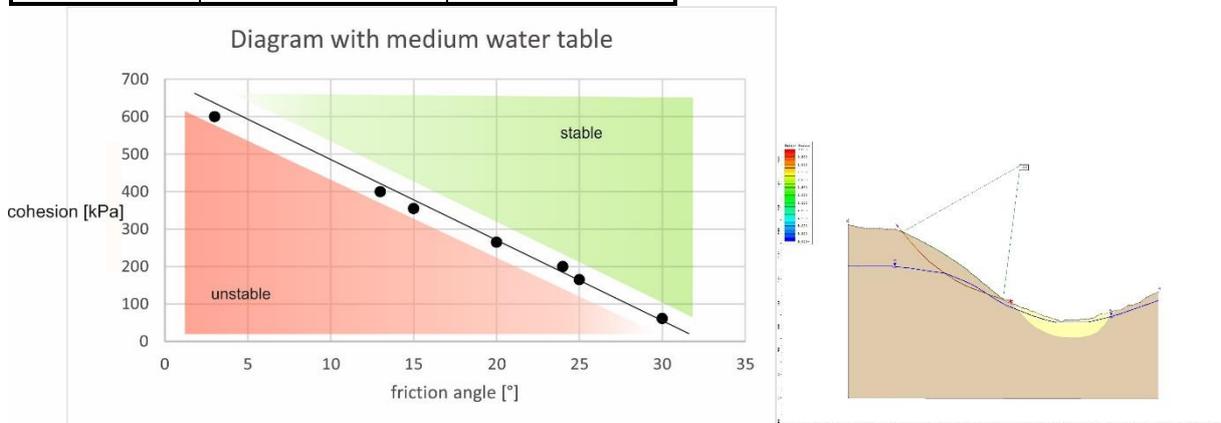
Figure 46: Material properties which lead to FS = 1 charted at the left diagram. The trend line indicates limit equilibrium conditions. The red sector represents the unstable parameter conditions and the green sector the stable conditions.

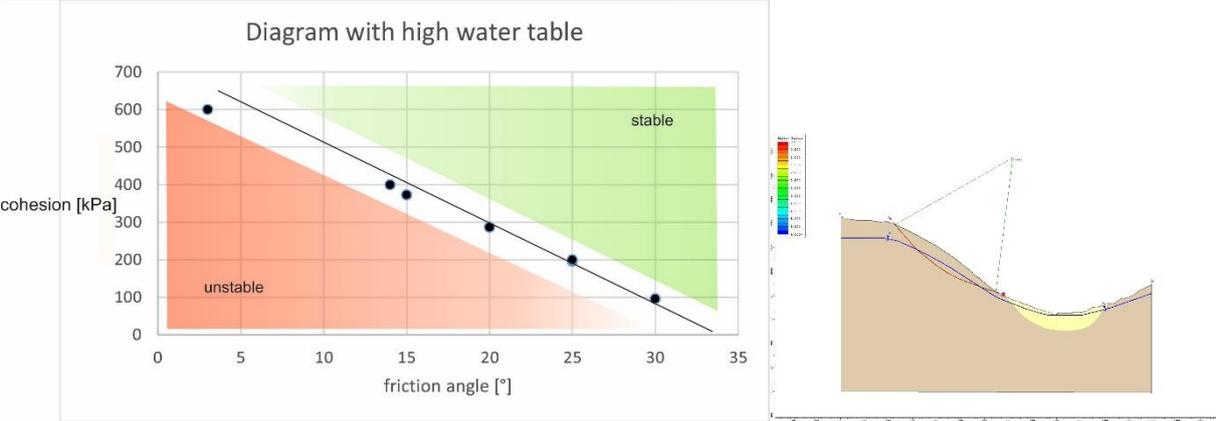
Figure 47: Material properties which lead to FS = 1 charted at the left diagram. The trend line indicates limit equilibrium conditions. The red sector represents the unstable parameter conditions and the green sector the stable conditions.

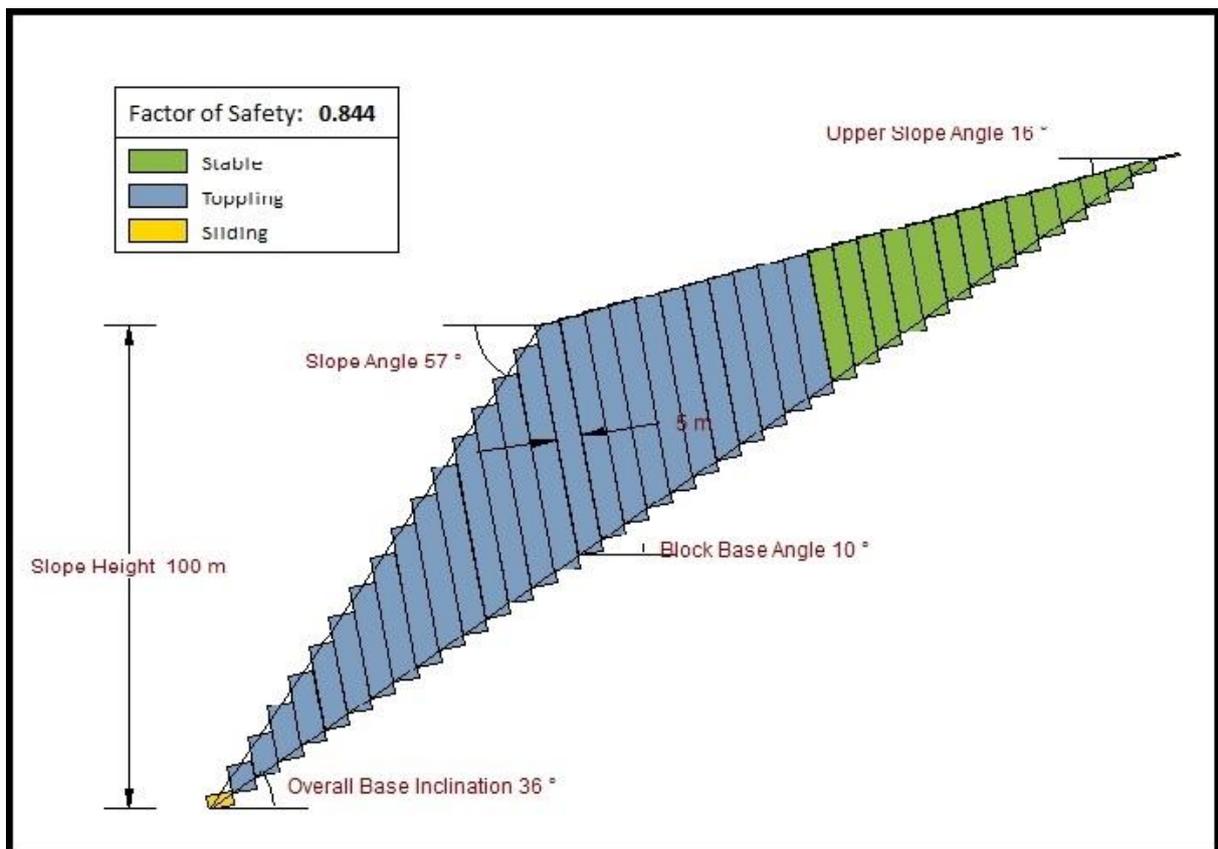
Figure 48: Stability analysis at the area under the church of Tobadill with respect to toppling.

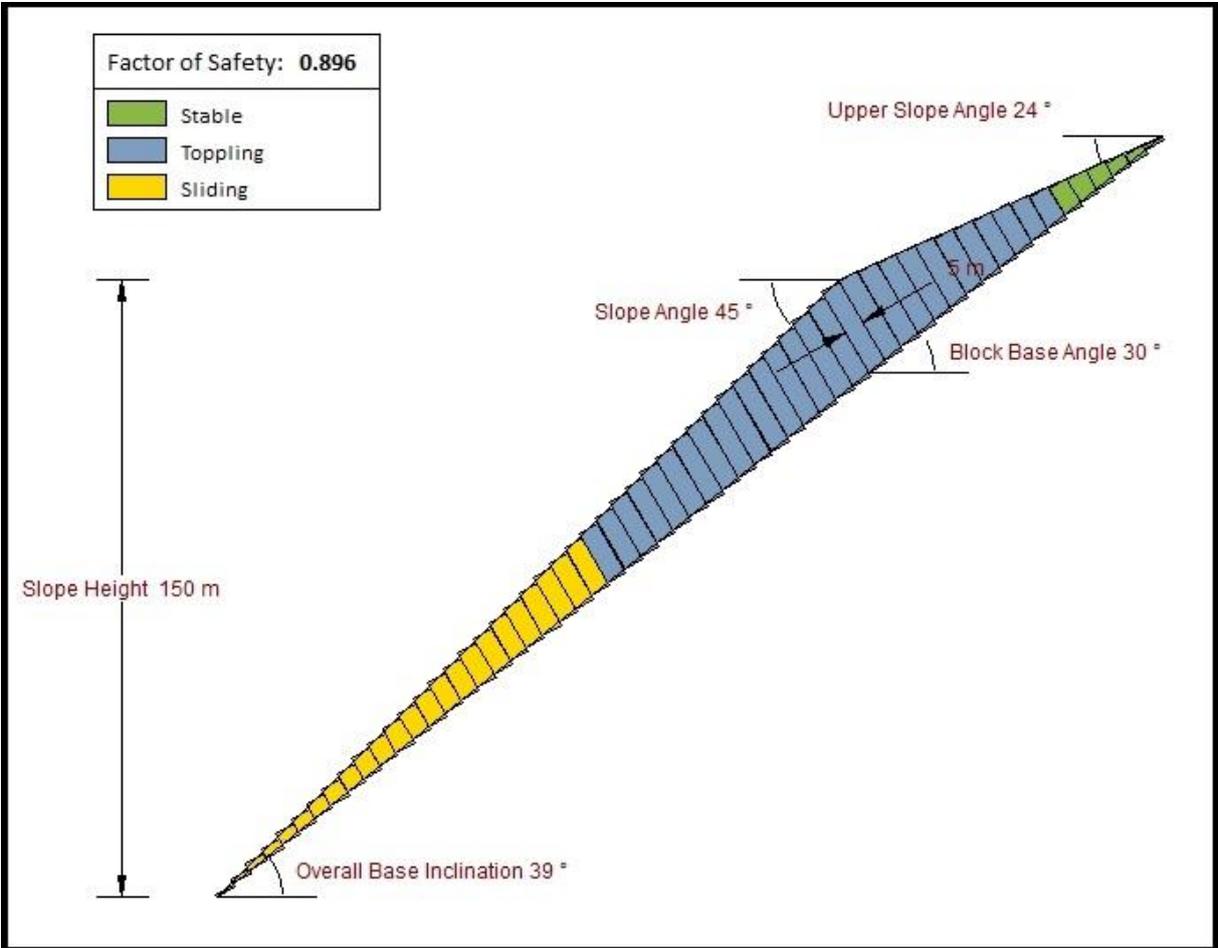
Figure 49: Stability analysis with respect to toppling at Area 1.

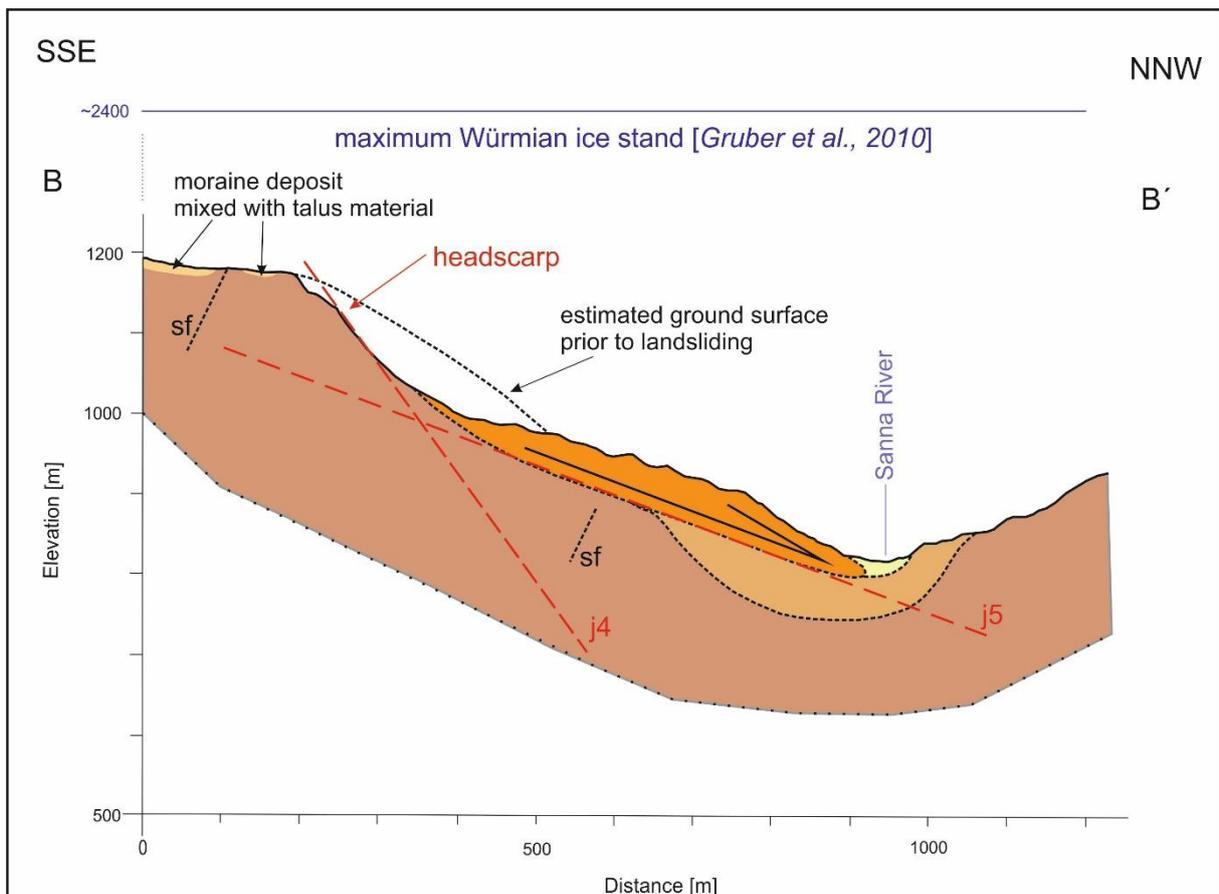
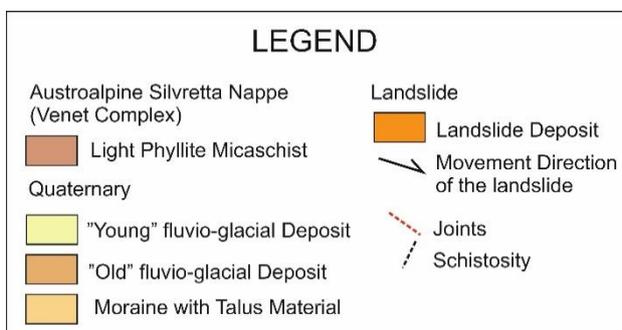
Figure 50: Geologic cross section of Area 1 from the study area. The exact location of the cross section can be taken from Figure 30.

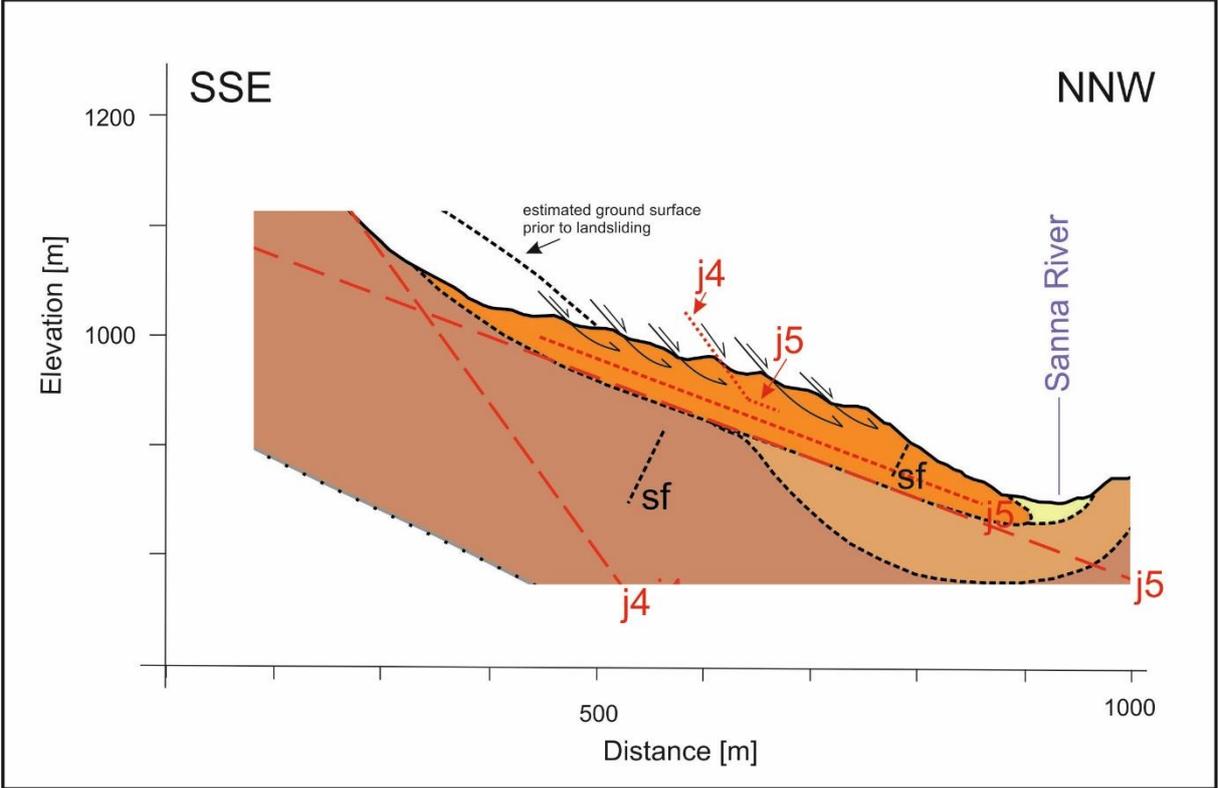
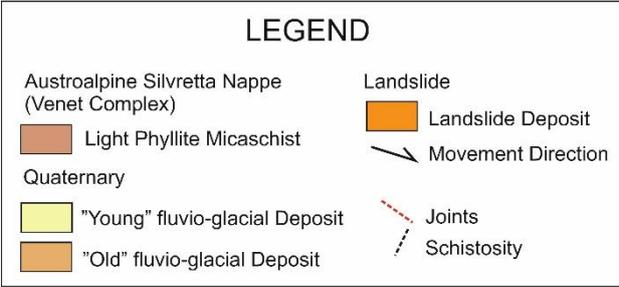
Figure 51: Cross section of the estimated internal structure of the landslide deposit.

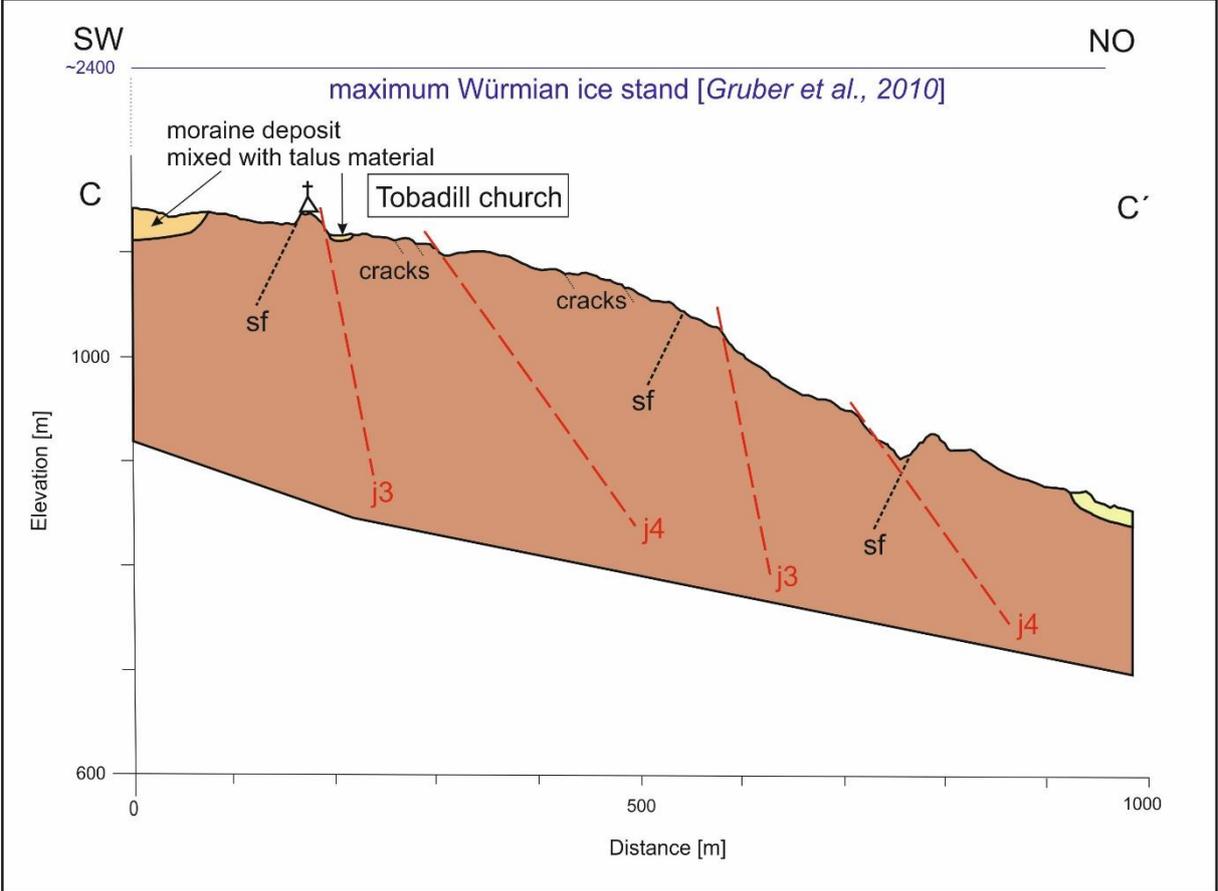
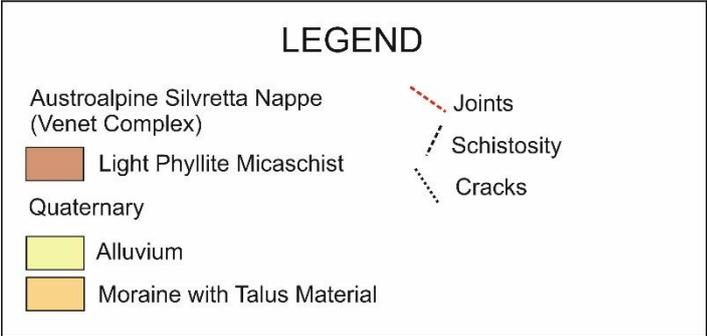
Figure 52: Cross section under the church of Tobadill. The exact location of the cross section can be taken from Figure 30.

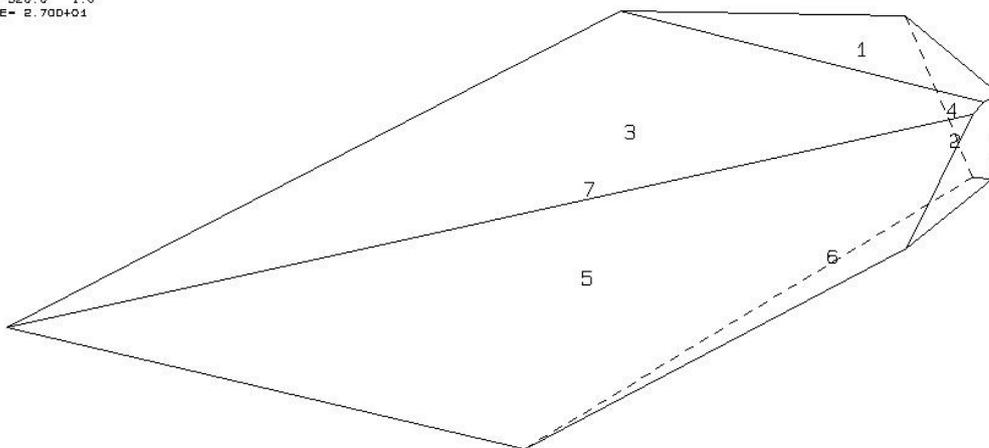
Model of Block 100100:

PROJECTIVE DIRECTION:
 0.5 -0.5 -0.7
 DIP, DIP D., DISTANCE
 68.0 139.0 1.0
 51.0 249.0 1.0
 81.0 337.0 1.0
 52.0 53.0 1.0
 21.0 336.0 1.0
 53.0 175.0 1.0
 45.0 320.0 1.0
 VOLUME= 2.70D+01
