**Response of Ricobayo Dam spillway walls to extensive  
rock scour**

**MASTER THESIS**

Institute of Applied Geosciences  
Graz University of Technology

Graz, March 2012

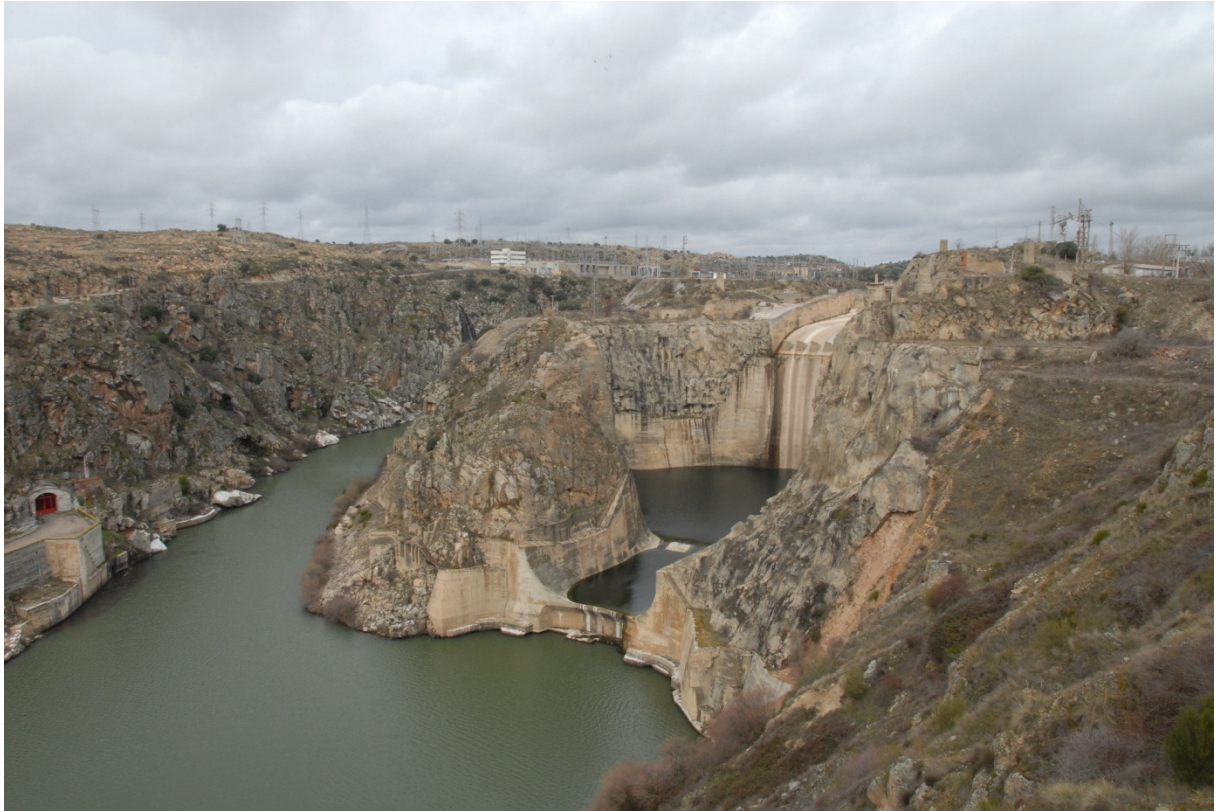
**Figure 1.1 – The Ricobayo plunge pool**

The following work applies Block Theory, in a deterministic and probabilistic manner, to a known scour case at Ricobayo Dam (Figure 1.1). This case has been studied by Annandale (2006), but the back-erosion of the head wall and related effects that led to large failures of the side walls and subsequent enlargement of the plunge pool have not been considered in detail. Rock slope failure processes had a considerable influence on the migration of the head wall towards the reservoir and on the stability of the plunge pool sidewalls, consequently influencing the geometry of the formed plunge pool and the volume of eroded material.

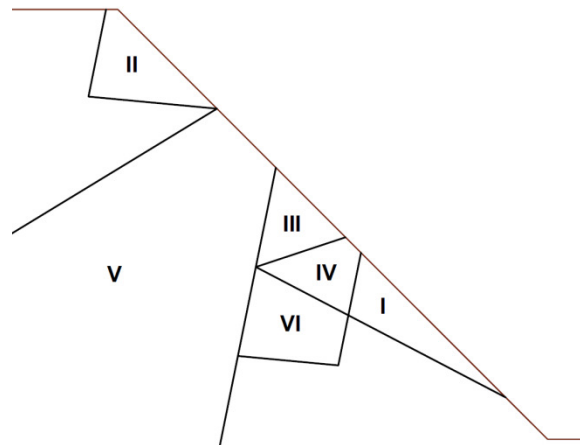
Figure 3.6 – Block types

Block type VI is a special case called “joint block”. Such a block is formed just by joint surfaces and has no face on the excavation perimeter. Block type V possesses a free face, but it is infinite unless new cracks are formed, what by definition is not covered by block theory. Type IV is finite, but it is not removable. There is no direction where it can move without pushing into adjacent rock mass. These blocks are called “tapered” (Goodman, 1989).

Remaining blocks are *finite* and *removable*. To differentiate them stability must be evaluated. Type III is safe under the action of gravity, even without friction. Type II is safe with enough friction; these are called “potential key blocks”. Blocks of type I are not just removable but also oriented in an unsafe manner in relation to the acting forces; these blocks are called “key blocks” (Goodman, 1989).

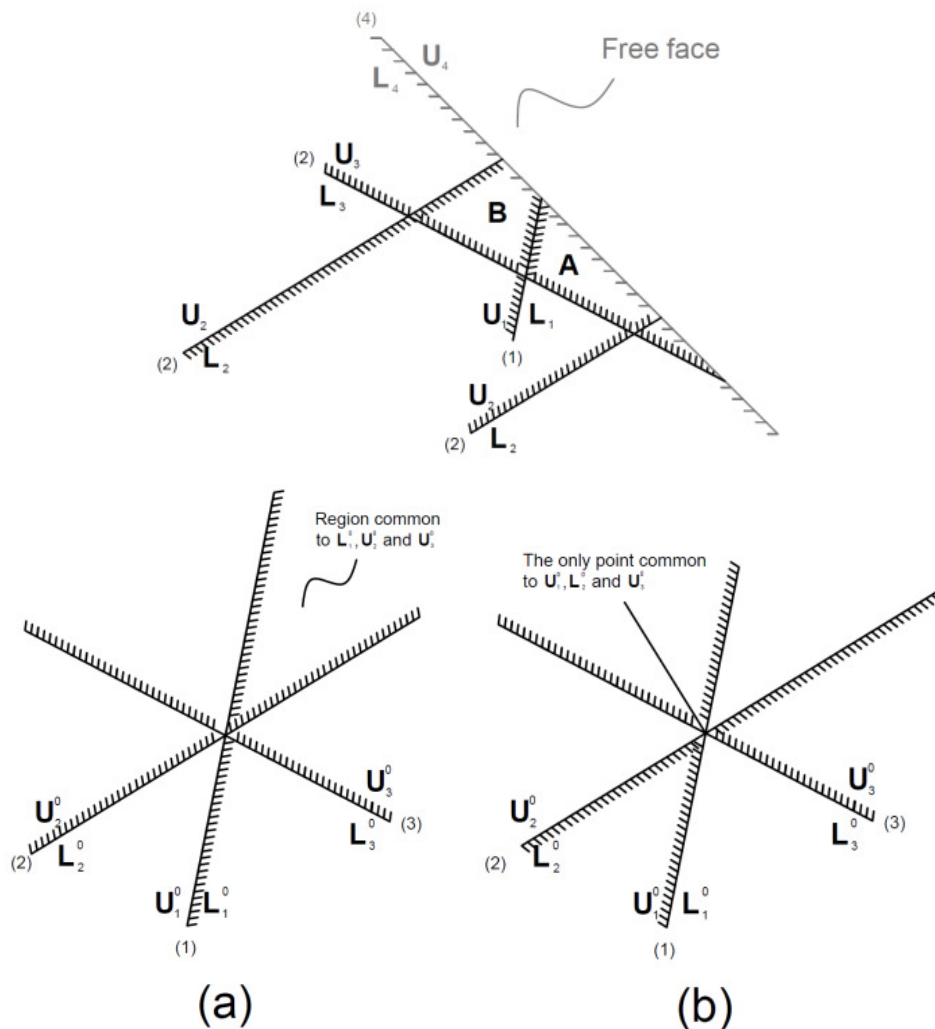
Figure 3.9 – Block removability in 2D – based on Goodman and Shi (1985)

Block B is determined by half-spaces  $U_1L_2U_3L_4$ . Its joint pyramid is formed by  $U_1^0L_2^0U_3^0$ , the only point in common to the shifted half-spaces is the origin itself.  $JP_B$  is therefore empty, and  $BP_B$  is also empty. In this case the theorem states that block B is non removable, therefore “tapered”.

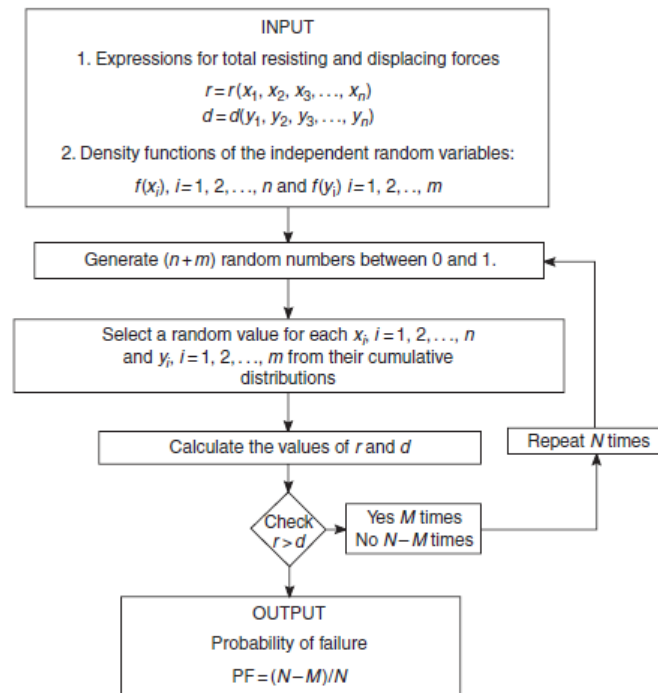
**Figure 3.11 – Flow chart for Monte Carlo simulation to calculate probability of failure of a slope (Athanasίου-Grivas (1980), extracted from Wyllie and Mah (2004))**

A probabilistic analysis is a systematic procedure to examine the effect of the variability of each parameter on slope stability (Wyllie and Mah, 2004). By the random generation of the analysis parameters following a given probability distribution function (PDF), the safety factors of several blocks can be evaluated and probabilistically presented as a probability of failure, which represents the probability at which a block may fail. In this matter the method depends on the ability to accurately model the probability distribution of the design parameters (Wyllie and Mah, 2004). For this Master Thesis the Monte Carlo technique has been chosen, and the probabilities of failure are calculated using the software *Swedge and RocPlane (RocScience)*. The Monte Carlo technique is an iterative procedure that can be summarized in four steps as presented by Wyllie and Mah (2004), Figure 3.11:

1. Estimate probability distributions for each of the variable input parameters,
2. Generate random values for each parameter,
3. Calculate the values of the driving and resisting forces and determine if the resisting force is greater than the driving force (if  $FS > 1$ ),
4. Repeat the process  $N$  times ( $N > 100$ ) and determine the probability of failure  $P_f$  from the ratio:

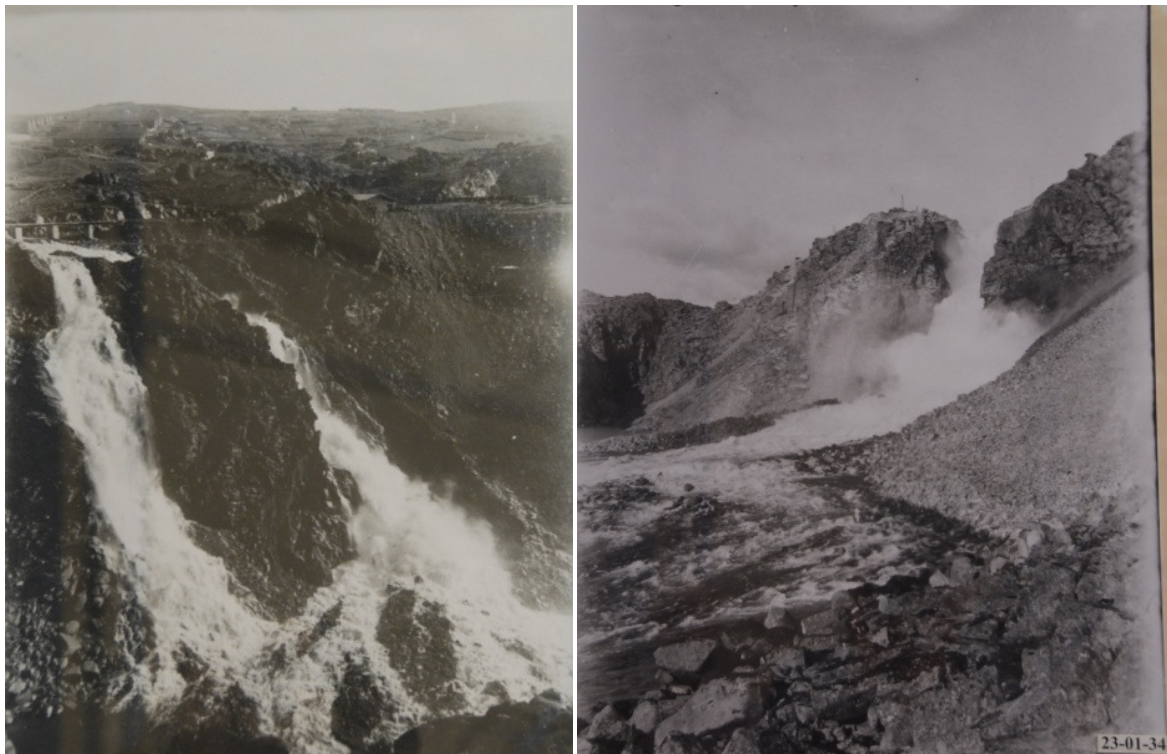
**Figure 4.5 – Initial spillway operation (27/12/1933), and after first phase of the second erosion period (23/01/1934) – Iberdrola S. A.**

From the end of December 1933, when it was put into operation, to June 1934 the spillway was constantly in use. Initially a flow of about  $100\text{m}^3/\text{s}$  was measured (Guía Técnica, 1997). Figure 4.5 illustrates the first days of operation. Scour process can already be observed, indicated by deposition of eroded material at the toe of the slope. The initial formation of the gorge at the final section of the channel is also shown.

In January of 1934 the first large scour event took place (scour event 1, SE1), modifying the frontal slope (Guía Técnica, 1997 and Iberduero S.A.). Gorge excavation may be observed in Figure 4.5. The water flow over this period did not exceed  $1200\text{ m}^3/\text{s}$  (Guía Técnica, 1997). According to documented observations, the erosion process did not occur continuously but rather in a periodic character: very

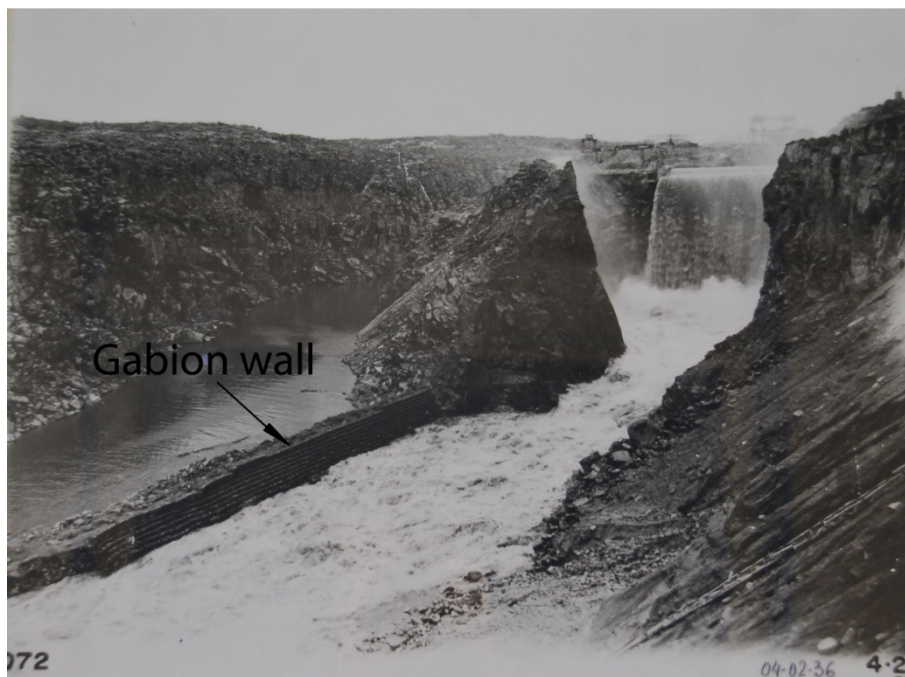
**Figure 4.10 – Detail of the spillway after first phase of the fourth scour event in 04/02/1936 (Iberdrola S.A.)**

Remediation works are illustrated in Figure 4.10.

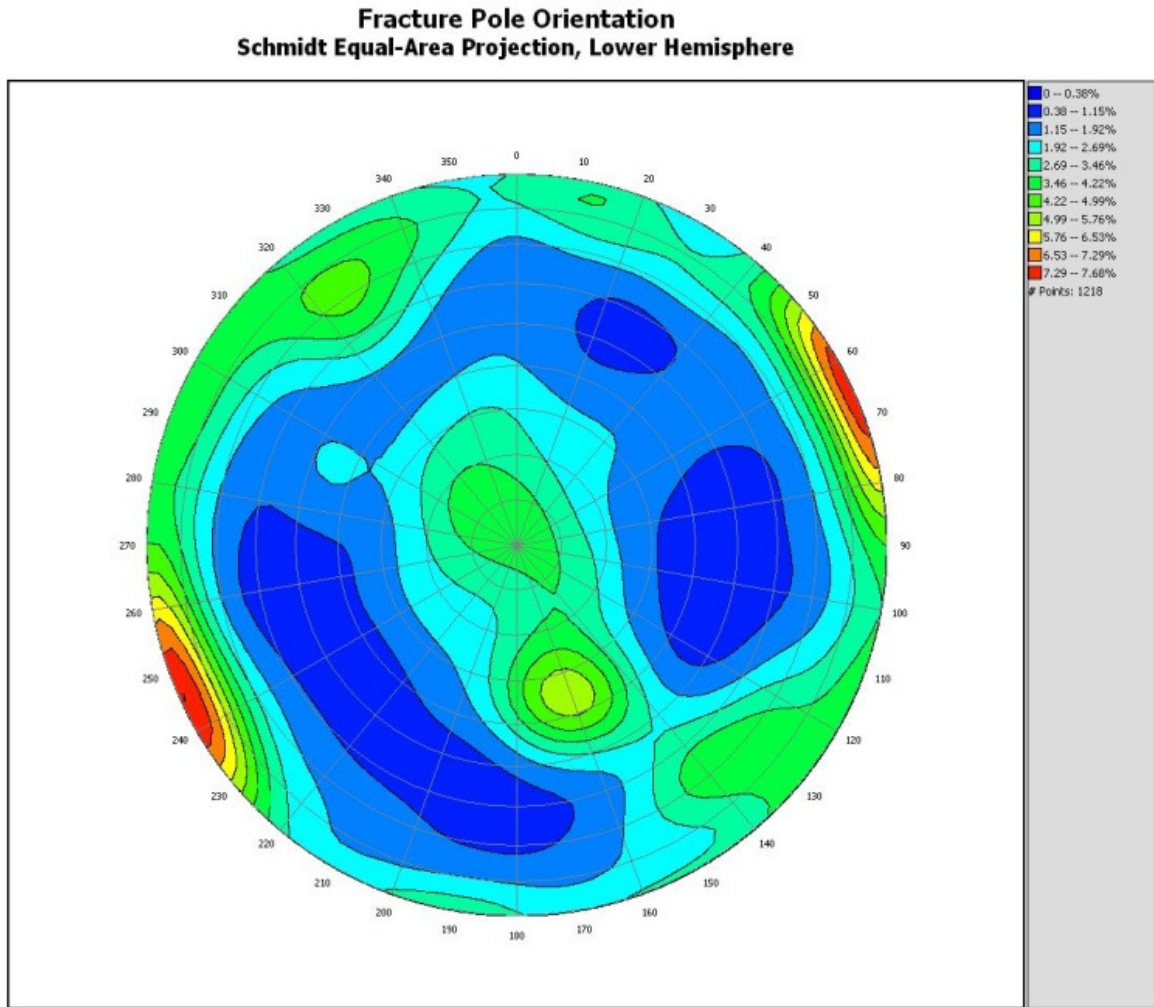
Figure 6.2 – Probability contours of all measured data (1218 measurements)

The joint structure was mapped in the field with a geological compass and also with the photogrammetric software ShapeMetrix<sup>3D</sup>. The results are presented in Figures 6.2 to 6.7, and Table 6.1 summarizes joint set orientation statistics.

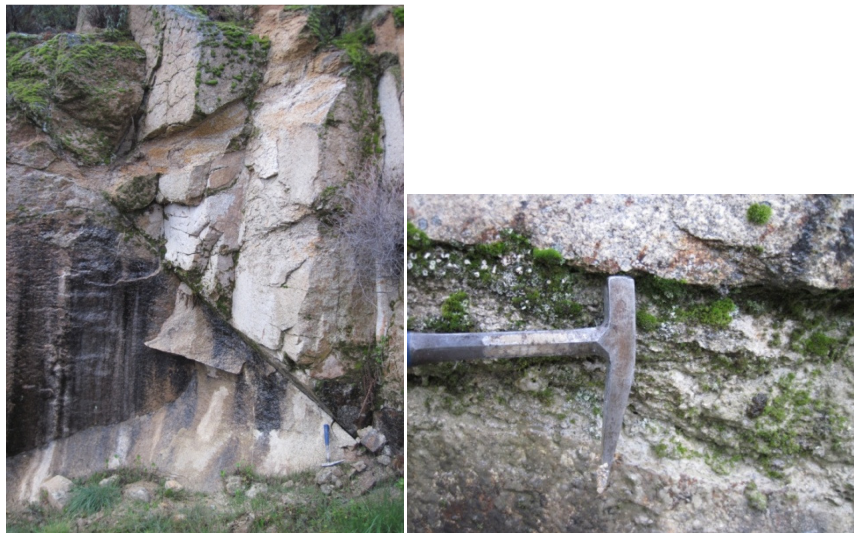
**Figure 6.23 – Typical weathering situation close to the surface and along discontinuity plane**

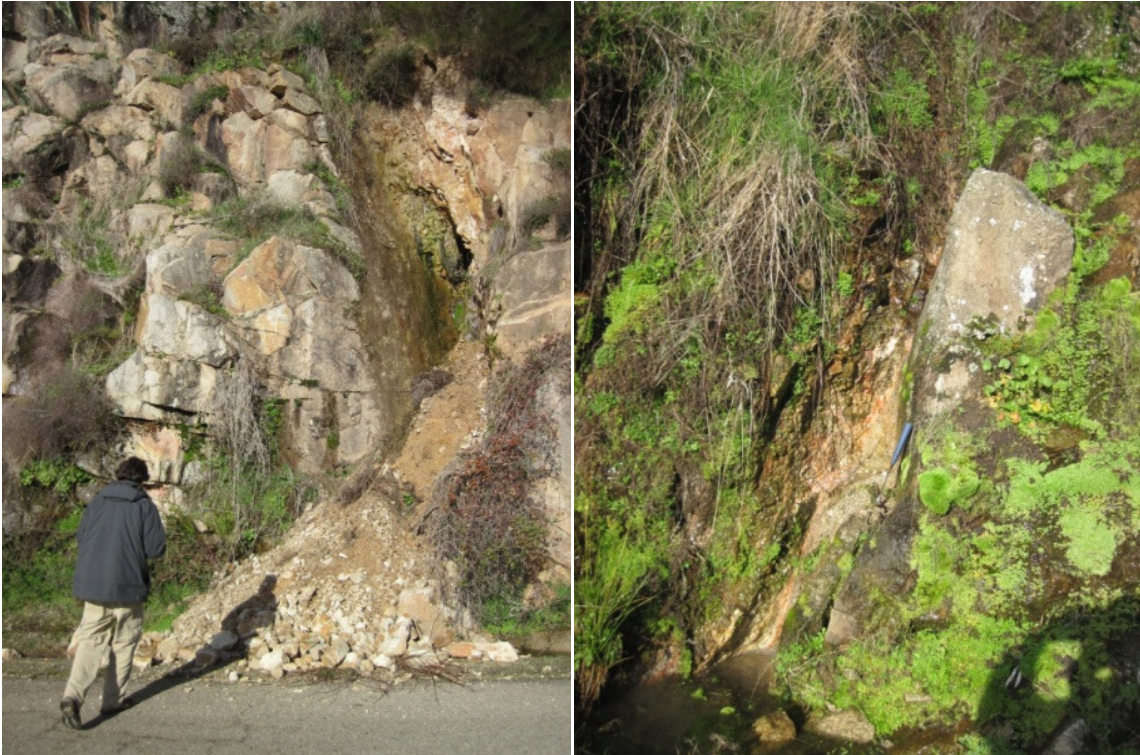
Figure 6.24 – Strong weathering observed along wet discontinuity planes.

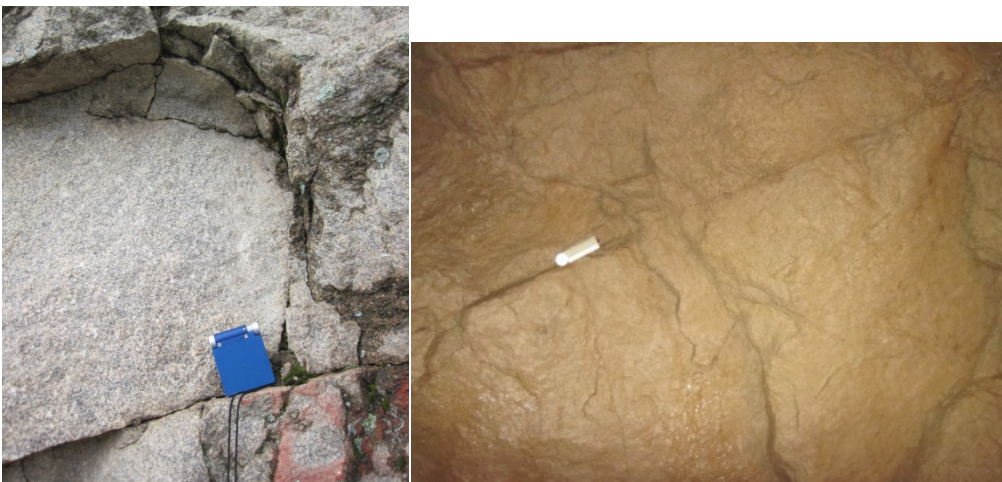
Figure 6.25 – Typical joint plane apertures at the surface and underground

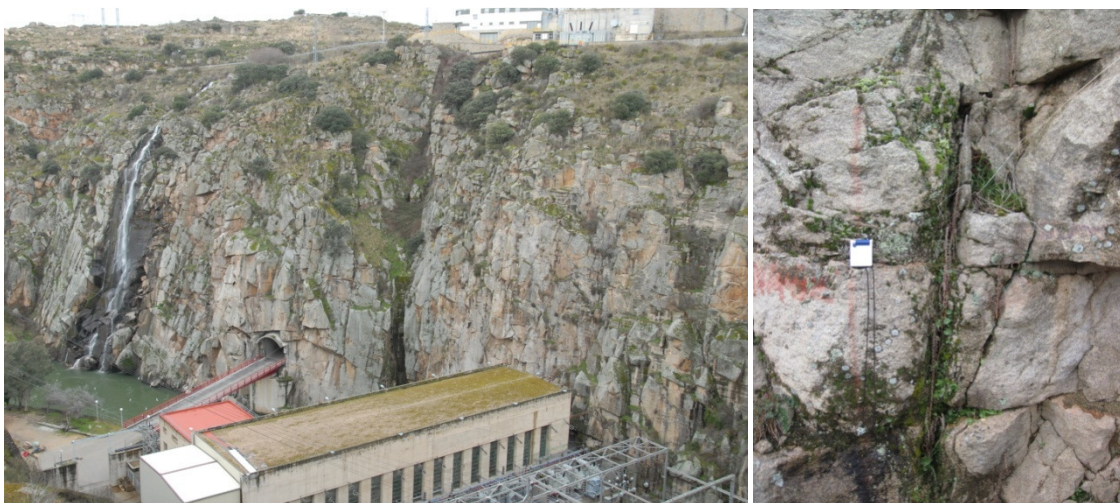
Figure 6.27 – Water condition observed in winter of 2011

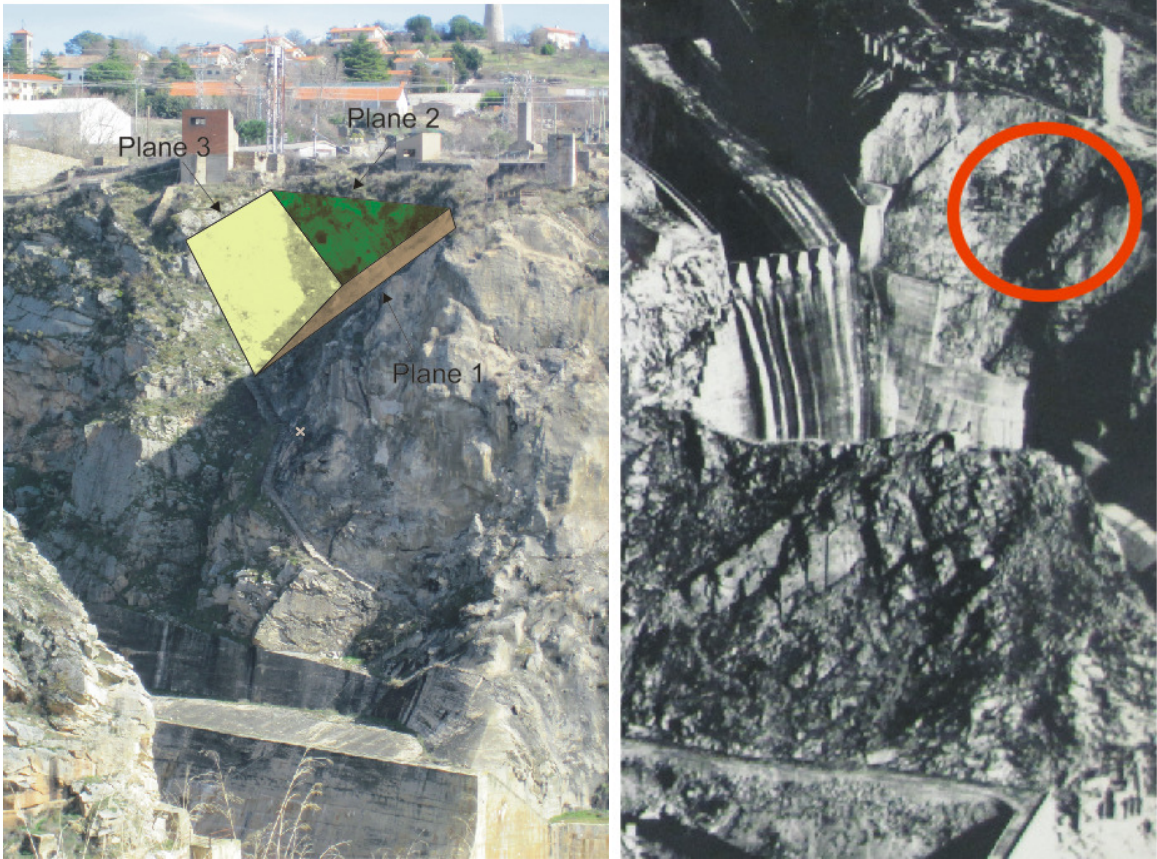
Figure 7.16 – Rock wedge moulds observed on the left wall
