GRAZ UNIVERSITY OF TECHNOLOGY

Master Thesis

**DETAILED INTERPRETATION OF GEORADAR
DATA AND DRILL CORES ON LANDSLIDE
DEPOSITS**

GRAZ, FEBRUARY, 2009

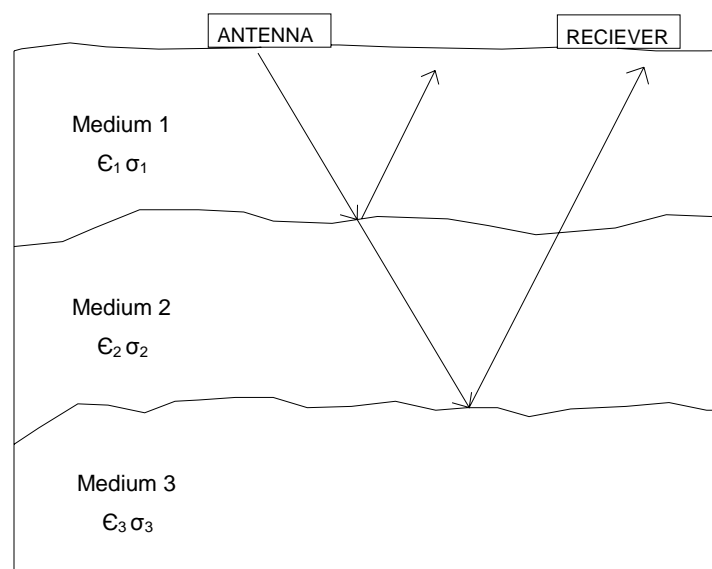
Figure 5. Schematic measuring method for GPR.

The amplitude of the reflected wave depends on the contrast of the dielectric characteristics of the underground (Morawetz 2009). As the dielectric characteristics of the materials differ the reflected signal is greater. The antenna receives the signal waves into the monitoring unit that are processed afterwards. Because there is a linear connection of the wave velocity and the depths of objects and structures, the depth of a reflector can be determined if the velocity is known. The following figure (Figure 5) is a schematic diagram of the Ground Penetrating Radar measuring method.

The data obtained from the georadar surveys is presented in a two dimensional depth profile along the scanned line. The vertical axis of the profile is the two way travel time of the reflected wave measured in nanoseconds. The two way travel time is the period of time that takes the signal to be transmitted from the antenna located at the surface to the reflector and back to the receiver antenna.

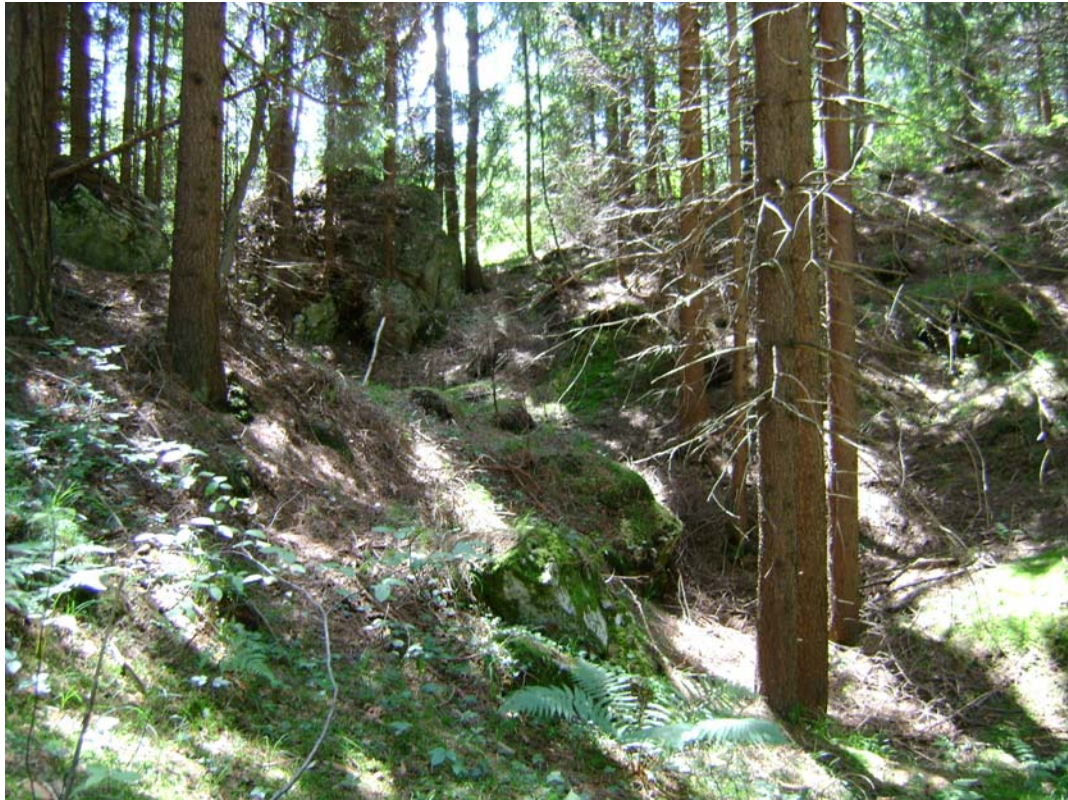
Figure 7. Prehistoric landslide deposit.

slide is deep, weathered and has developed a thick layer of humus and dense vegetation. The humus and soil development has created a smoother hill slope surface. Figure 7 displays the prehistoric landslide deposit. Large blocks can be observed as well as soil and hummus accumulation.

The prehistoric landslide deposit is composed of large dolomitic and carbonatic limestone blocks of up to 5 m in diameter. The blocks have an angular to subangular shape because of the weathering processes that have acted on the deposit. Because of the age of the landslide and the erosive and weathering processes that have acted on it, soil and humus has managed to develop.

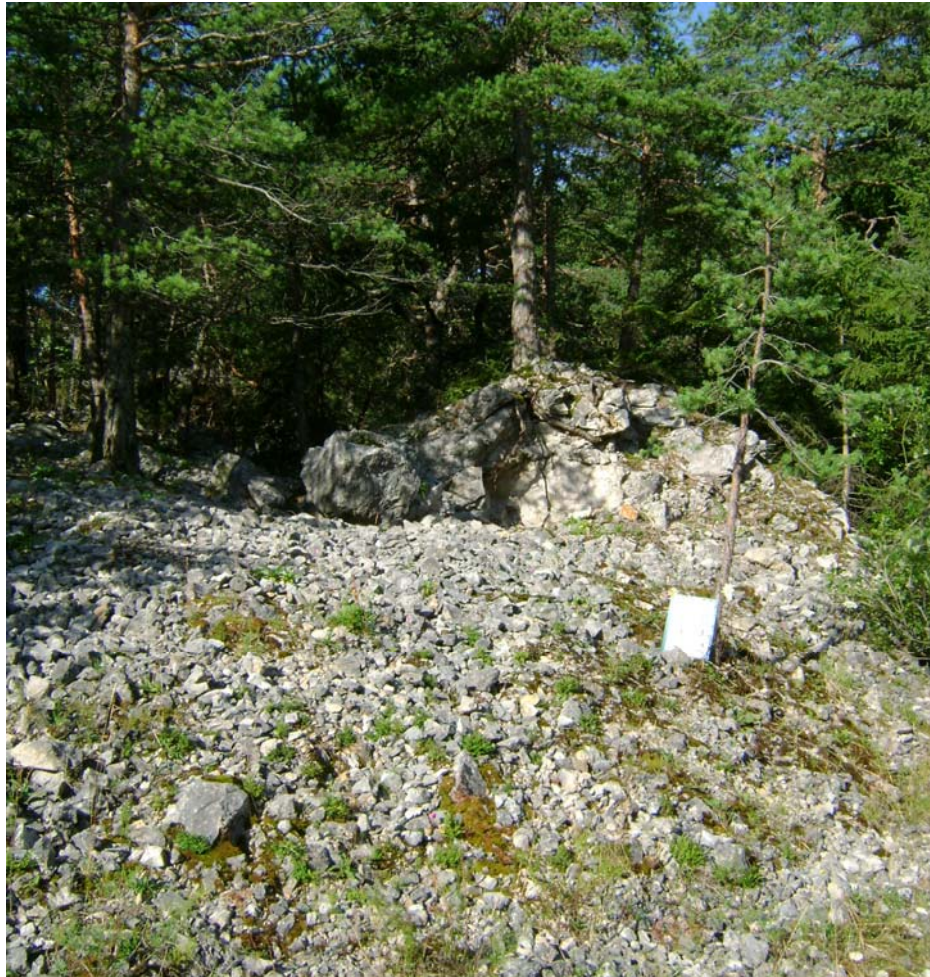
Figure 8. Historic landslide deposit.

Because of the relatively young age of the landslide event of the 13 hundreds, weathering has not been able to produce vast quantities of soil and humus, and therefore vegetation is not well developed in the deposit. The following photograph (Figure 8) displays the historic landslide deposit where the bare blocks and almost no soil cover is found.

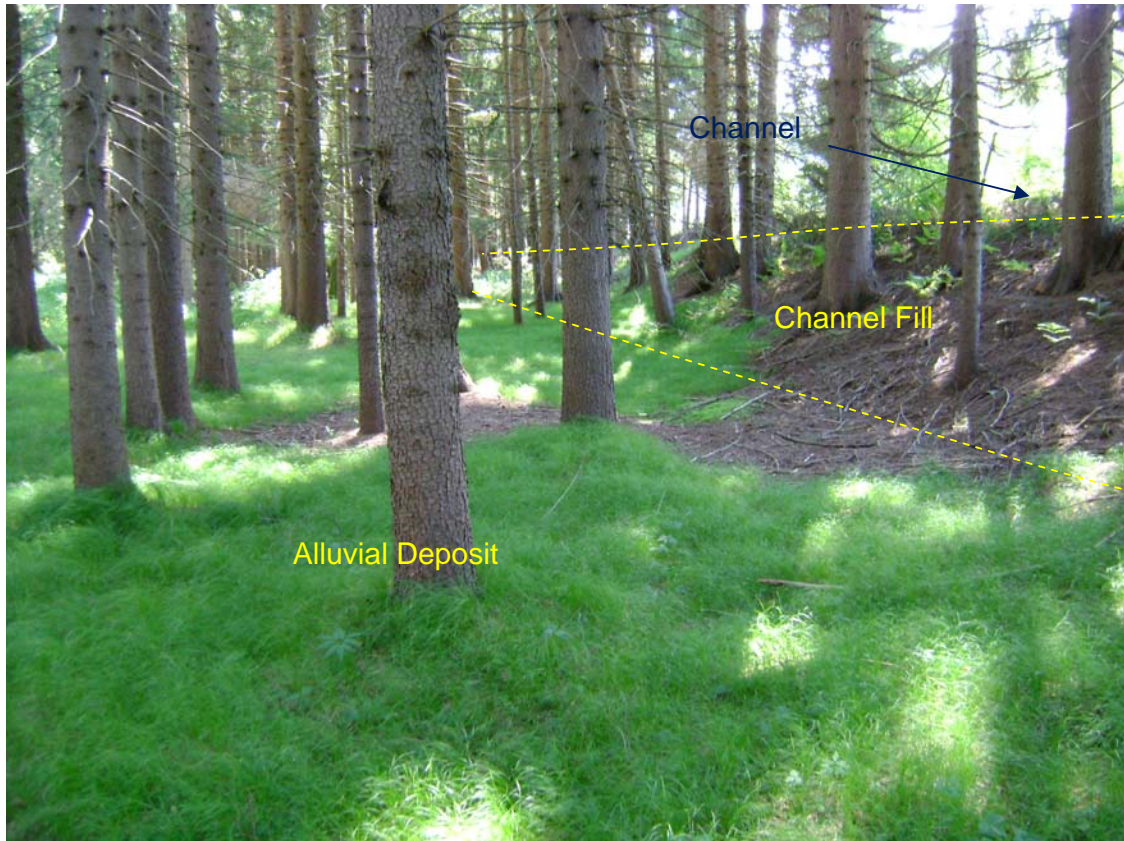
Figure 9. Alluvial terraces.

The surface of the landscape influenced by this unit is relatively flat with protuberances that correspond to large blocks. Because of the low topographic level of the areas where this unit is found, build up material was used to obtain a desirable level for the construction of the initial channel length. Figure 9 shows the topographically smooth and flat terrain of this unit.

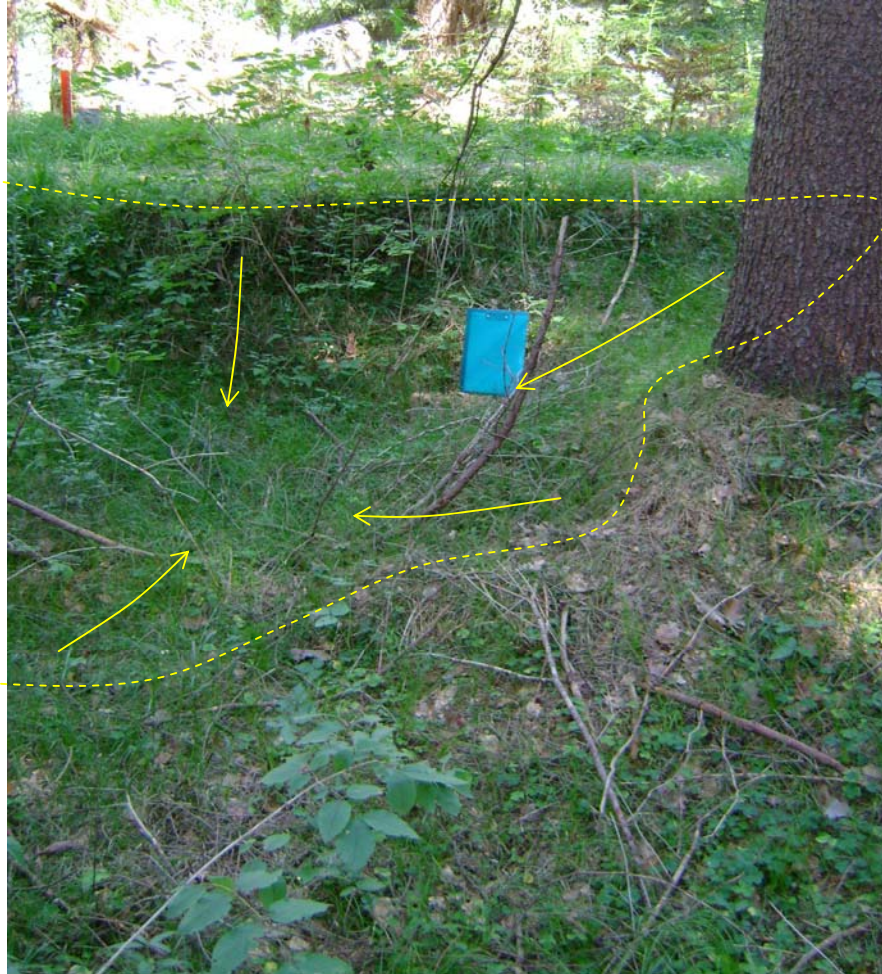
Figure 10. Sinkhole.

Evidence for such a process of sediment migration is observed in several locations within this deposit. Sinkholes and depressions are found in the initial section of the channel. The failures occurred on the channel could be related to cavities and/or migration of sediments. One of the features identified as a sinkhole can be observed in the previous photograph (Figure 10).

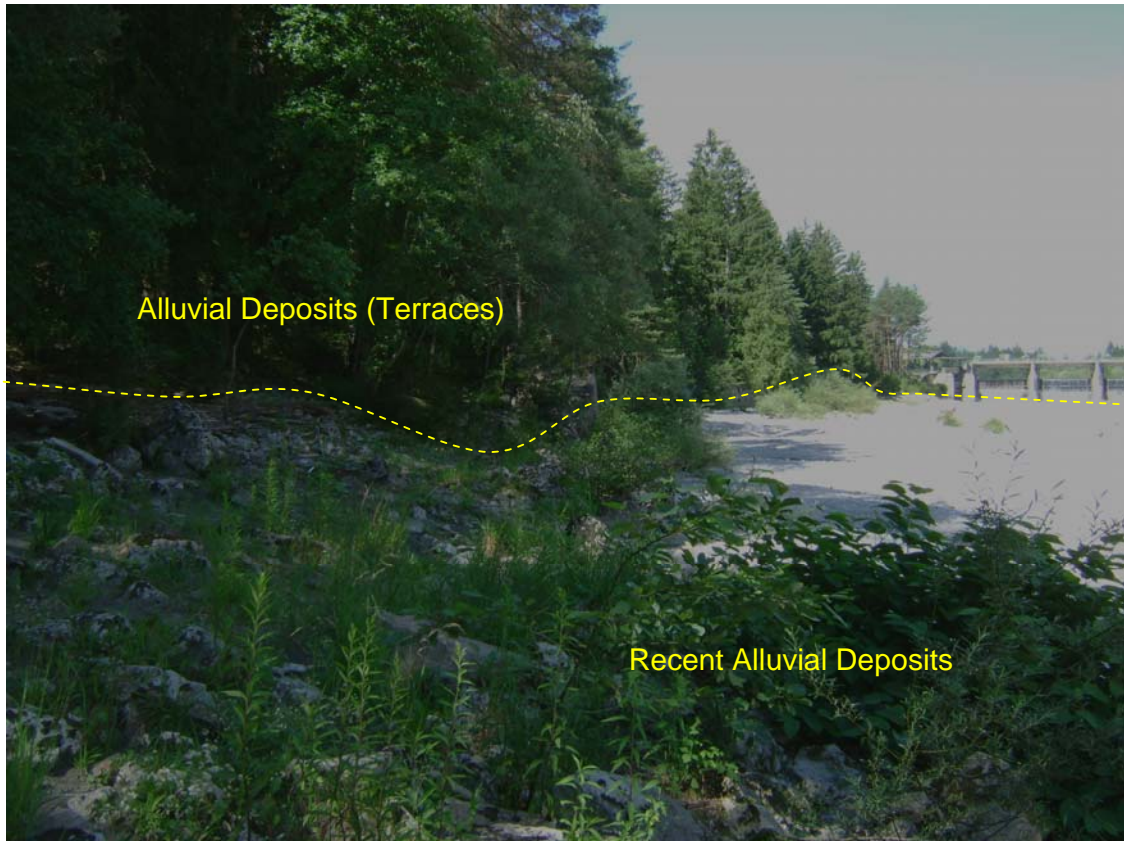
Figure 11. Alluvial terraces.

The location of this deposit is between the first alluvial terraces and the actual Gail fluvial deposit. Because of the topographic level it is relatively younger in age than the landslide and older alluvial units. Erosion and carving of the units by the flow of the river allows the deposition of this unit in a topographically lower elevation. During flooding events terraces can be created by accumulation of material. The following picture displays the recent fluvial deposits as well as the alluvial deposits forming terraces (Figure 11).

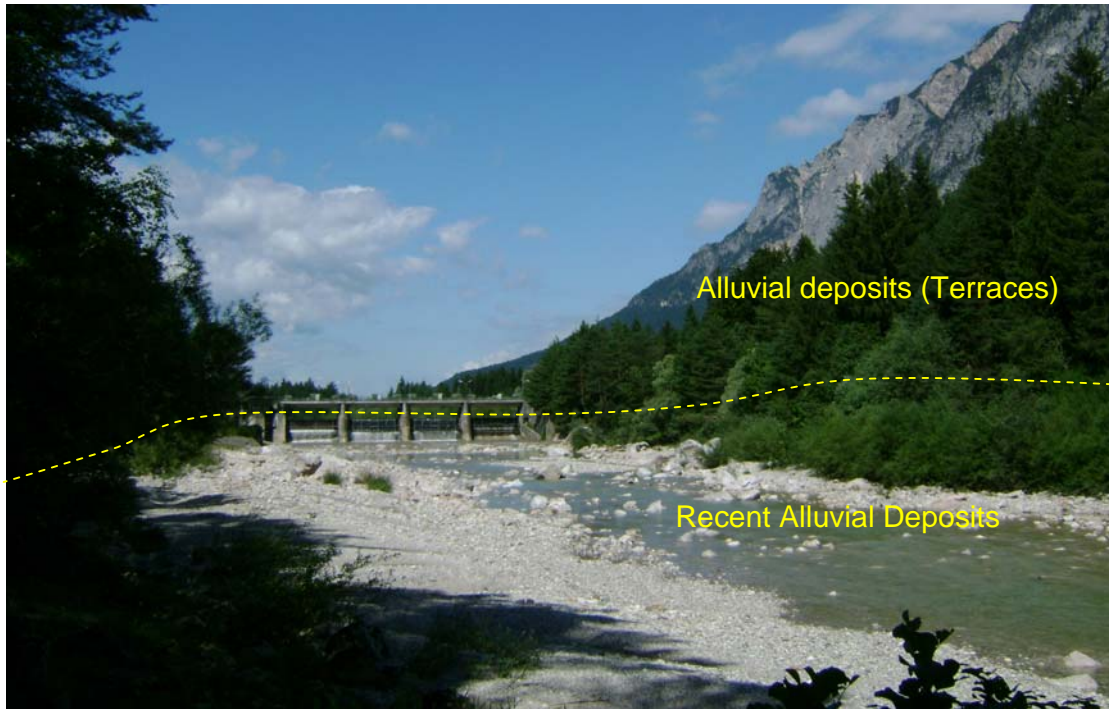
Figure 12. Recent fluvial deposits along the Gail River.

The erosional processes are diminished and are actually controlled with the damming of the river. However, the process is still active, especially in sporadic events where the river floods causing deposition and/or erosion of the river bed. The Gail has a sinuous watercourse in the surroundings of the Schütt being able to erode and deposit sediments on its meanders. The next photograph shows the recent fluvial deposits of the Gail (Figure 12).

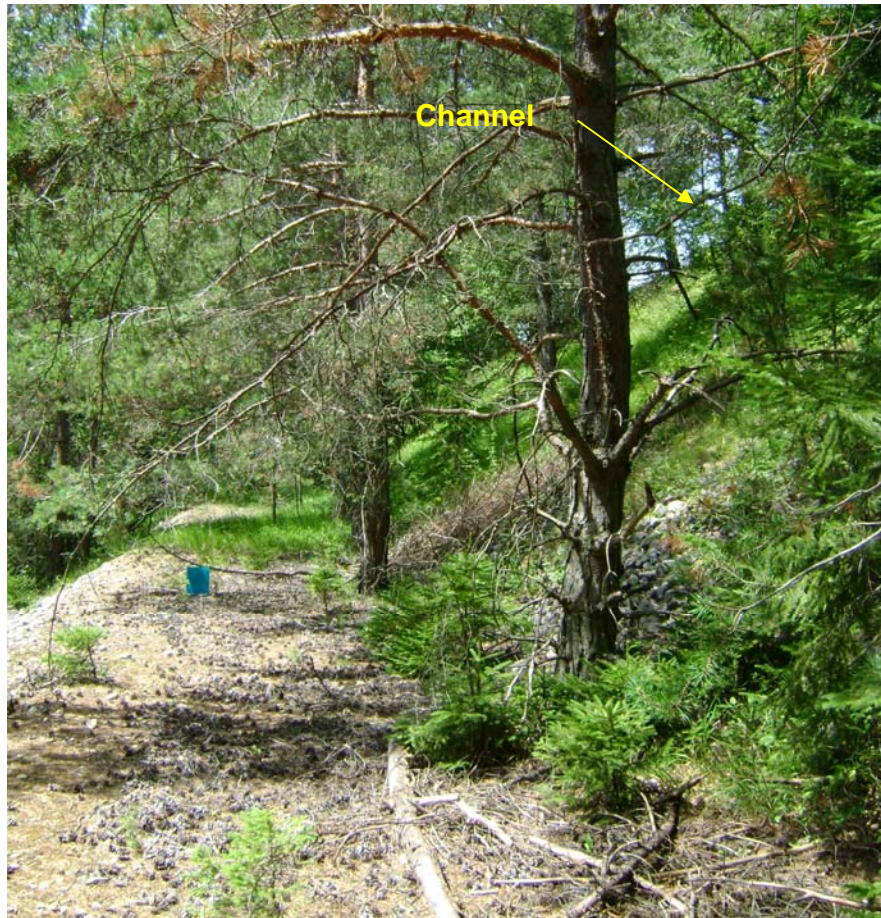
Figure 14. Artificially built up terrain.

The cross section profiles found in Annex 2 are sketches that indicate whether the channel lies on infilled or leveled terrains. A rough representation of the fills and cuts can be observed in such sketches at the different locations where they were observed along the channel. The following photograph (Figure 14) displays one of the highest fills along the channel.

The previous photograph (Figure 12) is from a built up area at the station of 2900.0 approximately on the right side of the channel. The level was built up approximately 25.0 m with several benches and slopes on both sides of the channel where the natural ground has a topographic low.

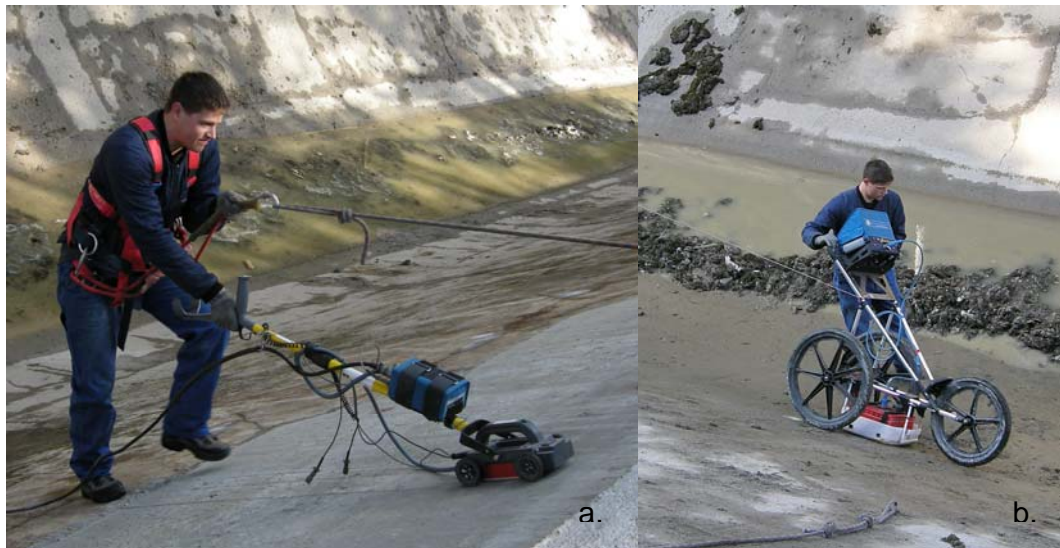
Figure 16. Antennae for georadar surveys

Modified from Morawetz, R. Bodenradaruntersuchung Testmesung Kanal von Kraftwerk Schütt. Institut für Wasser Ressourcen Management. Leoben. Jul. 2009. a.1.5GHz antenna b. 400 MHz antenna

For the 1500 MHz antenna measurements a similar procedure was carried out as with the 400 and 900 MHz. The antenna is provided with its own cart and odometer. The traverse profiles were measured upward, starting from the deeper section moving towards the upper edge of the channel. The reason for this different measuring scheme was the equipment manipulation.

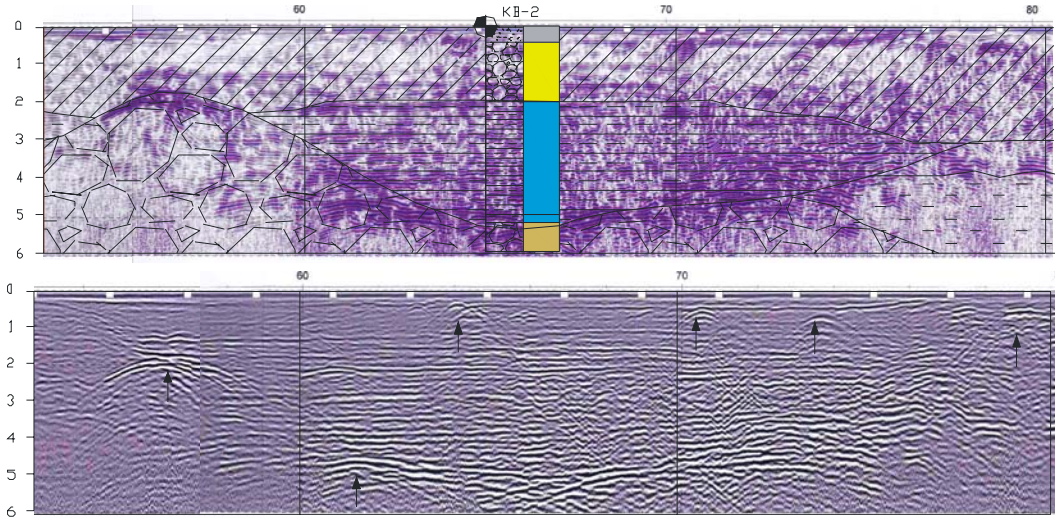
Figure 19. Interpretation for 400 MHz Georadar profile.

The basin like structure outlined in the previous diagram (Figure 19) is identified at the same distance where the failure zone lies (from 54 to 76 m). A few days prior to

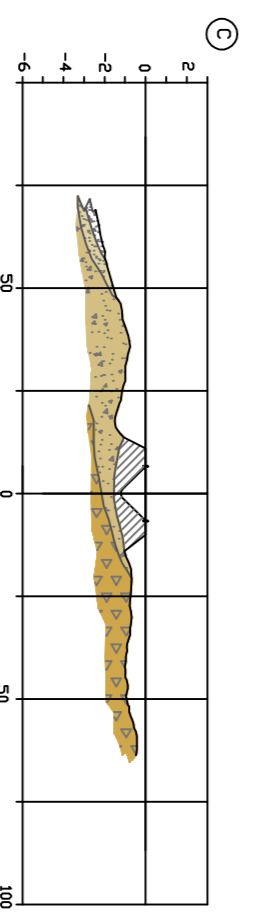
ANNEX 2 Sketched Cross Sections

- Fluvial, sand matrix with gravel up to 10 cm in diameter, subangular to subrounded, sorted, matrix supported.
- Alluvial, sand matrix with gravel and blocks up to 1 m in diameter, subangular to subrounded, unsorted, matrix supported.
- Alluvial, sand matrix with gravel up to 2 m in diameter, subangular to subrounded, unsorted, matrix supported.
- Cobble, blocks and rock fragments up to 5 m in diameter, singular to subangular, unsorted.
- Artificially leveled or built up area.
- Contact, inferred.
- Profile number.

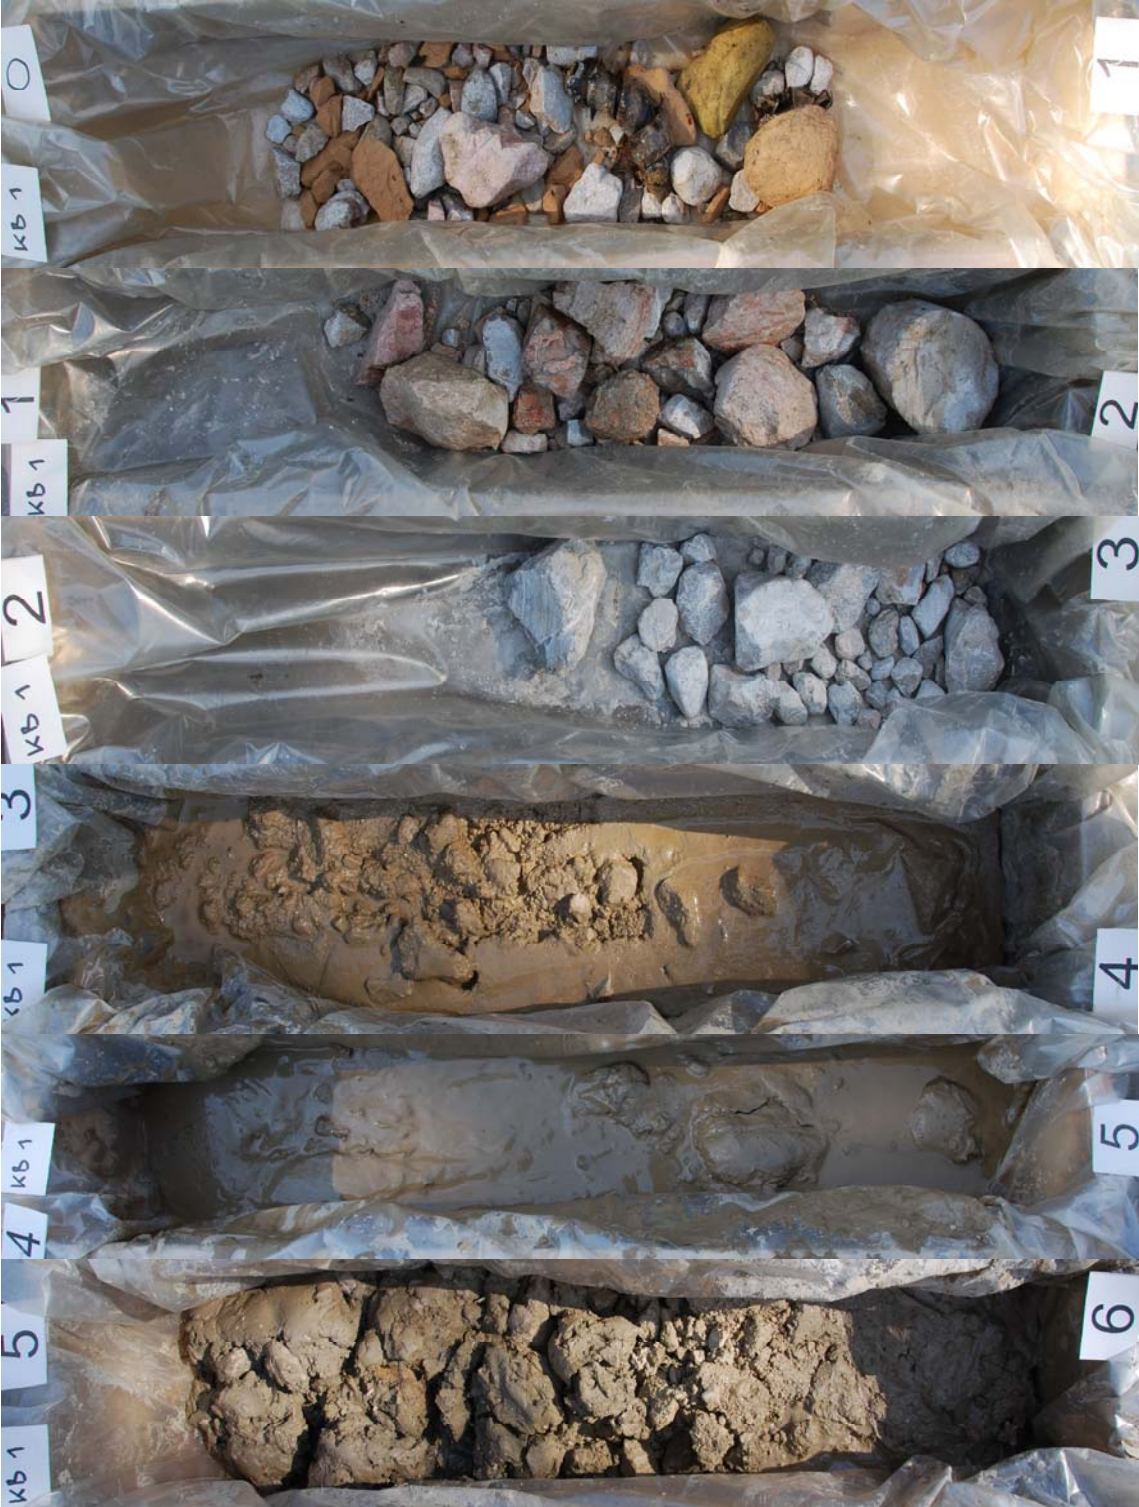
KB-1 WEHR

0.00-6.00 m

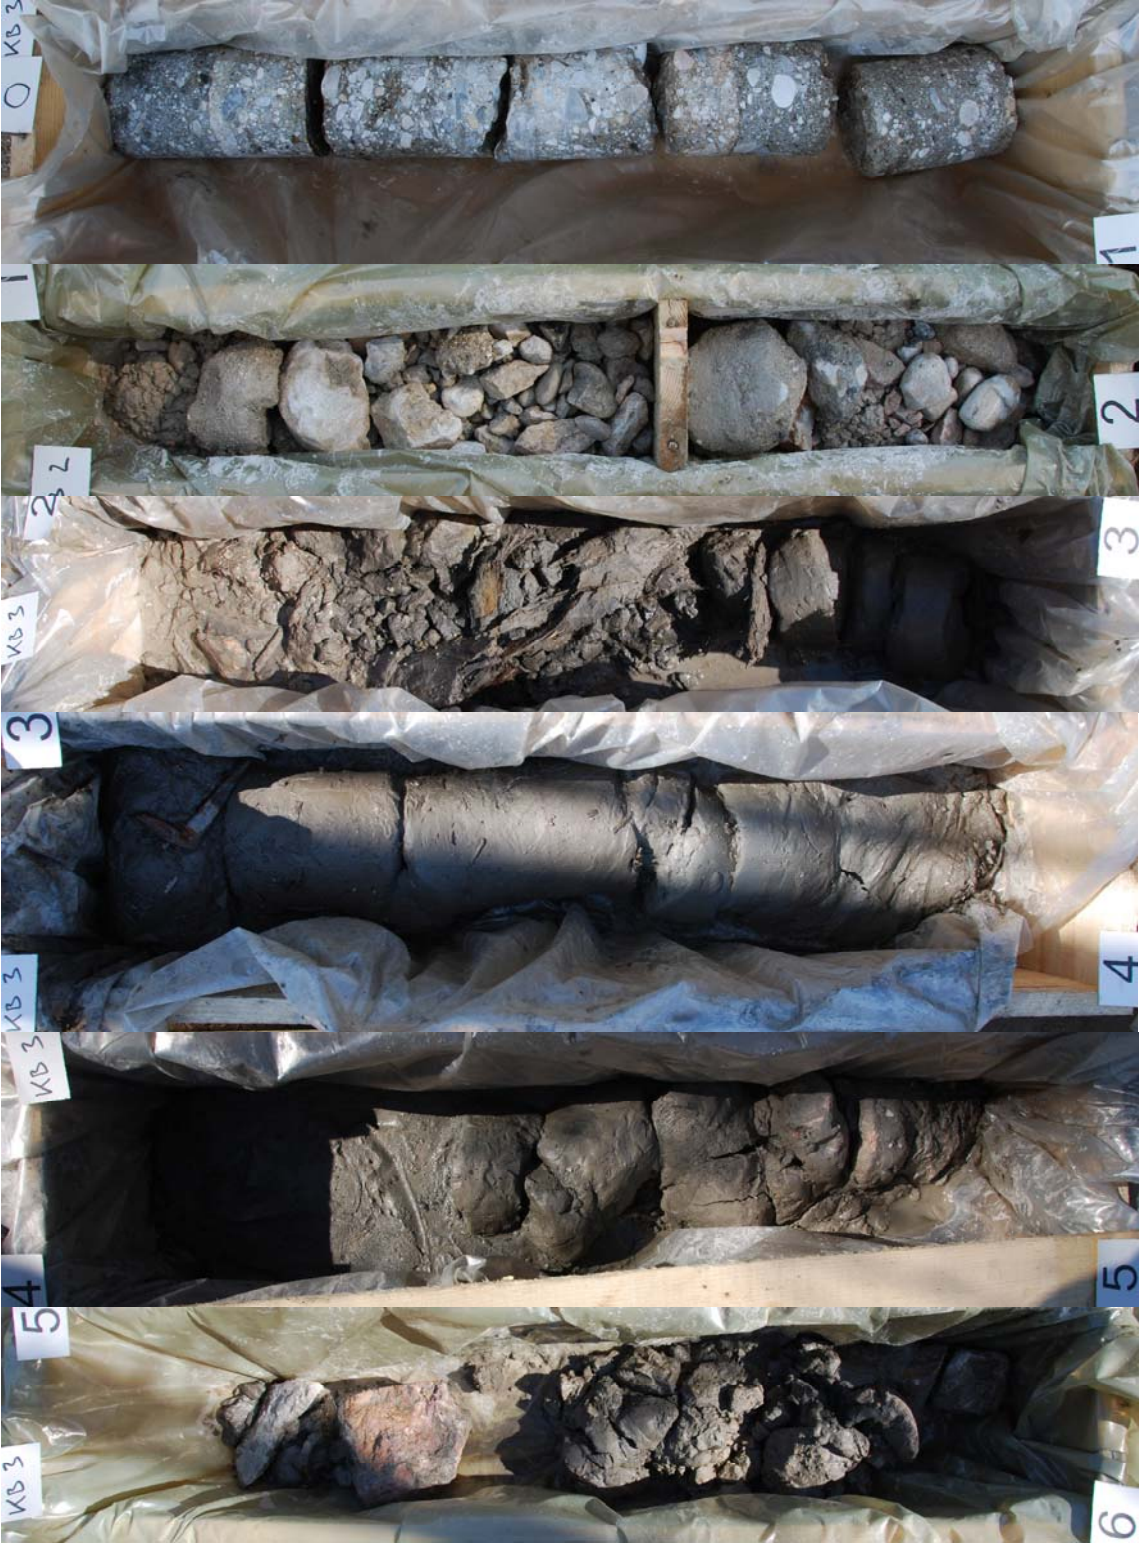
KB-3

0.00-6.00 m

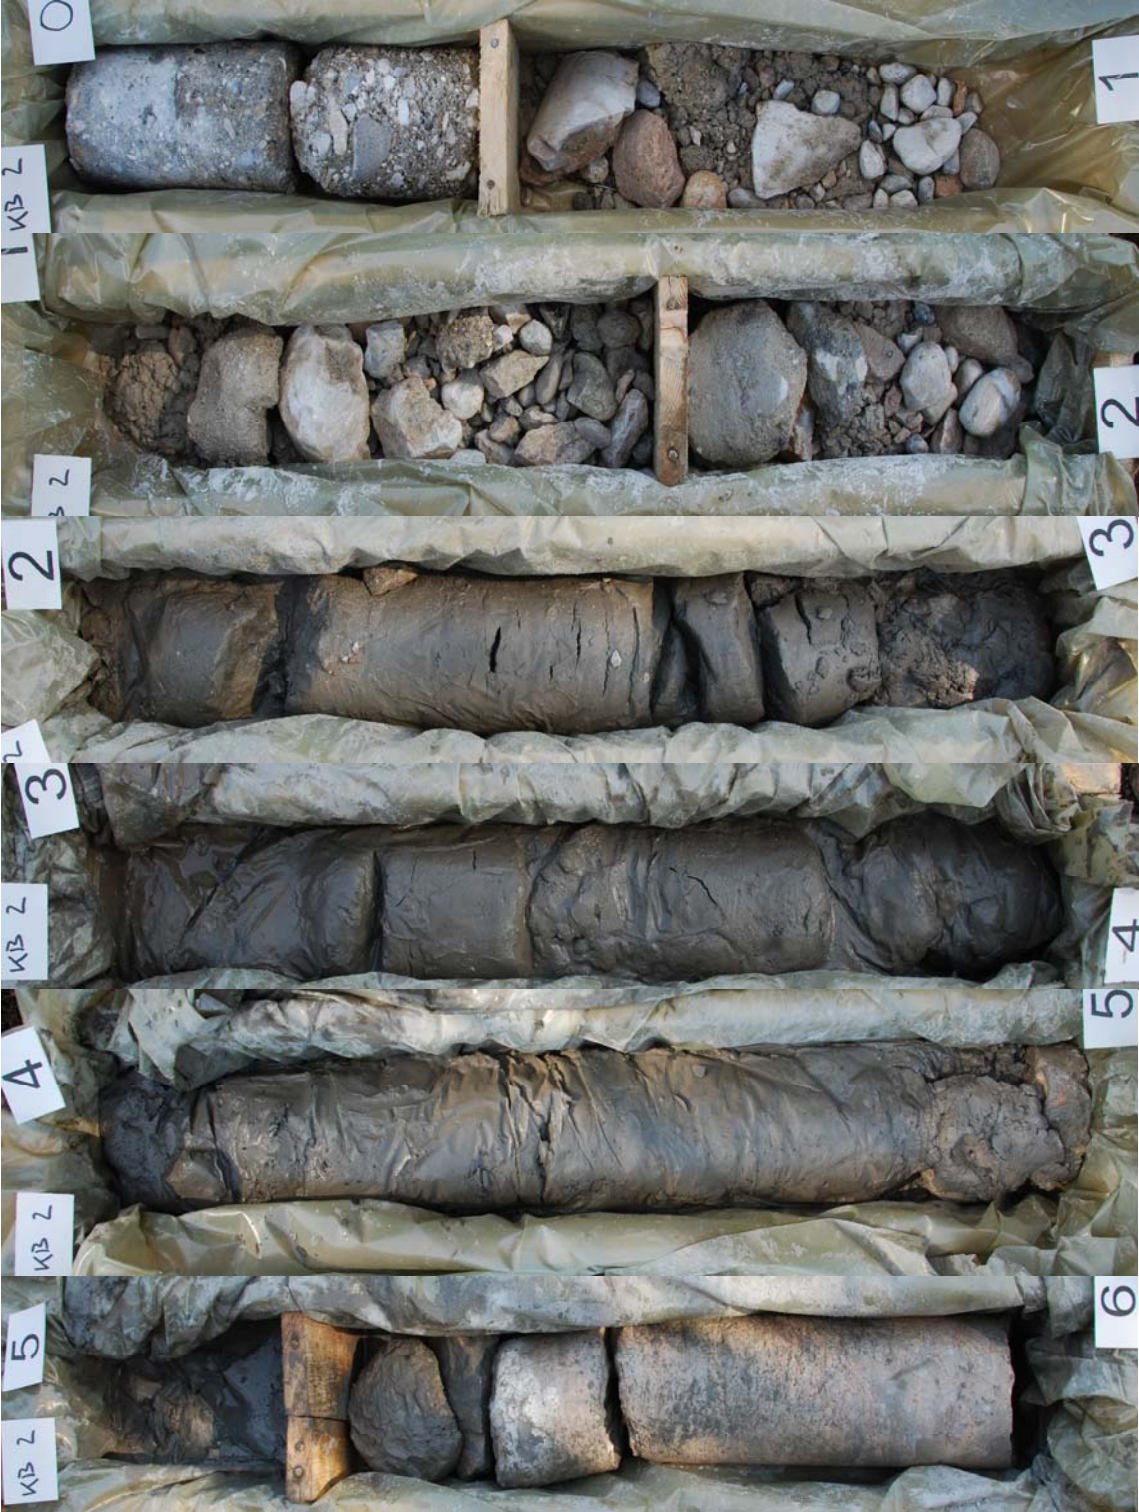
KB-2

0.00-6.00 m

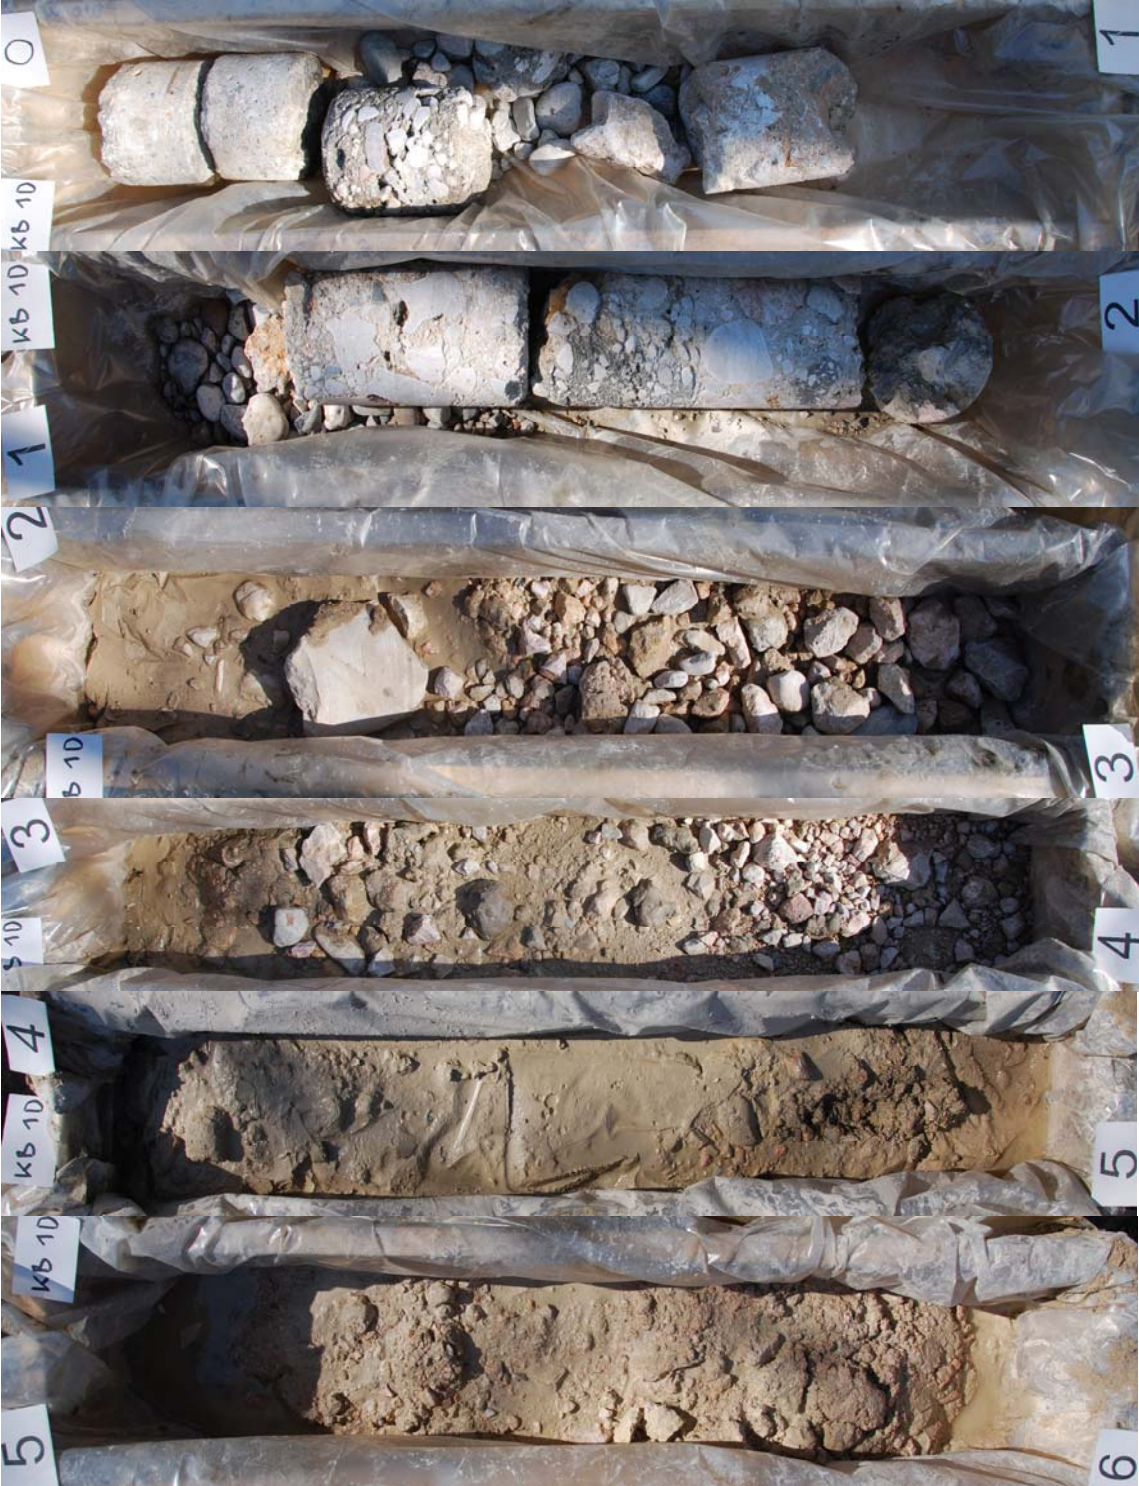
KB-1 DAMM

0.00-6.00 m

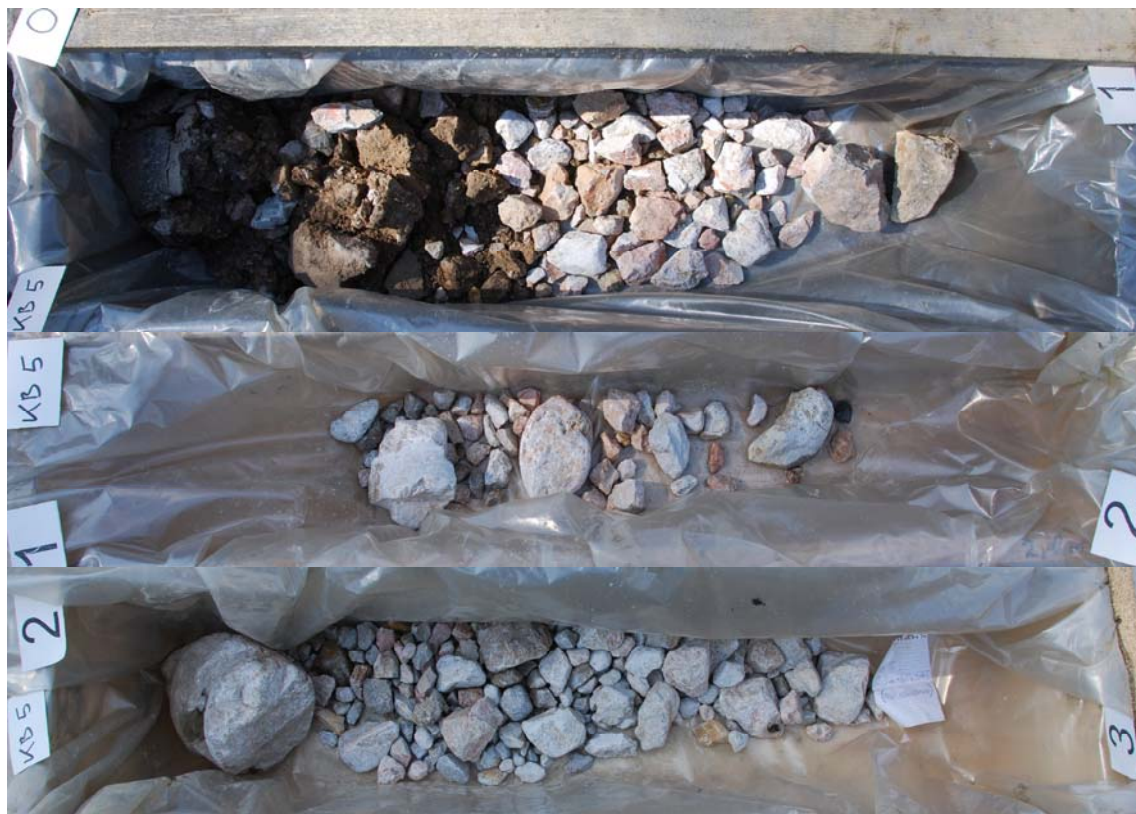
KB-5

0.00-6.00 m

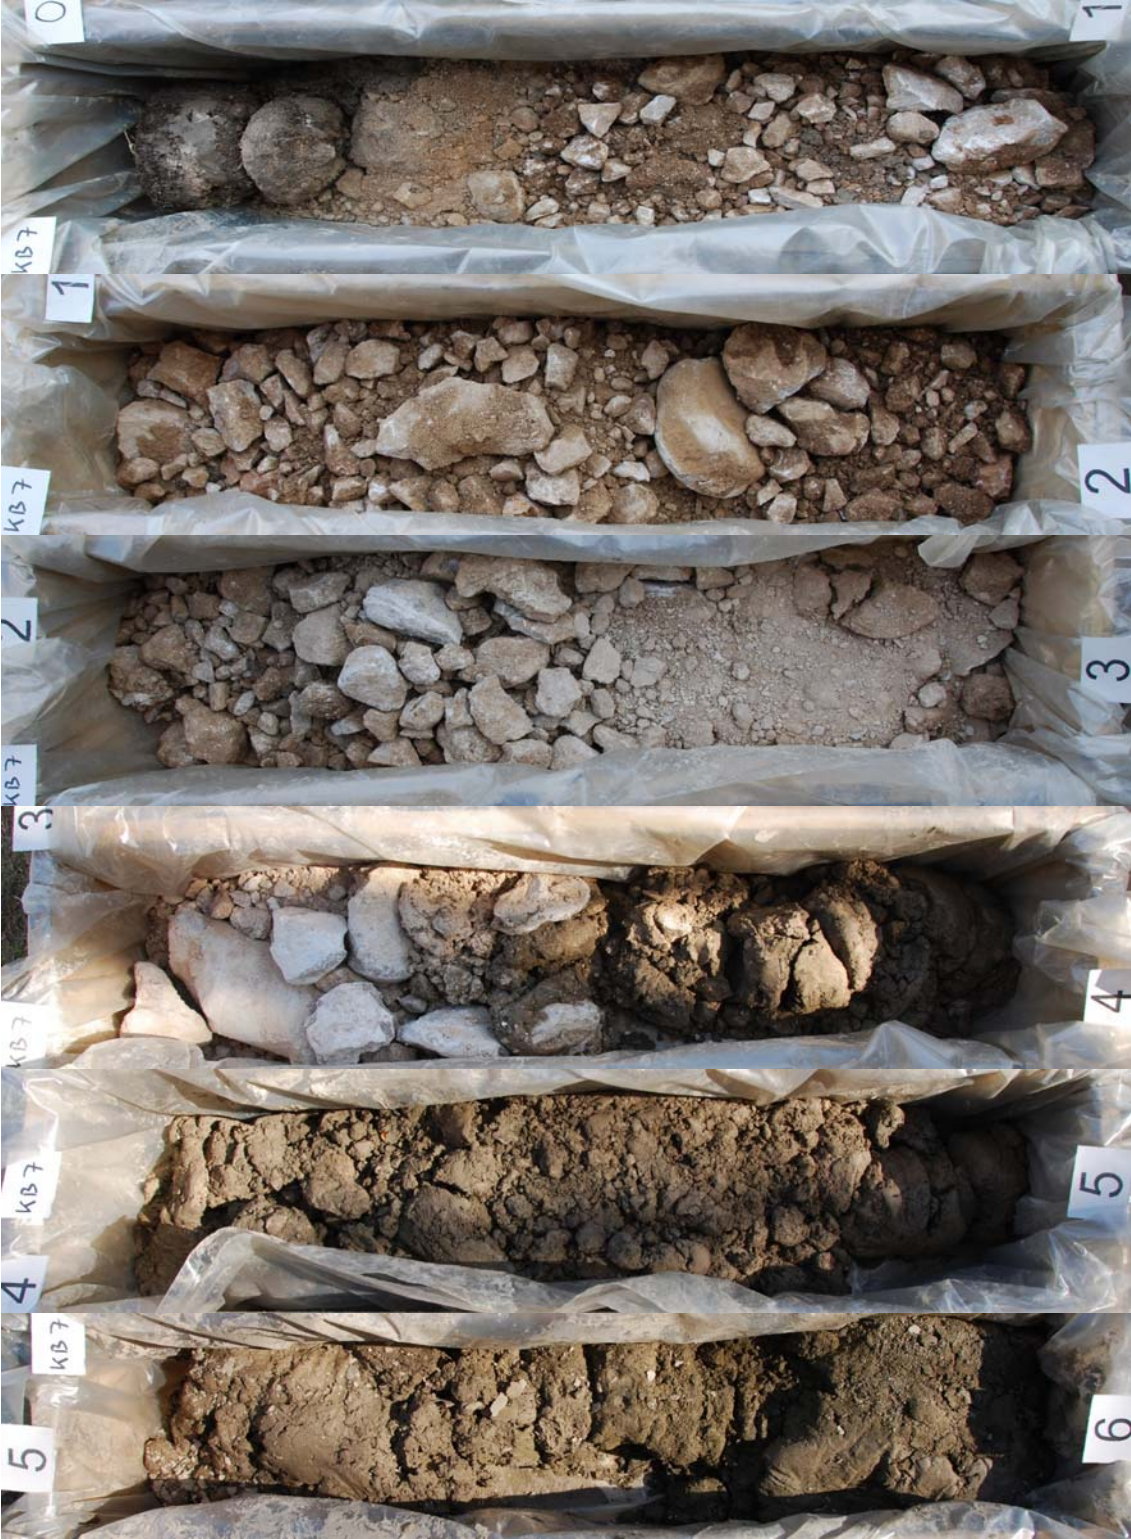
KB-7

0.00-6.00 m
