**Landslides triggered in the Sindhupalchok District during
the Mw 7.8 Nepal-Gorkha Earthquake of April 25, 2015**

Photo-Interpretive Landslide Assessment

MASTER'S THESIS

Graz University of Technology

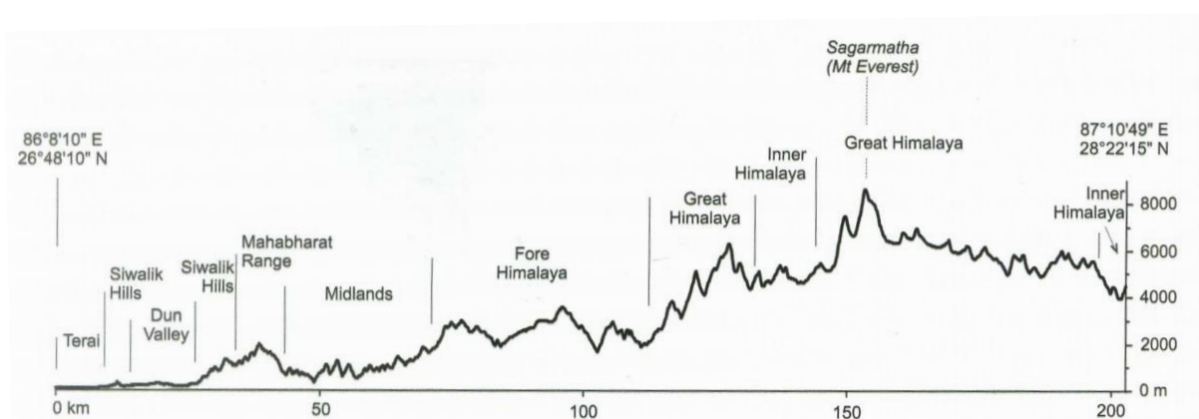
Figure 4 Profile of the Himalaya through east Nepal and position of physiographic regions. (Source: Dhital 2014)

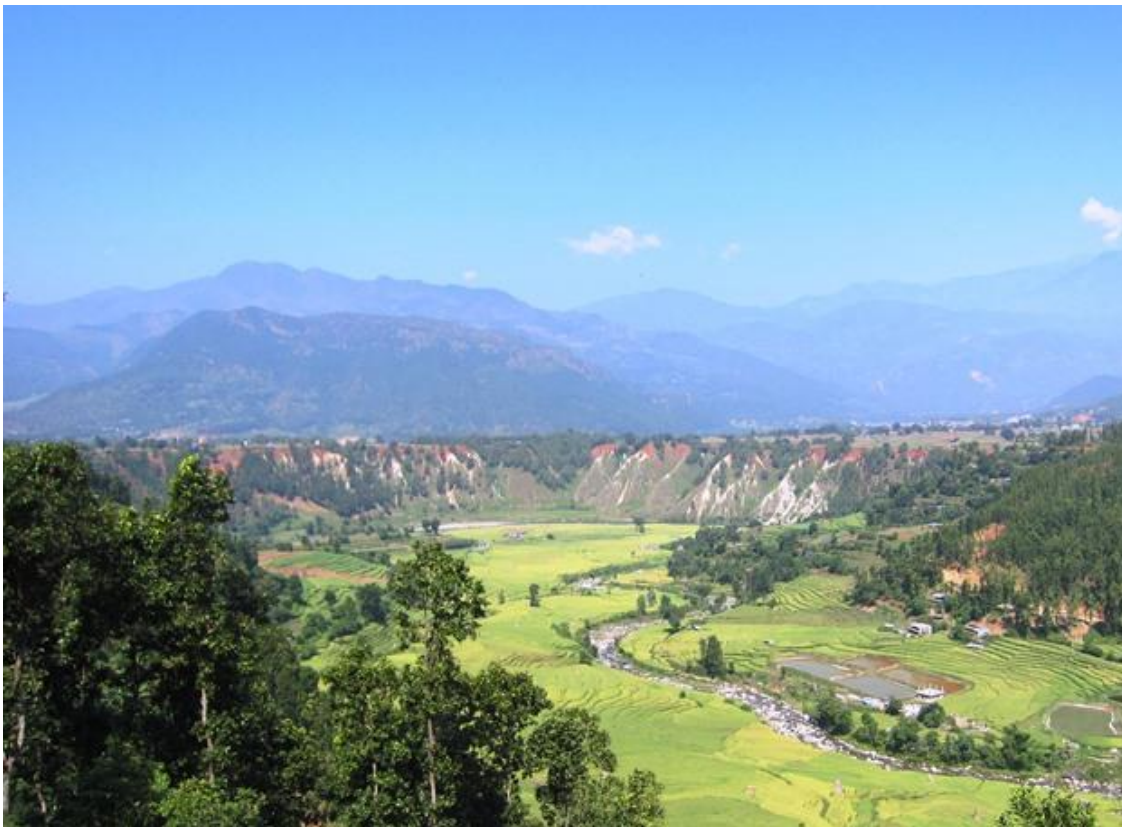
Figure 5 Red soil and morphology of the Midlands (© Ziselsberger); 27°51'51.02"N, 85°9'9.77"E

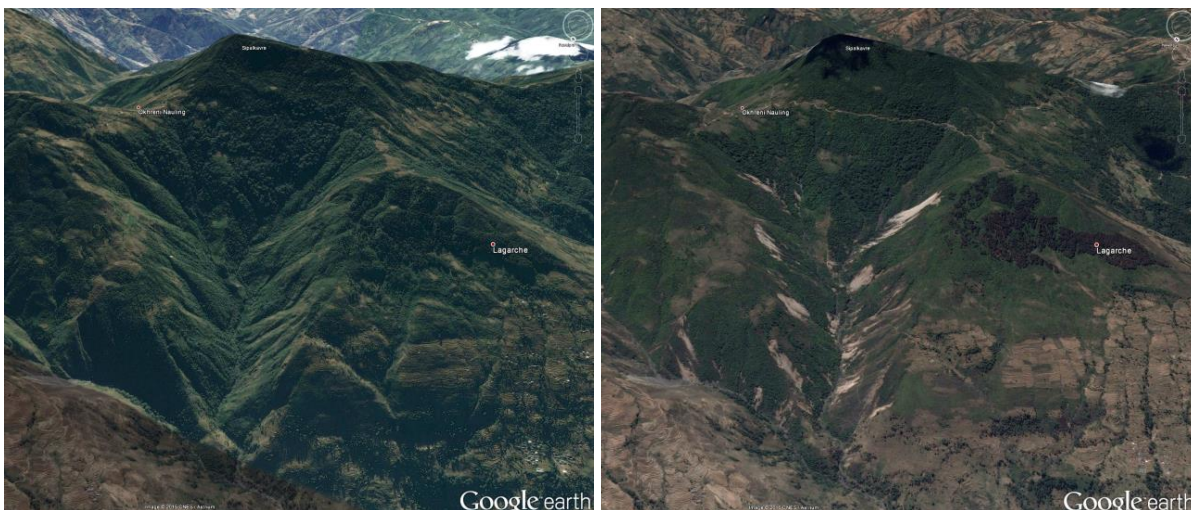
Figure 9 Before (left) and after (right) April 25 M7.8 earthquake, 27°52'3.57"N, 85°39'5.41"E (Source: Google Earth)

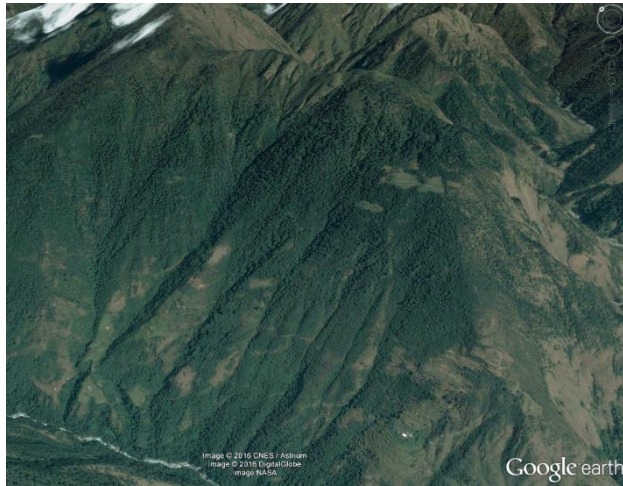
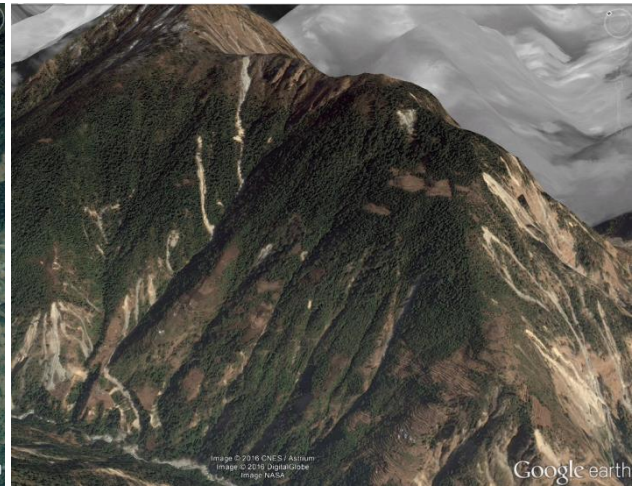
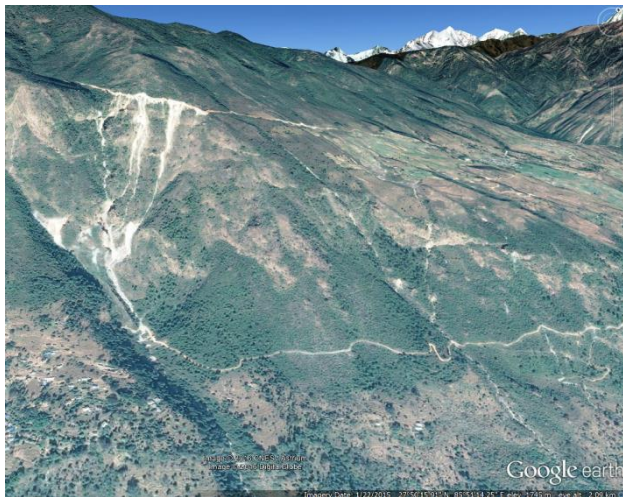
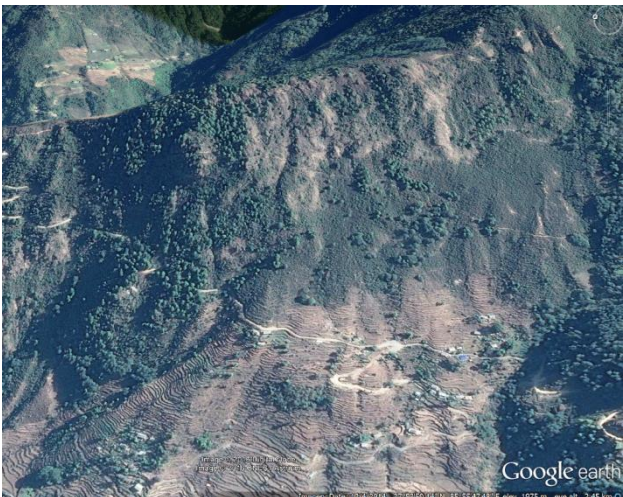
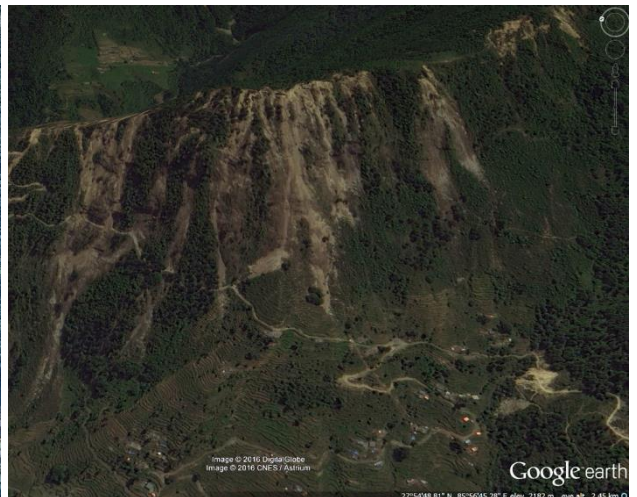
**Figure 10 Before (left) and after (right) April 25 M7.8 earthquake (Source: Google Earth):
top (28° 1'7.70"N, 85°39'42.38"E), middle (27°50'23.76"N, 85°50'59.28"E), bottom (27°53'50.14"N, 85°55'47.48"E)**

By comparing pre- and post-earthquake images fresh and reactivated mass movements were located (Figure 9, Figure 10). Up-to-date images of the affected areas in Nepal were available within a few days after the earthquake to help relief organizations. The imagery covering the study area was provided by DigitalGlobe and CNES/Astrium². After determining all identifiable landslides, several other parameters were recorded: size, length, width, slope relief, landslide relief, slope aspect and affected infrastructure (roads, houses, villages).

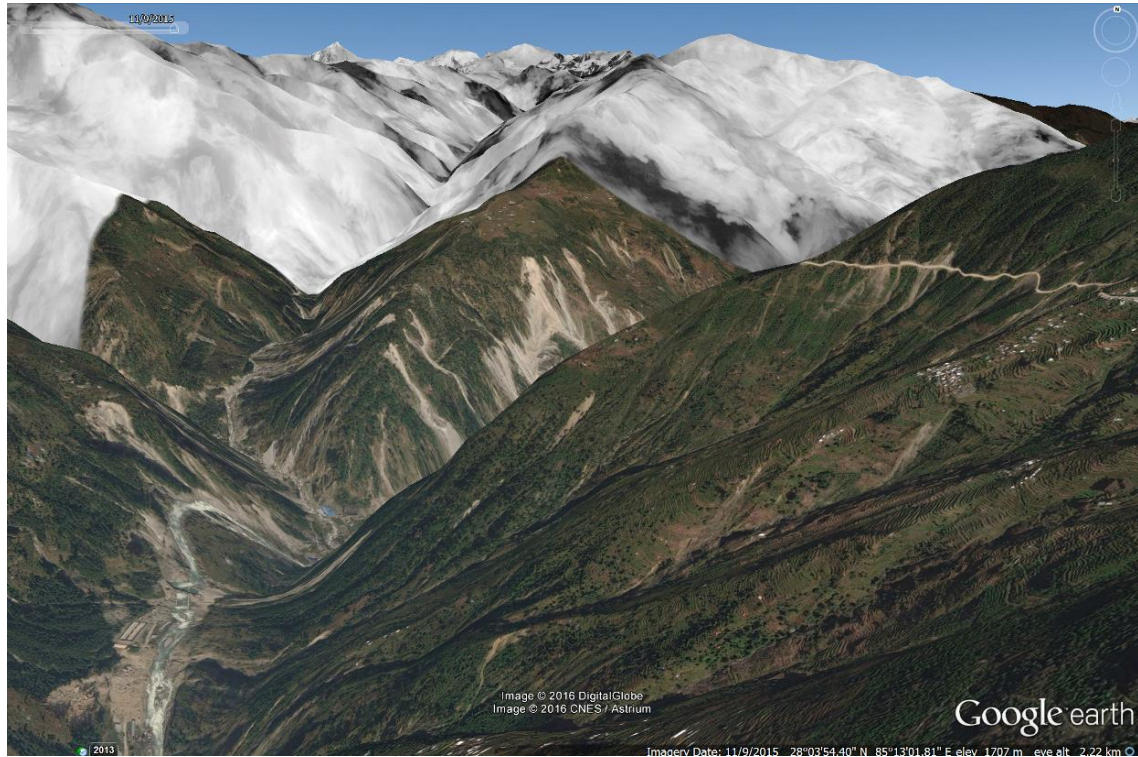
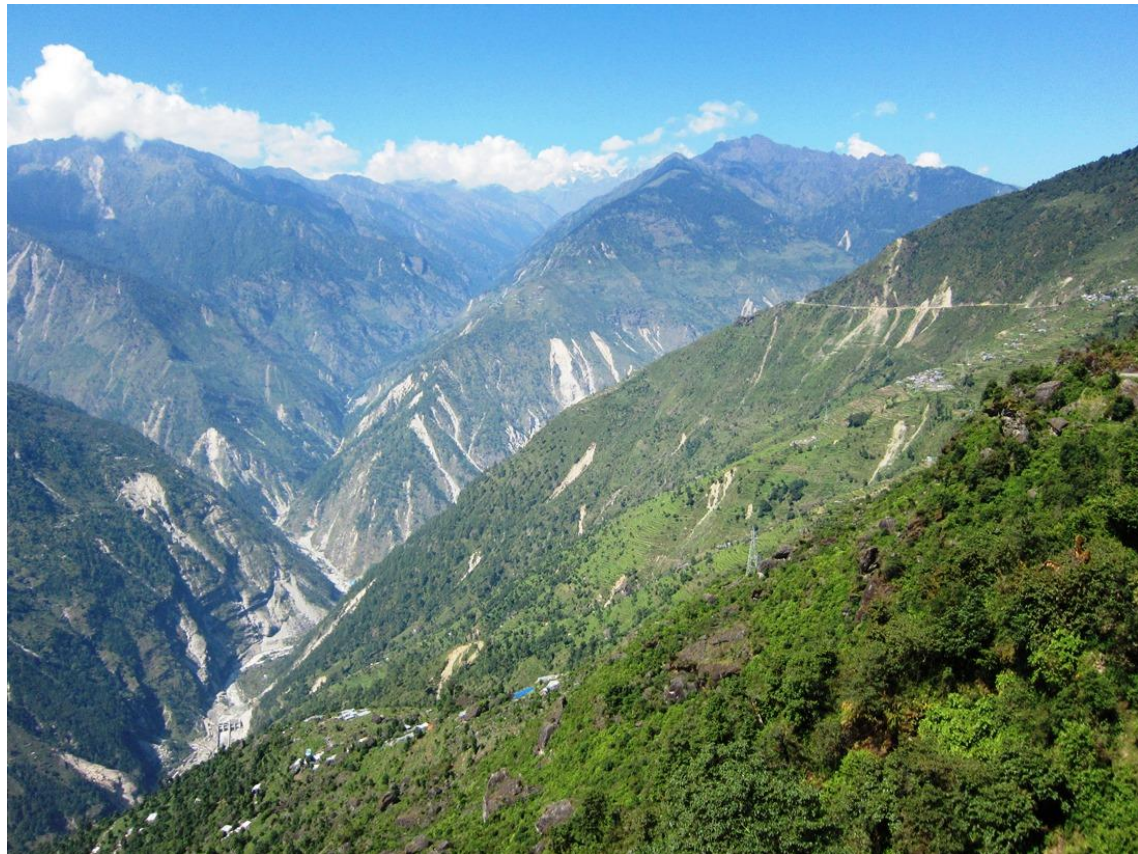
Figure 12 Google Earth screenshot (top; Source: Google Earth) vs. on the ground taken photograph (bottom; © Ziselsberger).
28°2'28.75"N, 85°13'11.80"E

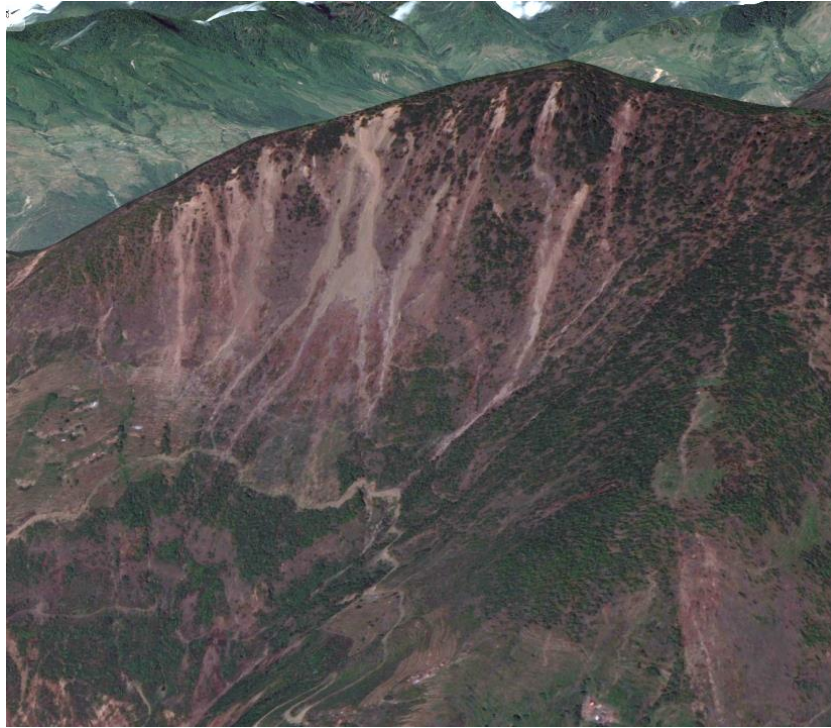
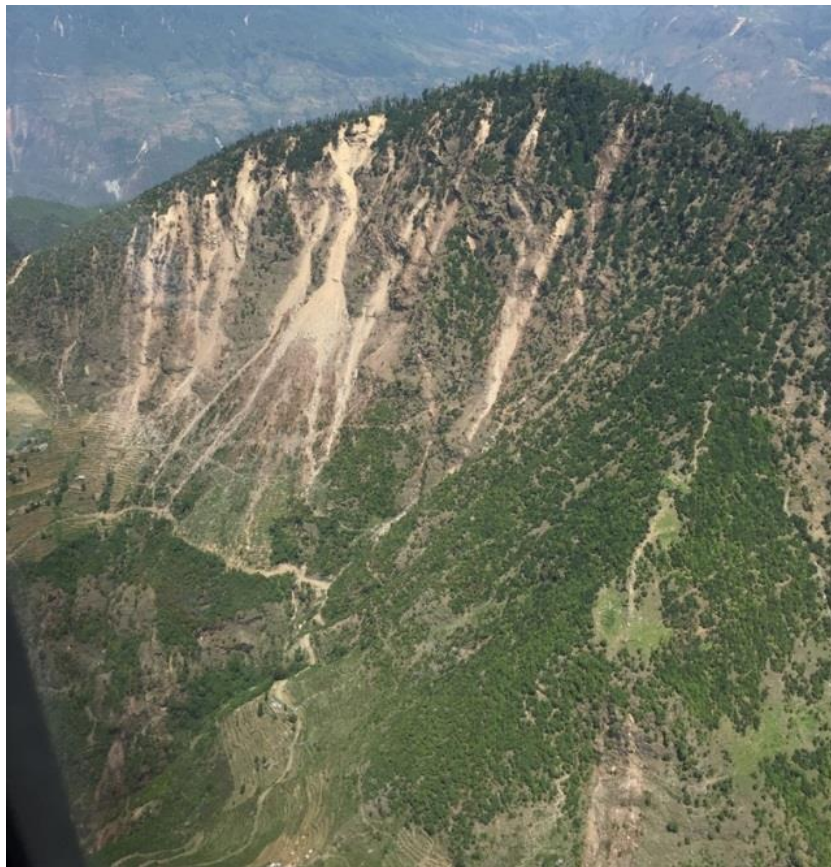
Figure 13 Google Earth screenshot (top; Source: Google Earth) vs. photograph taken in the helicopter (bottom; © Pehlivan).
27°49'25.00"N, 85°55'47.00"E

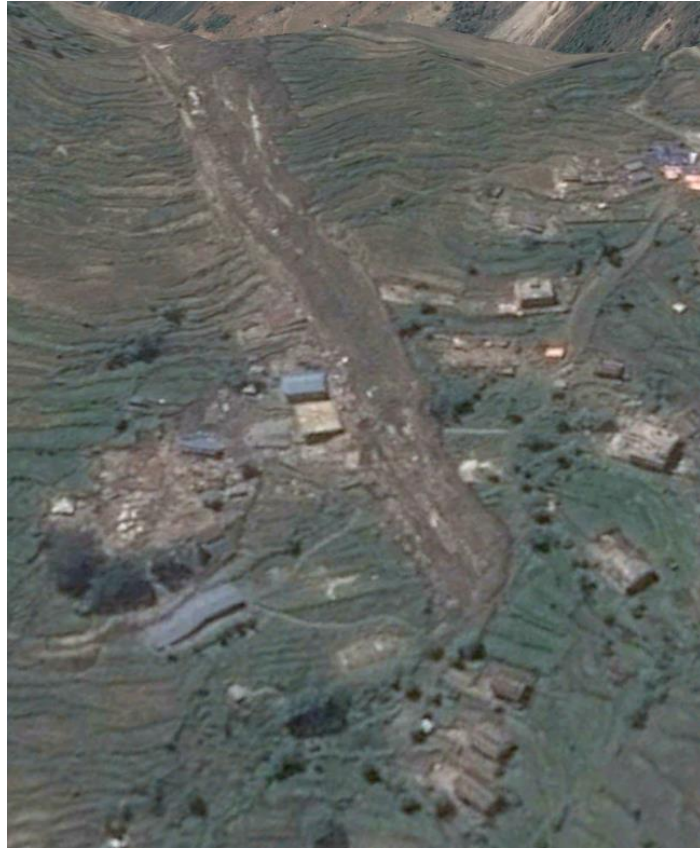
Figure 22 Village destroyed by a landslide, 27°55'08.95"N, 85°54'52.64"E (Source: Google Earth)

Affected infrastructure – including houses, roads or pipelines – was documented whenever a landslide was responsible for the damage (Figure 22).

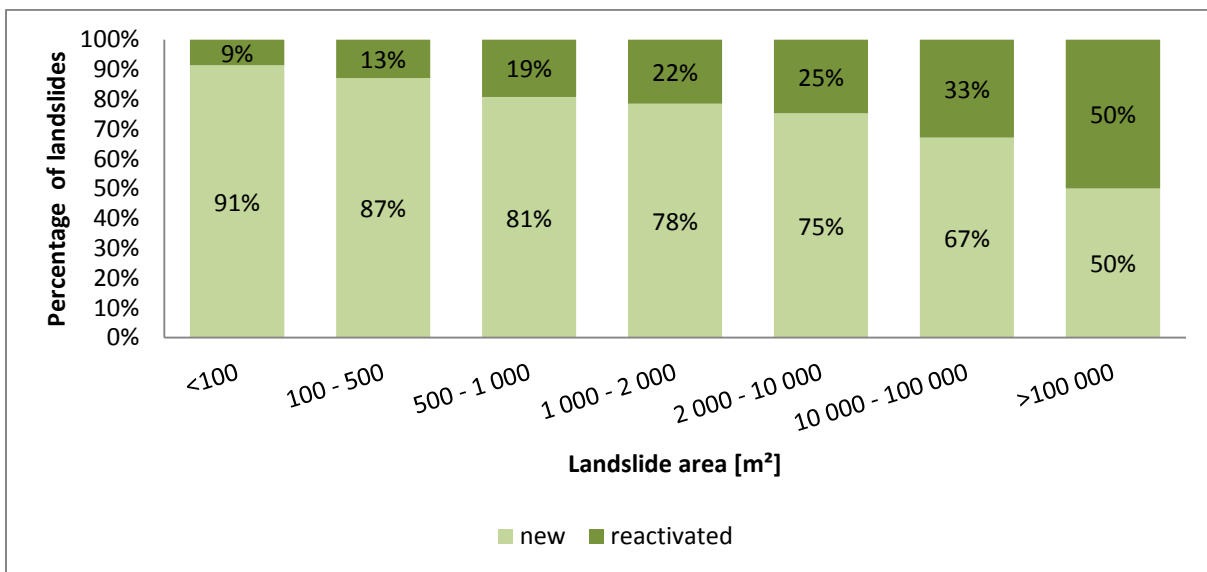
Figure 27 By comparing the size of new (light green) and reactivated (dark green) landslides, an increase in the number of reactivated landslides with rising area can be seen.

Figure 27 shows an increase in reactivated landslides with rising landslide area. This trend might be caused by the fact that traces of former landslides are easier to identify, the bigger the landslides had been.

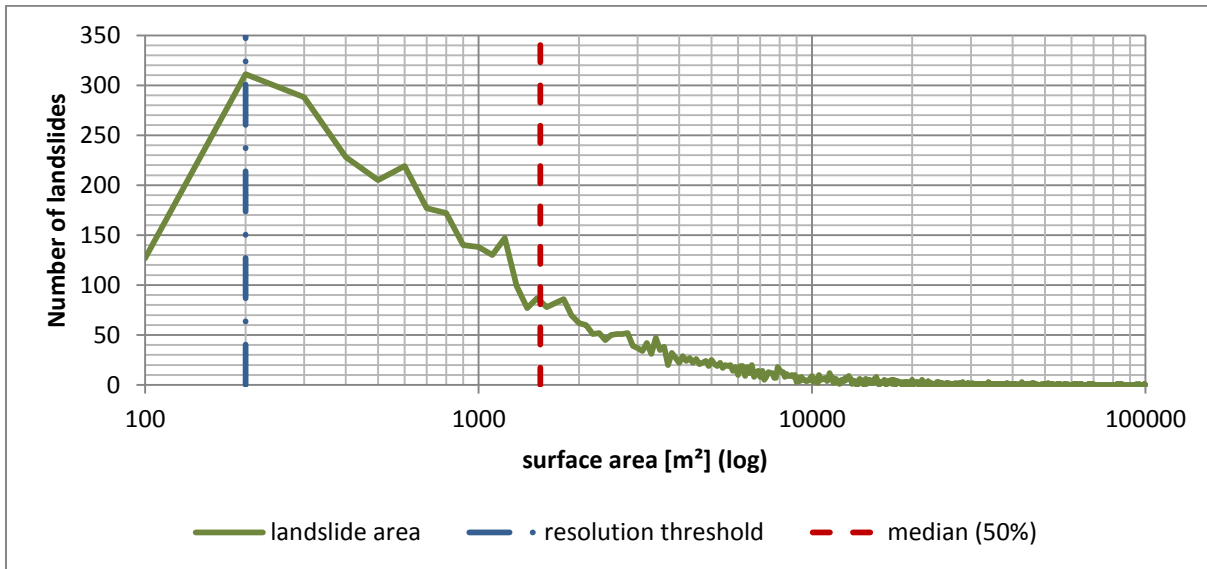
Figure 28 Distribution of landslides depending on the landslide area [m²], blue dashed line indicates resolution threshold. After the peak, the distribution shows a decrease in landslide occurrence which follows a power law regression of $y = 10^6 x^{-1.295}$ (Figure 29, black line).

Landslide areas range from 10 m² to 558 055 m² with a median size of 1532 m² (Figure 28, red dashed line). As shown in Figure 28, the number of landslides increases up to a size of 200 m², which seems to be the resolution threshold (blue dash-dot line). This means that probably not all landslides smaller than 200 m² have been recorded due to bad image quality caused by distortion or weather effects (clouds).

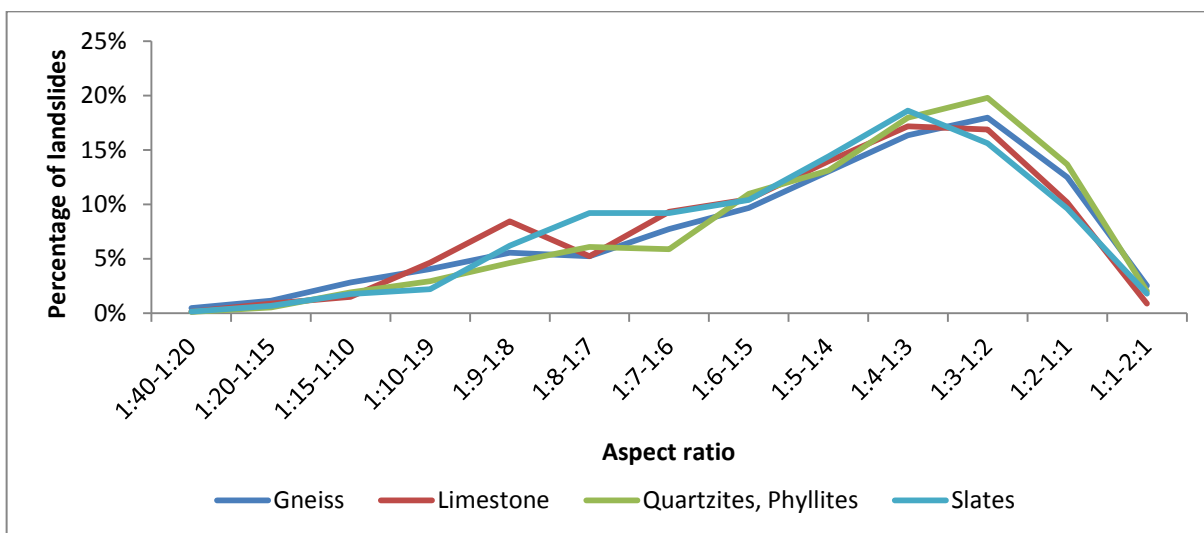
Figure 32 Geology vs. aspect ratio. The little anomaly in the limestone curve (red) might explain the break in the aspect ratio histogram (Figure 31) between 1:9 and 1:7.

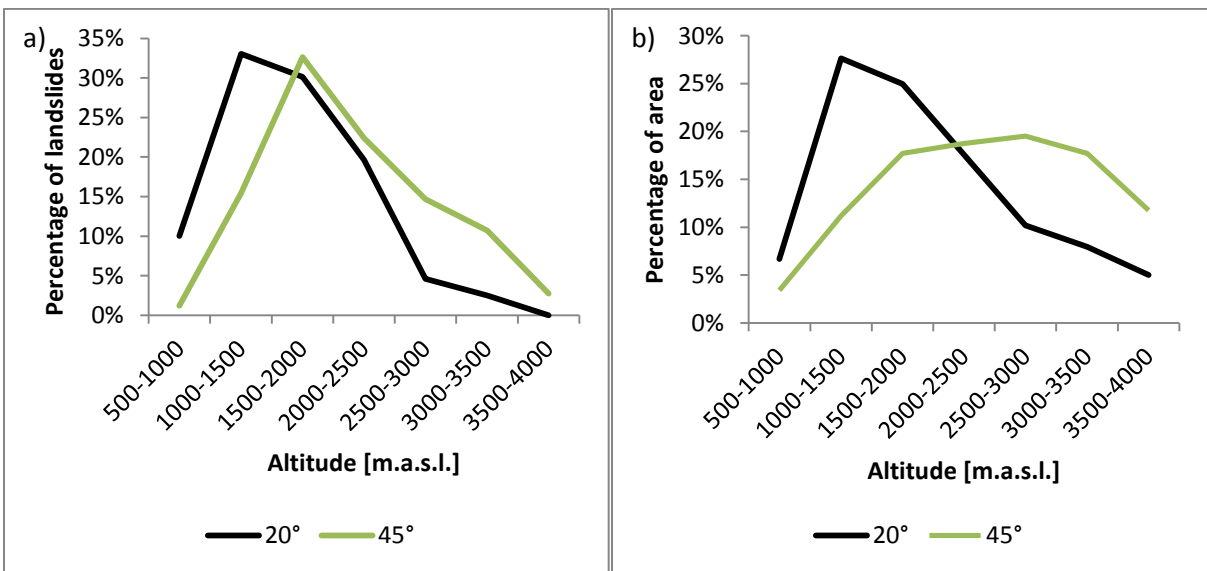
Figure 35 (a) Slope angle vs. altitude: the percentage of landslides triggered on slopes with an angle of 45° surpasses those triggered on shallower slopes at an altitude of 1500 m; (b) slope angle area distribution: up to a height of 2000 meters, the percentage of slopes with an angle of 20° (black line) dominates over those with an angle of 45° (green line).

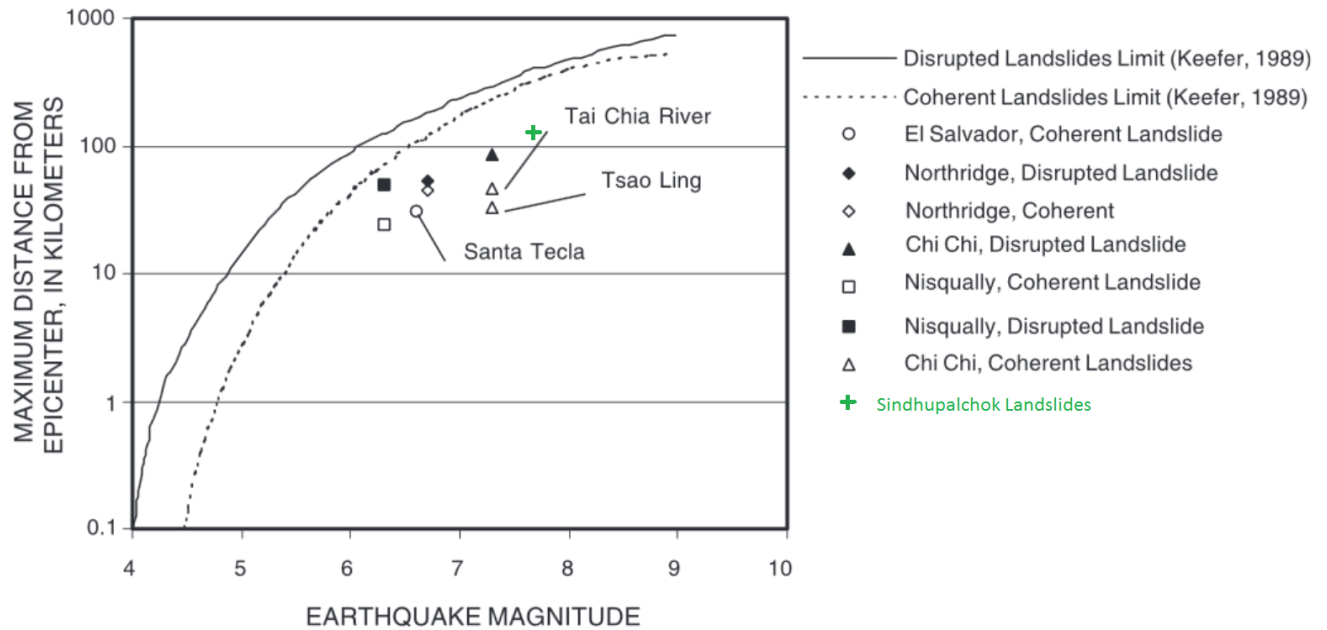
Figure 55 Maximum distance from epicenter for seismically induced landslides as a function of earthquake magnitude (limits from Keefer, 1989). (Source: Khazai, Sitar (2004))
Green cross indicates landslides in Sindhupalchok.

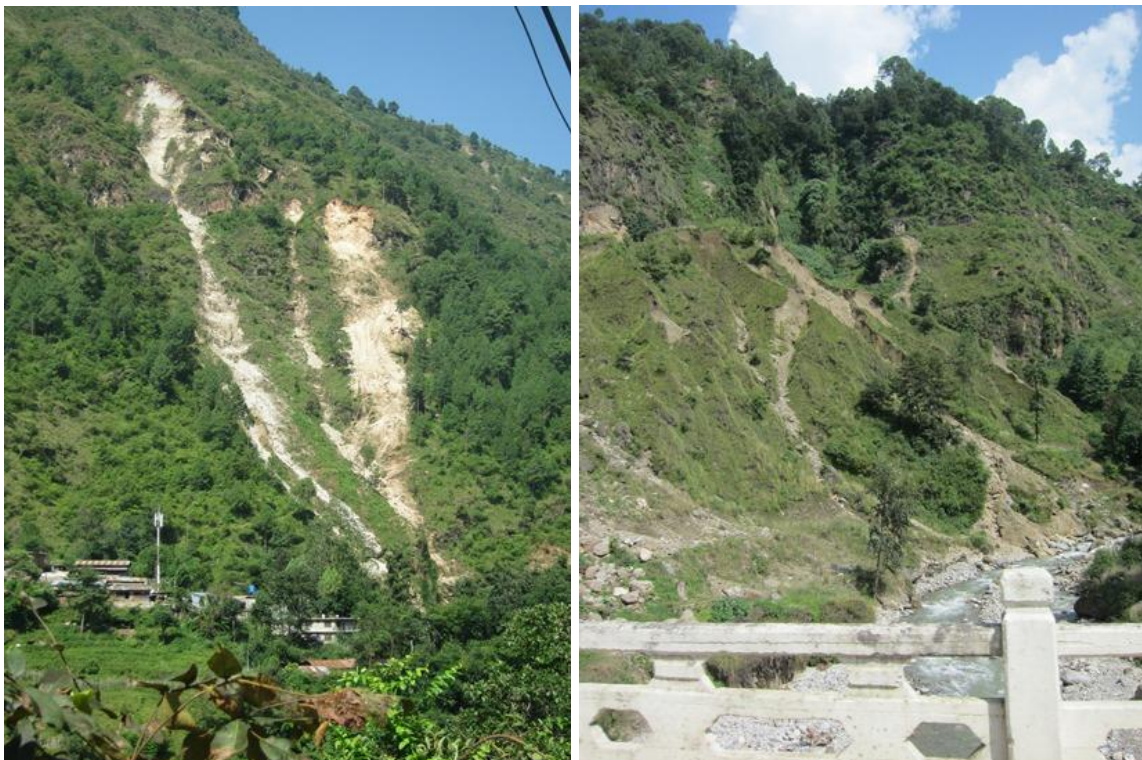
Figure 65 Shallow, dry slope failures (© Ziselsberger).
Left (27°52'33.74"N, 85°53'54.32"E), right (27°52'58.85"N, 85°54'48.81" E)

These slips were often seen along roads which are cut into the hillsides. Landslides started either on the outer edge of the cut or on the uphill slope, spilling onto and eventually blocking the road. Another common location for those dry earthflow-like slides was within steep gullies and along ridgetops. Besides all those landslides, lots of (tension) cracks were visible along the hillsides.

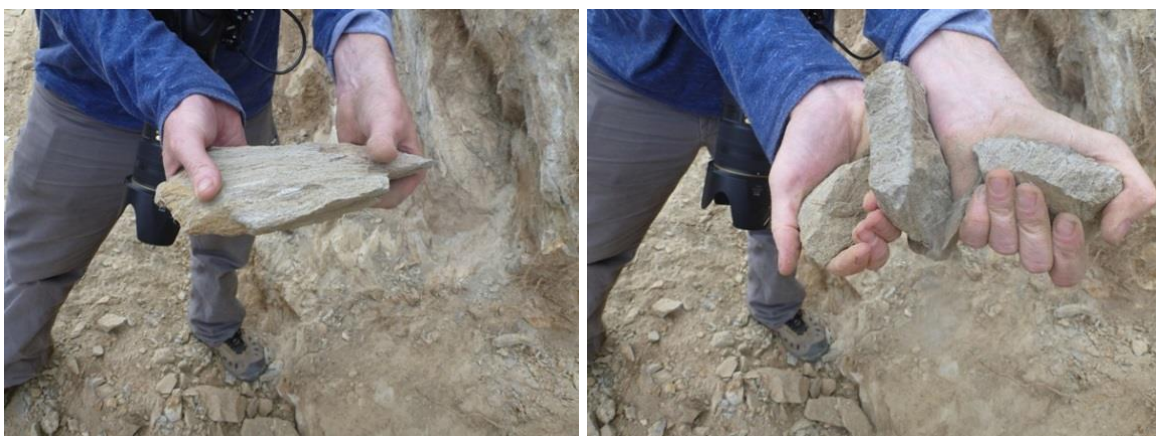
Figure 66 Some of the viewed outcrops along the road exhibited highly weathered rocks (mostly Gneiss), which are described as friable due to their preserved texture but high breakability (© Ziselsberger)

Lying on the southern side of the Himalayan range, Nepal's climate is highly influenced by the monsoon during the summer months. As the earthquake occurred only weeks before the monsoon began, the soil and rocks covering the hillsides of Sindhupalchok were rather dry. The landslides examined during the first field trip in May were primarily shallow slips of regolith (Figure 65), which consists of loose material like soil or weathered rock that covers the underlying bedrock (Figure 66).

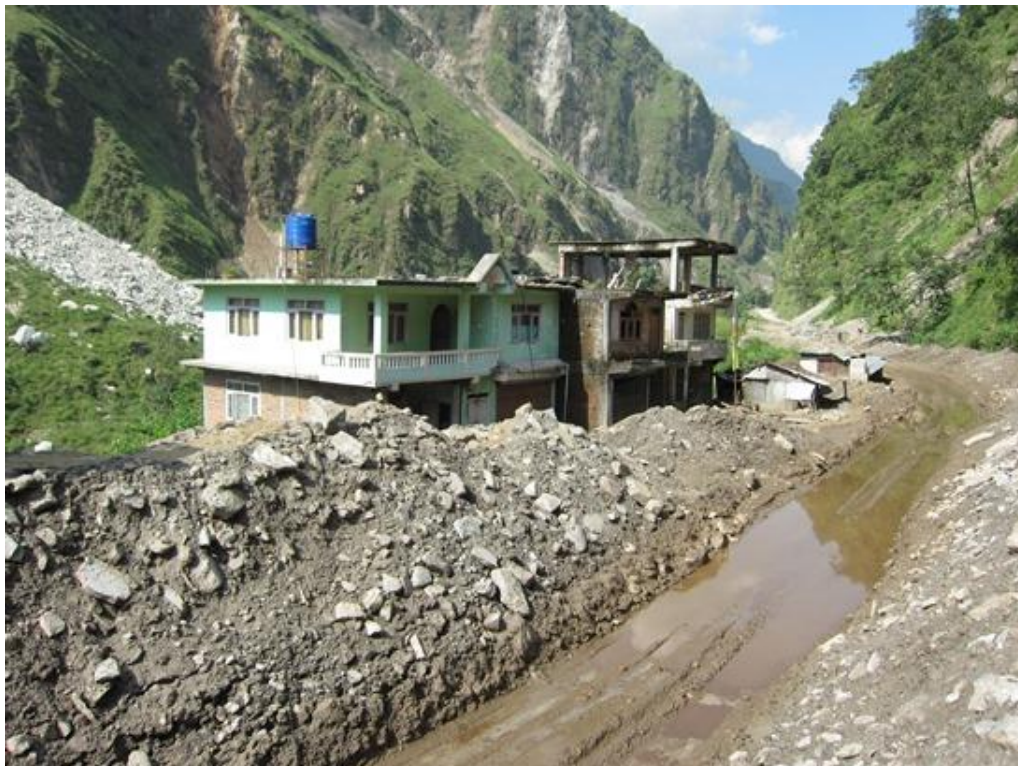
Figure 67 Massive debris masses blocked the roads during and after the monsoon (© Ziselsberger)
27°54'23.37"N, 85°55'15.37"E

The monsoonal effects on those shaken slopes were studied during the second field trip in October 2015. Open cracks and loosened rocks and debris provided easy access for the water to penetrate into the ground. The rising water saturation lead to further destabilization of the hillsides and huge masses started to move down towards the valley. These mass movements were described as slow and continuous processes by the local inhabitants. Compared to the earthquake-induced landslides, these masses buried several villages and blocked many roads (Figure 67 - Figure 69). As can be seen in Figure 70 and Figure 71, the vegetation recovered rapidly between the two field trips. This fact once more underlines the time sensitivity of the gathered information. Under the right climatic conditions traces of landslide activity fade within a short period of time.

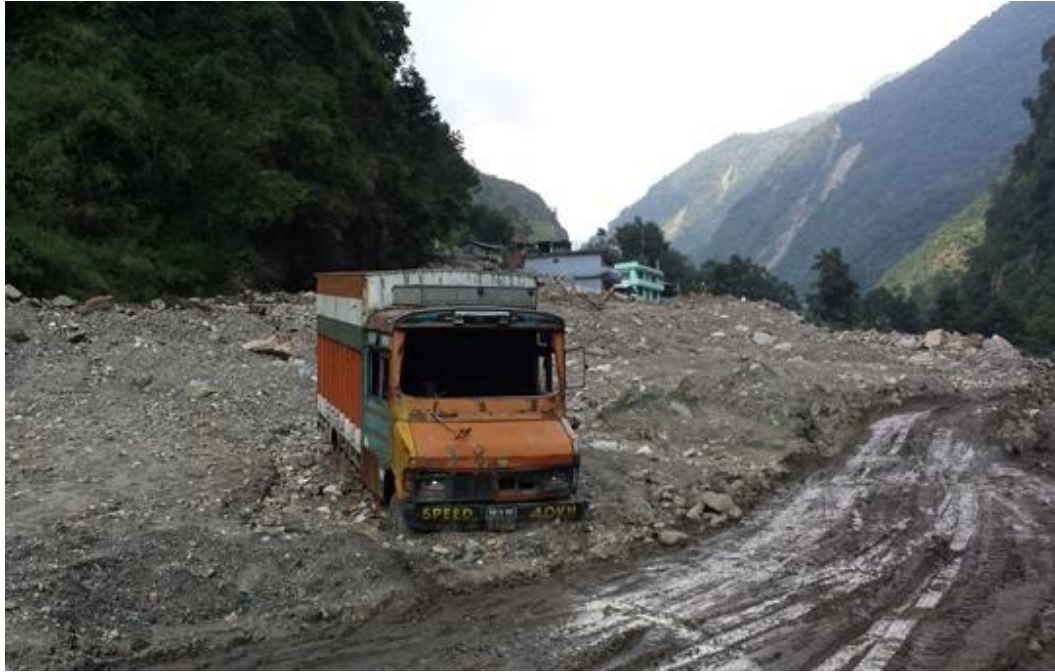
Figure 68 Massive debris masses covered the roads after the monsoon (© Ziselsberger); 27°56'11.52"N, 85°56'28.56"E

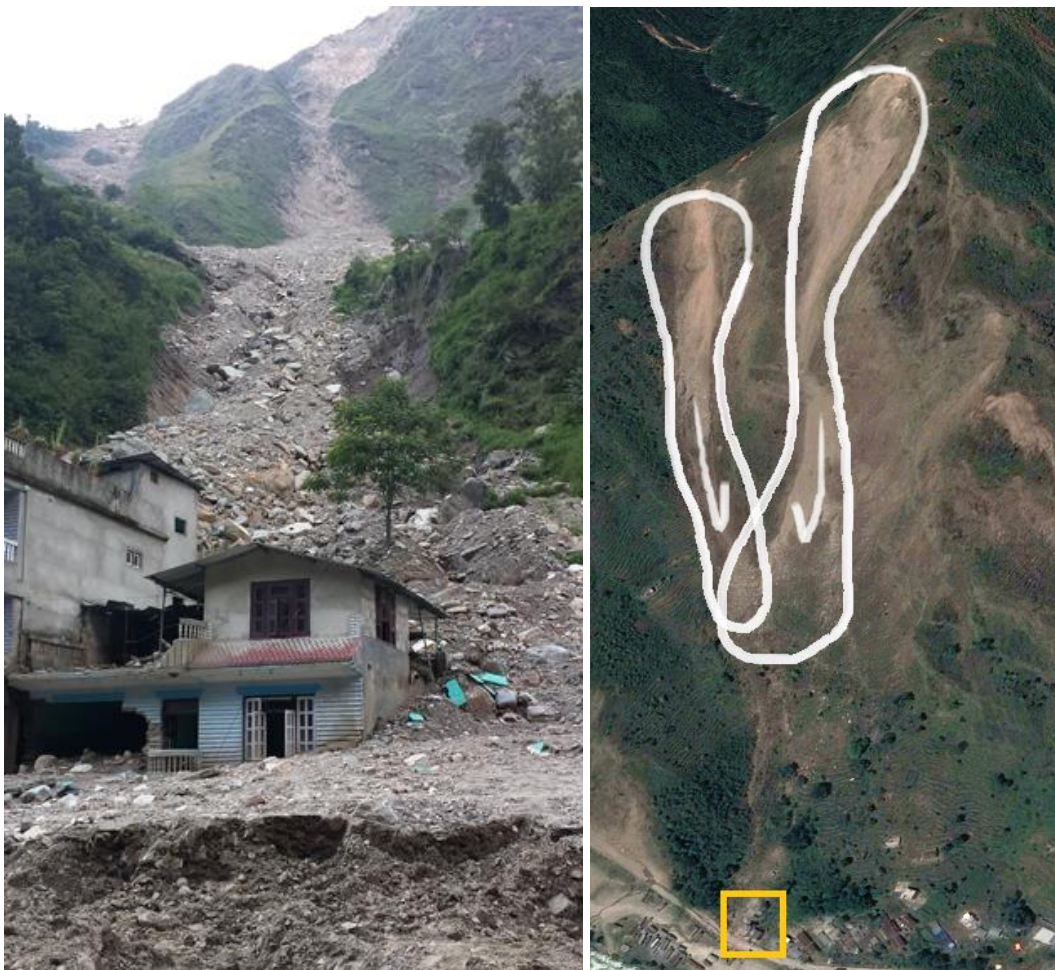
Figure 69 Landslides reactivated by monsoonal rainfall (left; © Ziselsberger), Google Earth image (right) shows extent of landslides (white) and location of houses (yellow box) before monsoon; 27°56'16.33"N, 85°56'34.75"E

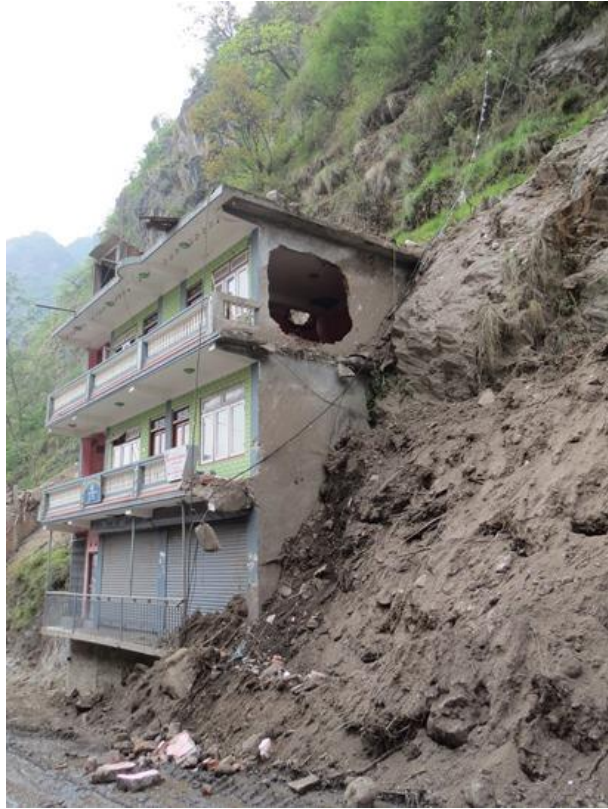
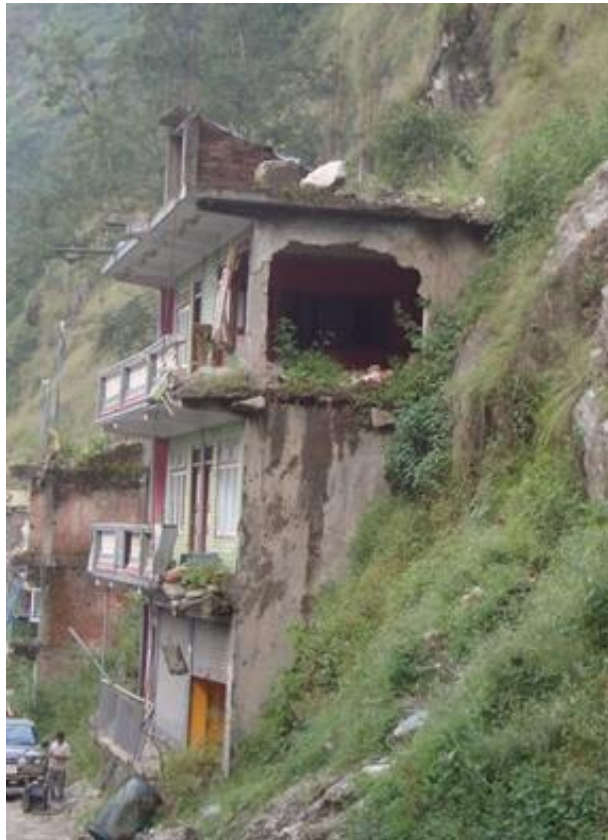
Figure 70 Destroyed house in Kodari ($27^{\circ}58'17.12''\text{N}$, $85^{\circ}57'41.78''\text{E}$).
Before (left) and after (right) the monsoon (© Ziselsberger).

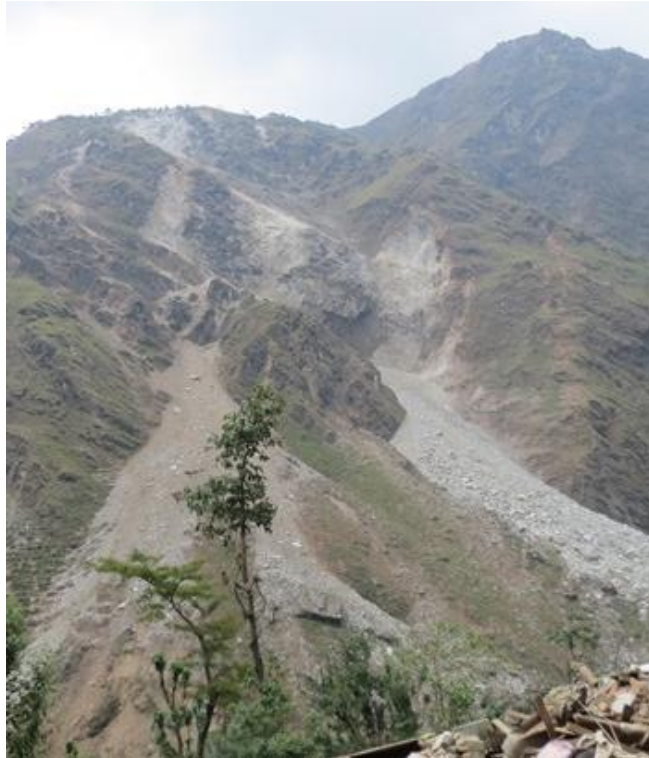
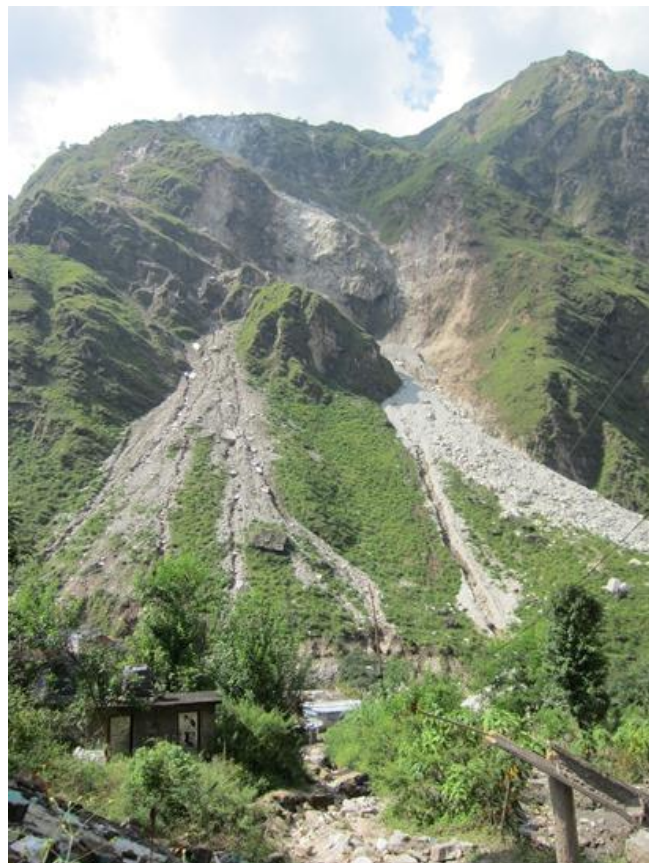
Figure 71 Before (left) and after (right) the monsoon (© Ziselsberger)
27°54'23.36"N, 85°55'15.78"E

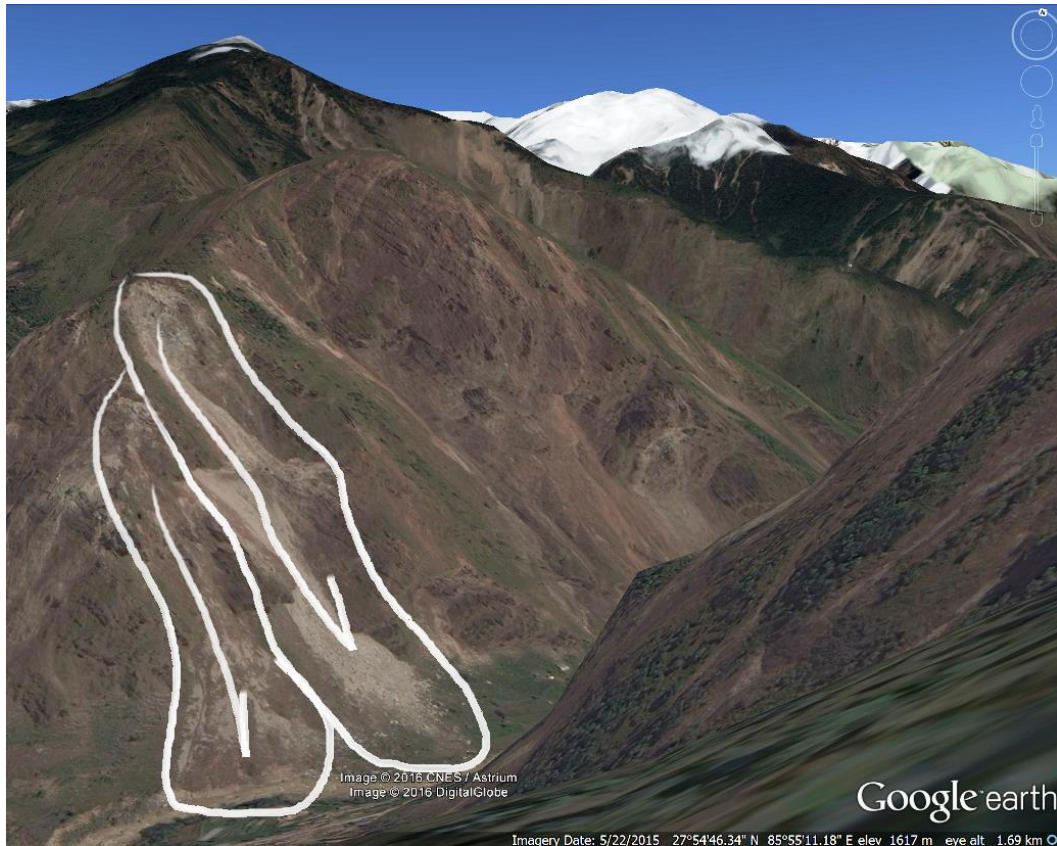
Figure 72 Google Earth image showing the landslides of Figure 71; 27°54'23.36"N, 85°55'15.78"E (Source: Google Earth)
