Unreinforced and reinforced openings in GLT beams- A comparison based on experimental investigations

Lada ILIĆ
Institute of Timber Engineering and Wood Technology
Graz University of Technology

**UNREINFORCED AND
REINFORCED OPENINGS IN GLT
BEAMS -
A COMPARISON BASED ON
EXPERIMENTAL
INVESTIGATIONS
MASTER THESIS**

for obtaining the academic degree
graduate engineer
Civil Engineering Sciences - Structural Engineering

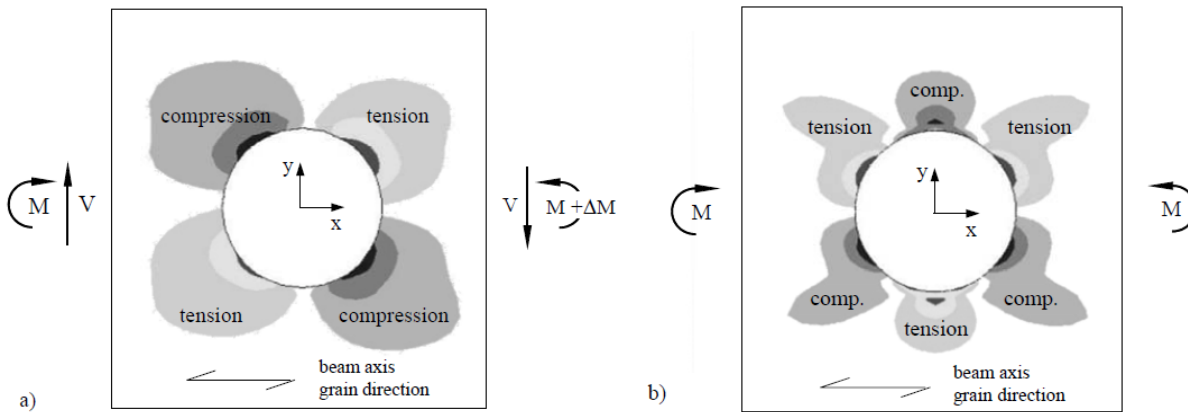
Figure 2.6: Tension and compression stress fields perpendicular to grain at the opening periphery depending on the M/V -ratio and opening height to opening diameter ratio $d/h = 0.4$; a) $M/V = 1.5 \cdot h$; b) $M/V = \infty$ (pure moment) [7]

An opening in a glulam beam, under application of a bending load, disturbs the distribution of bending and shear stresses. Large tension stresses perpendicular to the grain appear at explicit areas at the opening edges (figures 2.6 a, b). The peak of tension stress perpendicular to grain is around the edges of the opening (figures 2.7 a, b). On the upper right and down left side of the opening, the cracks appear under the angle of 60° and $180 + 45^\circ$ respectively, due to the influence of the applied load combination of the bending moment and shear force (see figure 2.7 a). In the case of applying a pure bending moment, this places are set to the opening periphery by the angles of 60° and $360^\circ - 60^\circ$ (see figure 2.7 b). The differences between applied loads are causing the appearance of the crack on different places on the periphery of the opening. The value of the tensile stress area decreases exponentially with increasing distance from the opening. Loading conditions of the beam are influencing the location and the magnitude of the maximum tensile stress perpendicular to grain and can be related to the proportion of bending moment M to shear force V . Also the ratio of the opening diameter d to beam height h has a strong influence on tension stress perpendicular to grain. Based on these findings, the tension stress perpendicular to the grain can be expressed as a function of opening diameter d , beam height h , and bending moment M to shear force V ratio (equation 2.6) [7]:

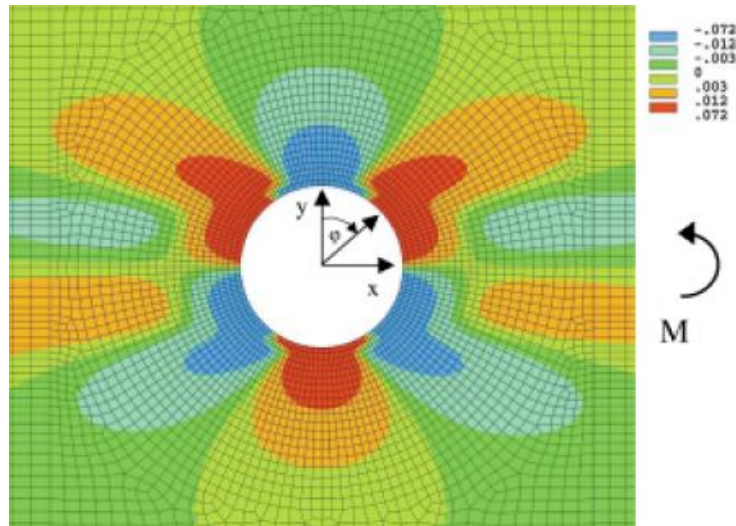
Figure 2.17: Stress distribution on the round opening edge due to constant moment action [11]

In 2001, Aicher and Höfflin [11], made a contribution to the analysis of beams with openings with FE model for the DIN 1052:2000 [35]. General stress distributions perpendicular to the grain around the opening are given in figures 2.17 and 2.18. Tension stress areas appear on the opposite sides of the opening for the pure shear force (see figure 2.18). Tension stress areas caused by the pure bending moment are to be seen on down opening side (see figure 2.17) and compression stresses on the upper opening edge.

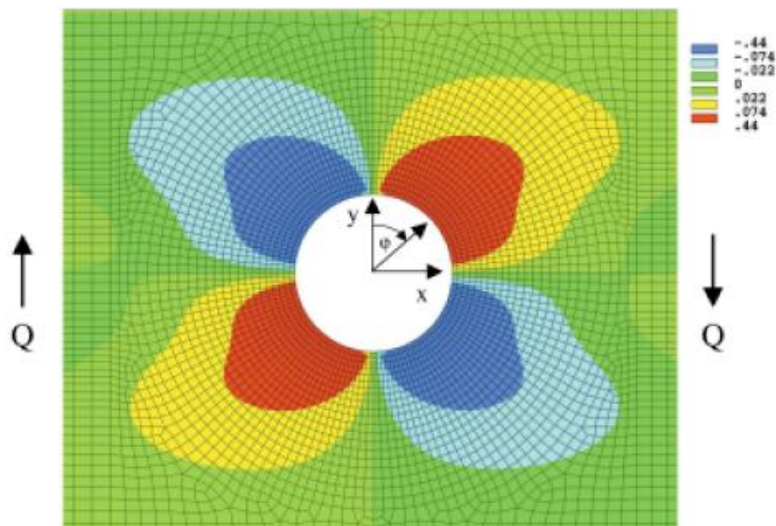
Figure 2.18: Stress distribution on the round opening edge due to pure shear force action [11]

In literature, it was wrongly assumed that the bending moment cannot cause tension stress perpendicular to the grain in the periphery of the opening, which was here proved to be very wrong.

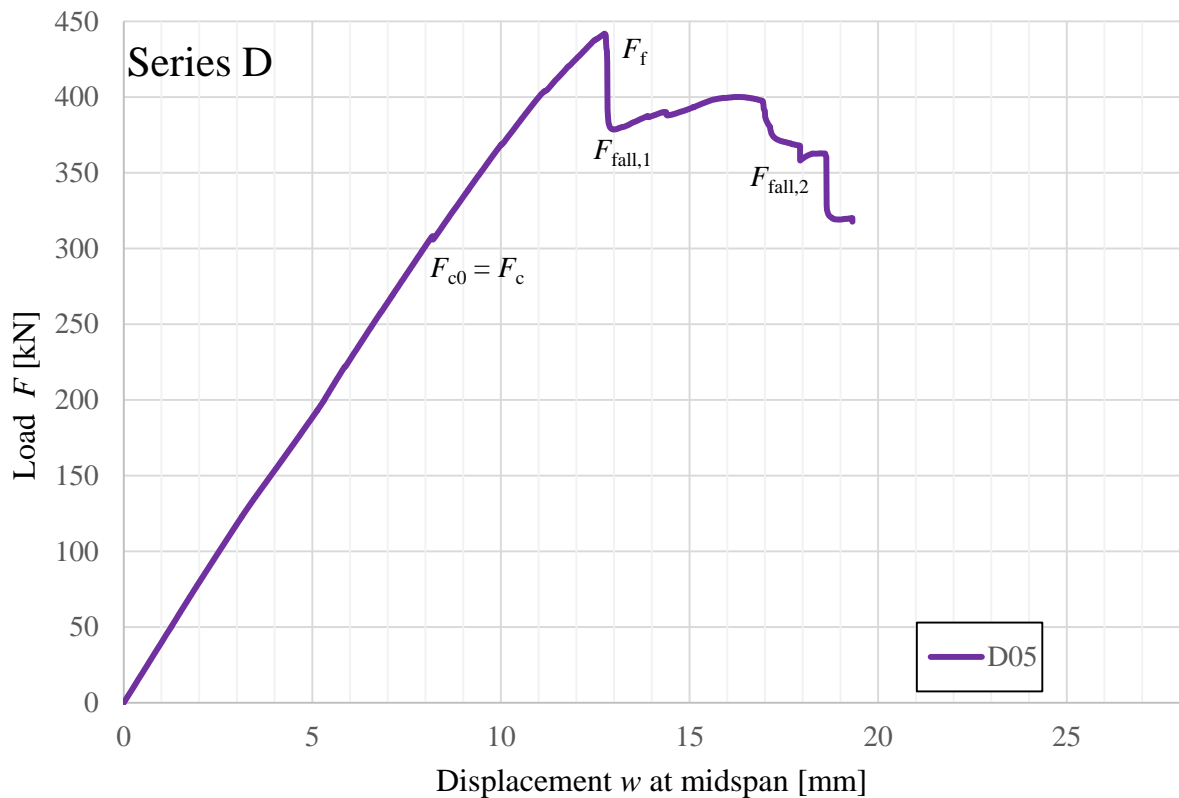
Figure 3.16: Load-displacement diagram of test specimen D05

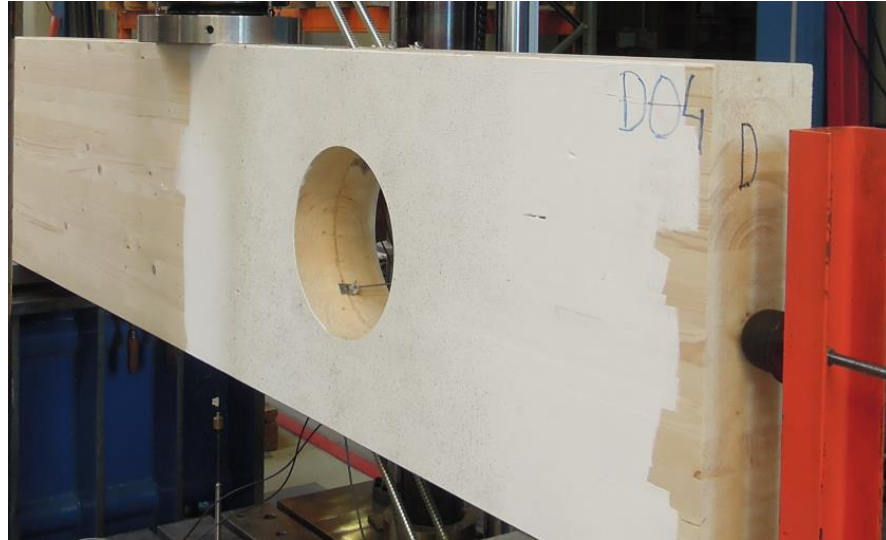
Figure 4.8: Test specimen D04 in the testing machine

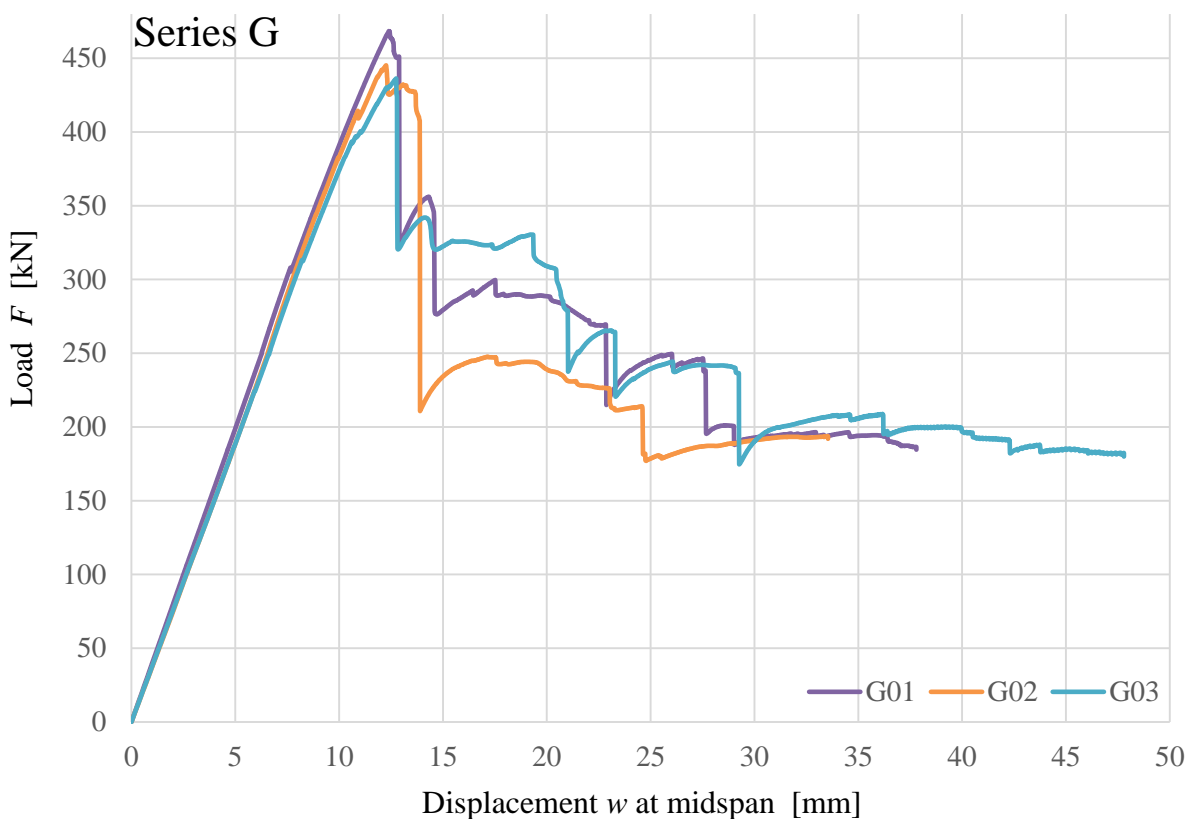
Figure 4.11: Load-displacement diagram of test series G

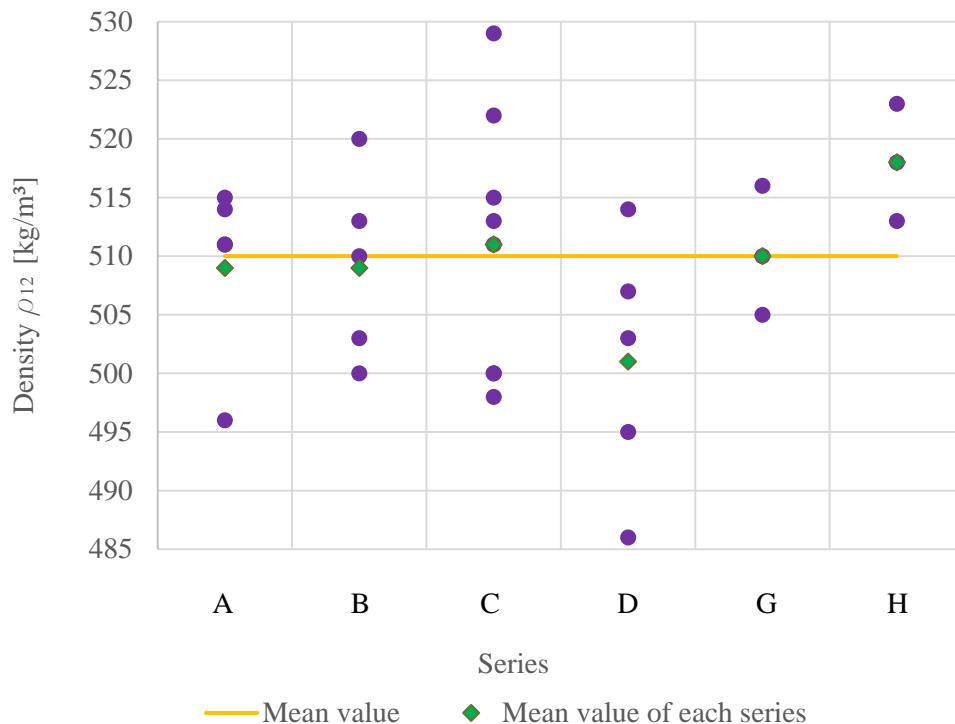
Figure 4.17: Scatter and line diagram of density results representation

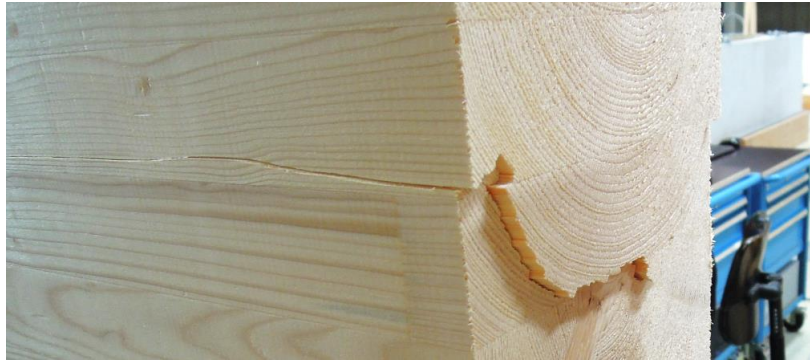
Figure B.2: Shear failure at the left end of specimen A04

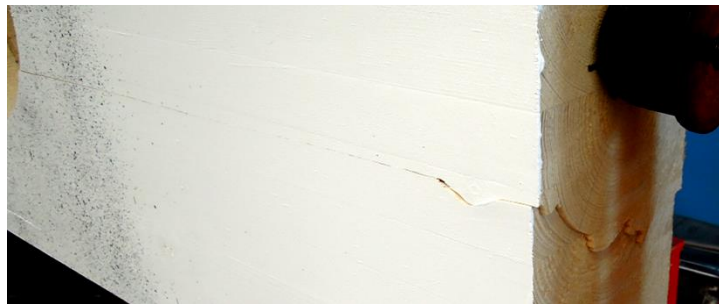
Figure B.4: Shear failure on the right edge of the beam of specimen B05

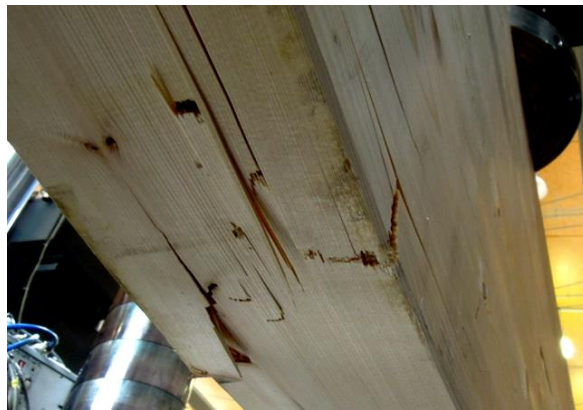
Figure B.10: Bending failure on the bottom side of the beam under the load application area of specimen C07

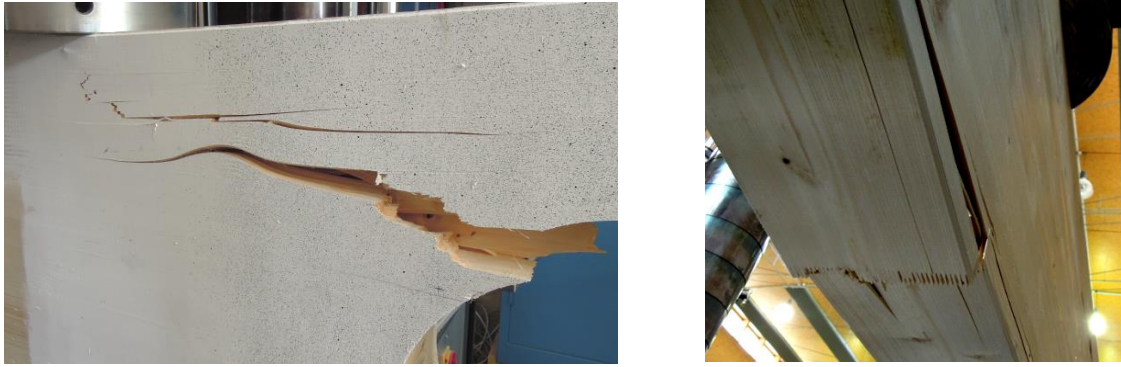
Figure B.11: *Stepped propagation of the upper left crack on the opening on the beam front side (left); finger joints failure mixed with the bending failure in the gross cross section (right) of specimen C08*

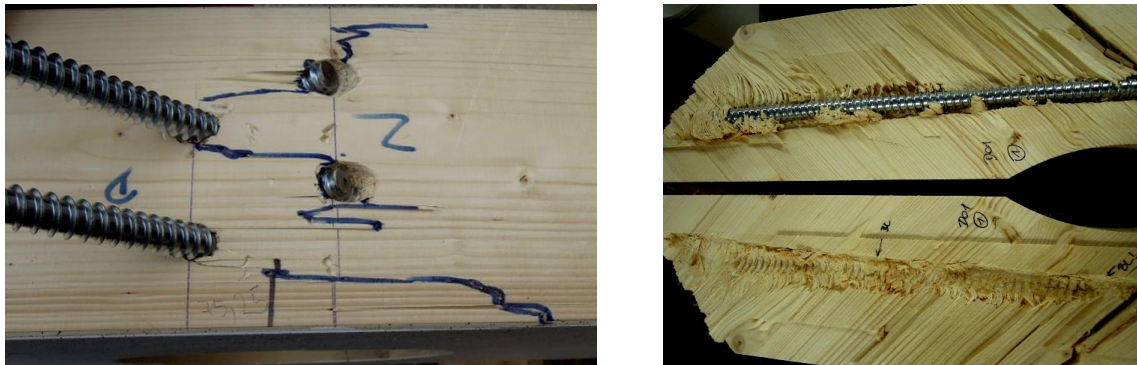
Figure B.16: Bending failure on the bottom side of the beam (left); threaded rod in the hole and pull through effect on the timber inside of the hole (right) of test specimen D01

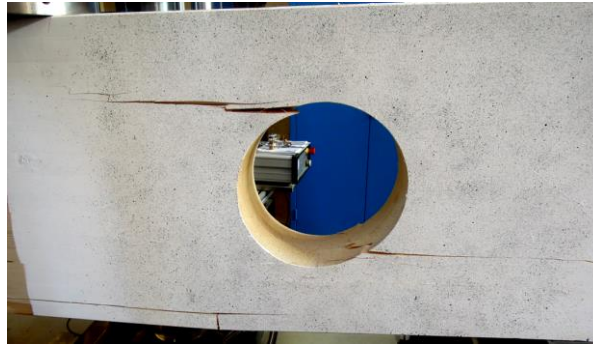
Figure B.17: Tensile stress perpendicular to the grain cracks on the upper left and lower right opening edge and bending crack of specimen D01

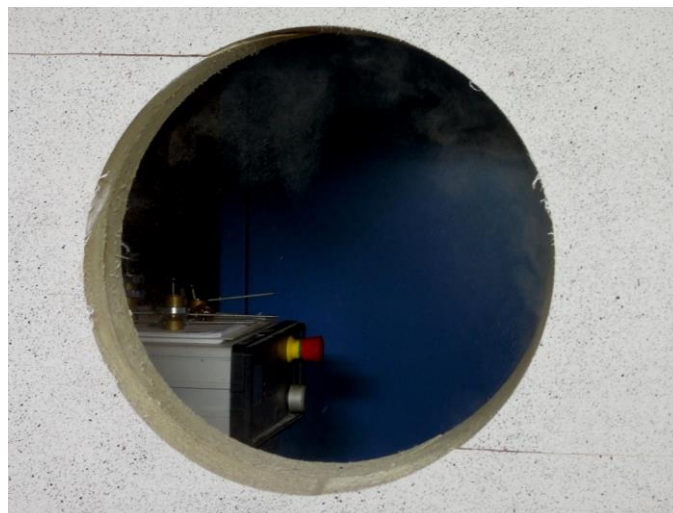
Figure B.18: Initial cracks on the upper left and lower right opening edge at 250 kN of test specimen D03

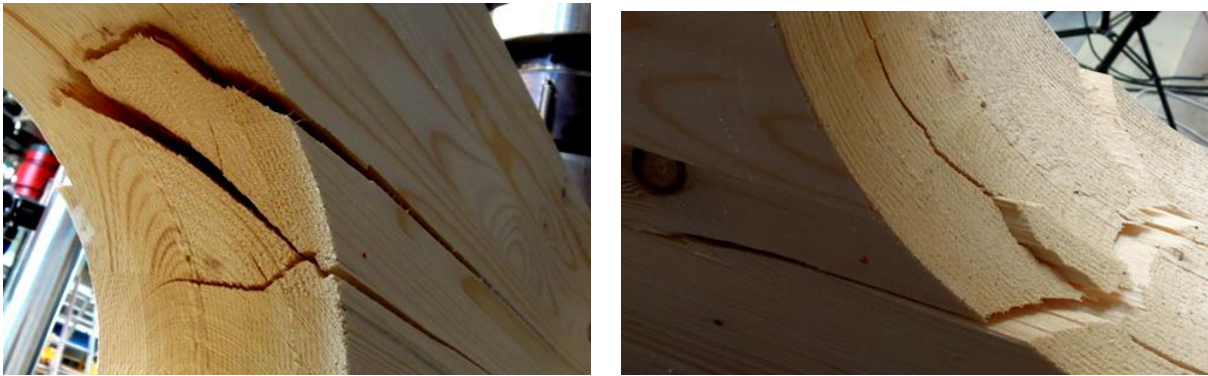
Figure B.19: Fully spread cracks on the upper left (left) and lower right (right) opening edge of specimen D03

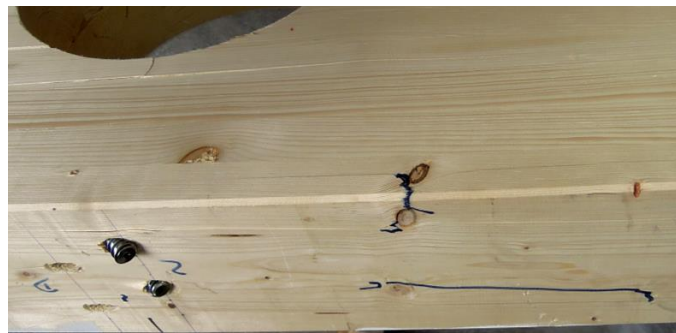
Figure B.20: Bending failure on the back and bottom side of the beam of test specimen D03

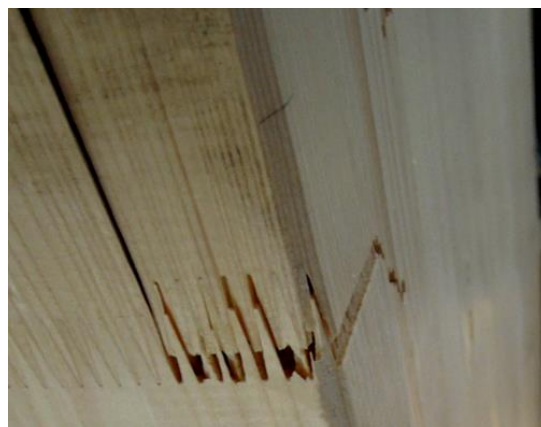
Figure B.23: Finger joints failure of test specimen D04

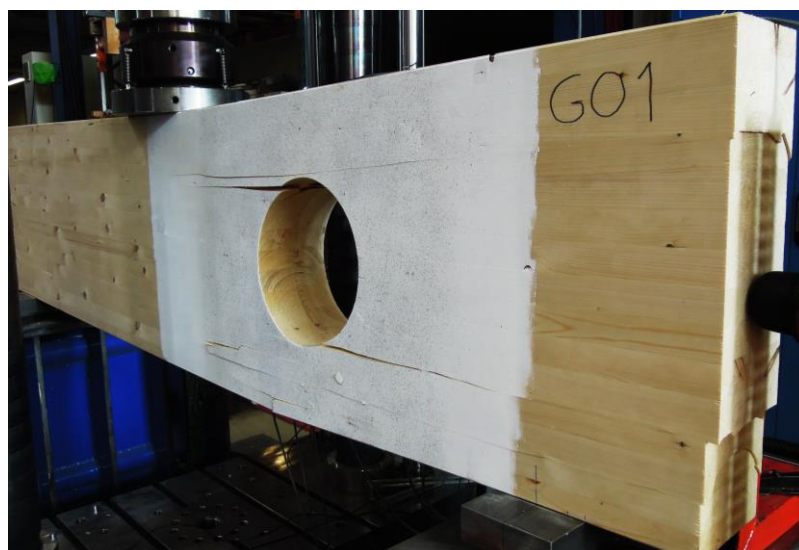
Figure B.26: Shear failures of test specimen G01

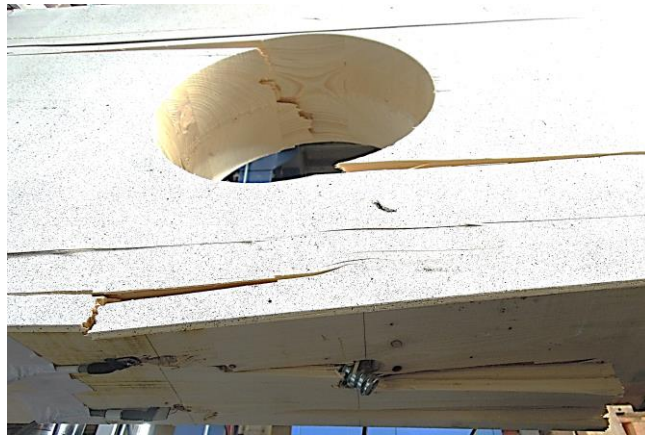
Figure B.27: Bending failure and cracks on the upper left opening edge of test specimen G01

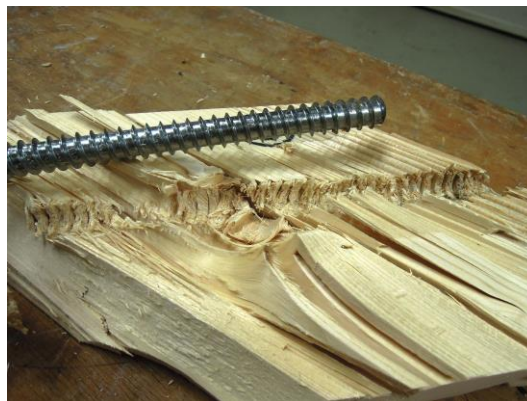
Figure B.28: Threaded rod hole of test specimen G01

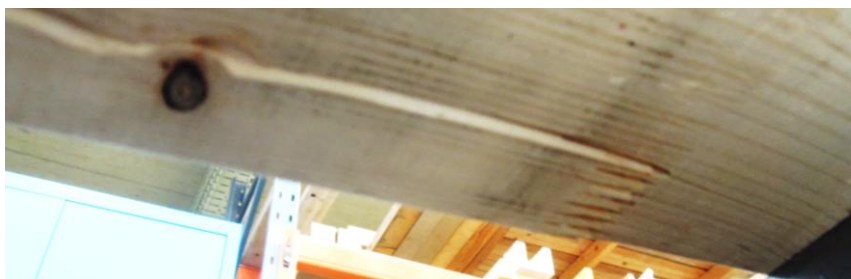
Figure B.31: Finger joints damage of test specimen G02

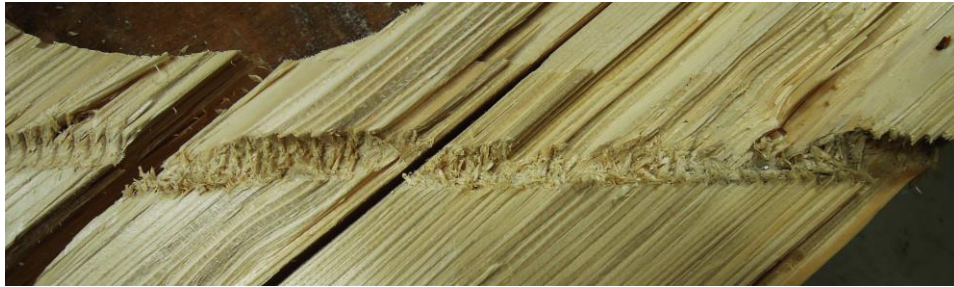
Figure B.32: Pull through effect of the threaded rods of test specimen G02

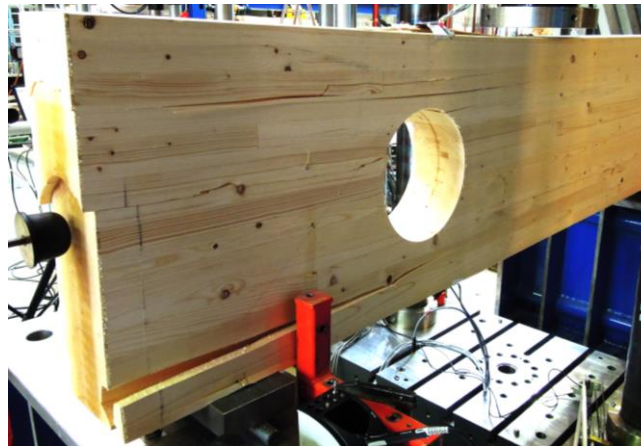
Figure B.37: Test specimen H01 back view with outbreak of timber part

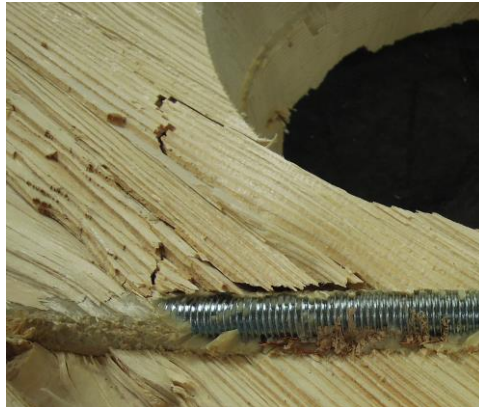
Figure B.41: Glued-in threaded rod inside of the damaged timber of test specimen H02
