In this framework, the cracking behaviour of one type of austenitic stainless steel in contact with liquid zinc was characterised. This was achieved by carrying out thermo-mechanical tests with a Gleeble® 3800 simulator.

and study the influence of different parameters on the embrittlement process of 301M austenitic stainless steel by liquid zinc.

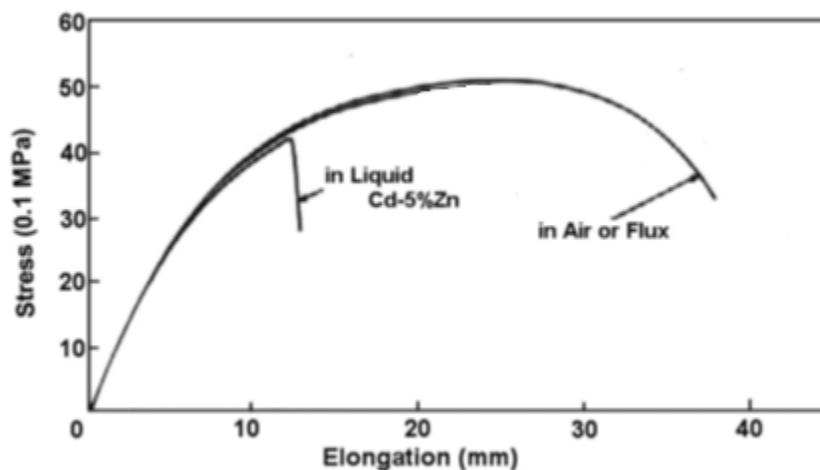
Figure 2: Stress-elongation curves of S355 grade steel in different environments at 350°C, 5 mm/min – modified from [7]

Figure 2 reveals such behaviour as S355 steel experiences heavy embrittlement in contact with liquid Cd-5%Zn.

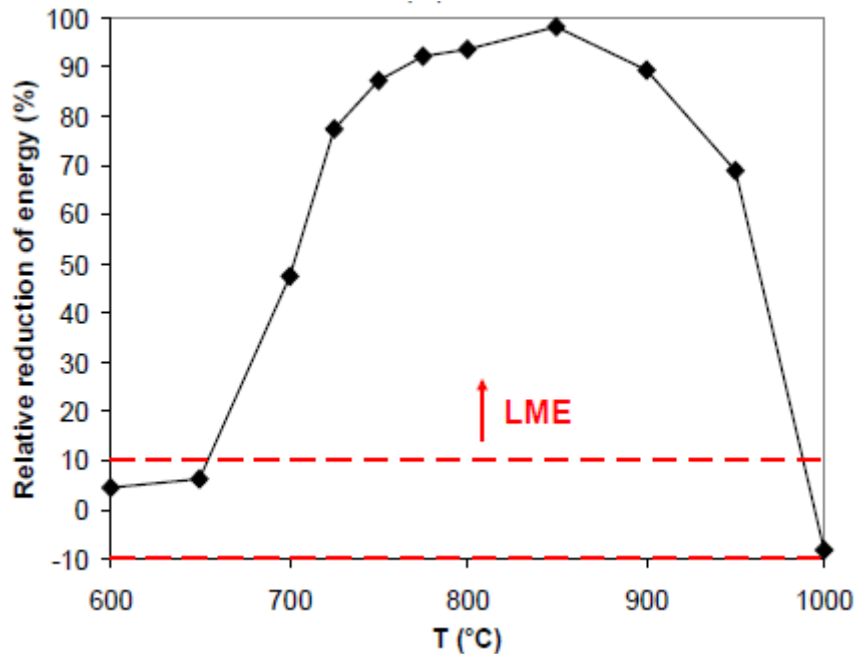
Figure 3: Relative reduction of energy over temperature represents the “ductility trough” for Fe-22Mn-0.6C steel in liquid zinc with a strain rate of $1.3 \times 10^{-1} \text{s}^{-1}$ [3]

Figure 3 illustrates the reduction of fracture energy as an indicator for the severity of LME in respect to the testing temperature of a Fe–22Mn–0.6C steel coated with zinc. This shape of

curve is known in literature as the ductility trough of LME incidents. In between the lower and the upper temperature limits, the ductility is progressively reduced until it reaches its minimum and afterwards starts a recovery until no more embrittlement occurs at the upper end of the trough [3].

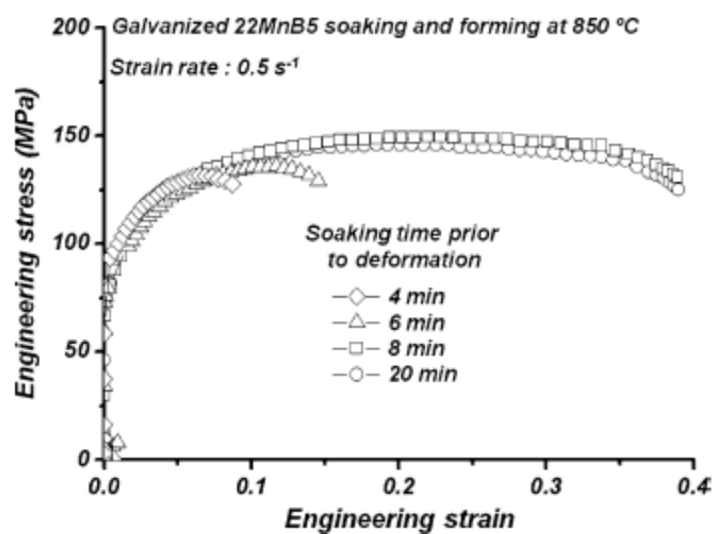
Figure 6: Engineering stress-strain curves of Zn-coated 22MnB5 steel deformed at 850°C with 0.5 s^{-1} after holding at the same temperature for 4, 6, 8 and 20 min [32].

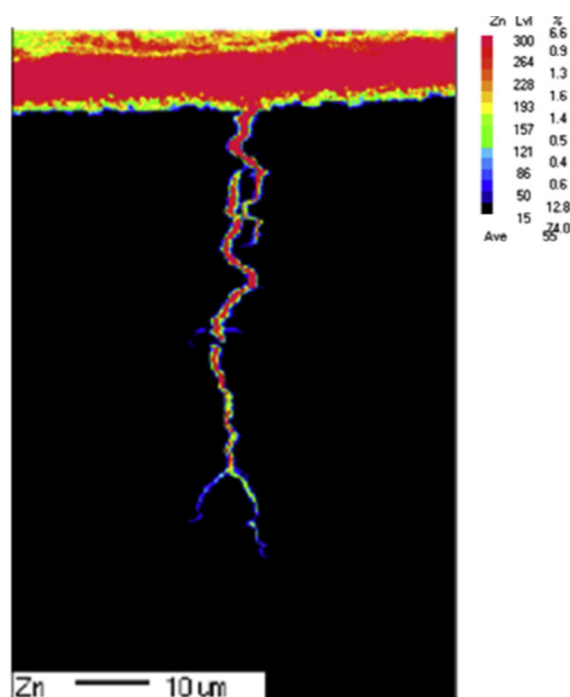
Figure 10: EPMA investigation of zinc distribution of a LME crack formed on Zn-coated TWIP steel during tensile testing/ adapted from [4]

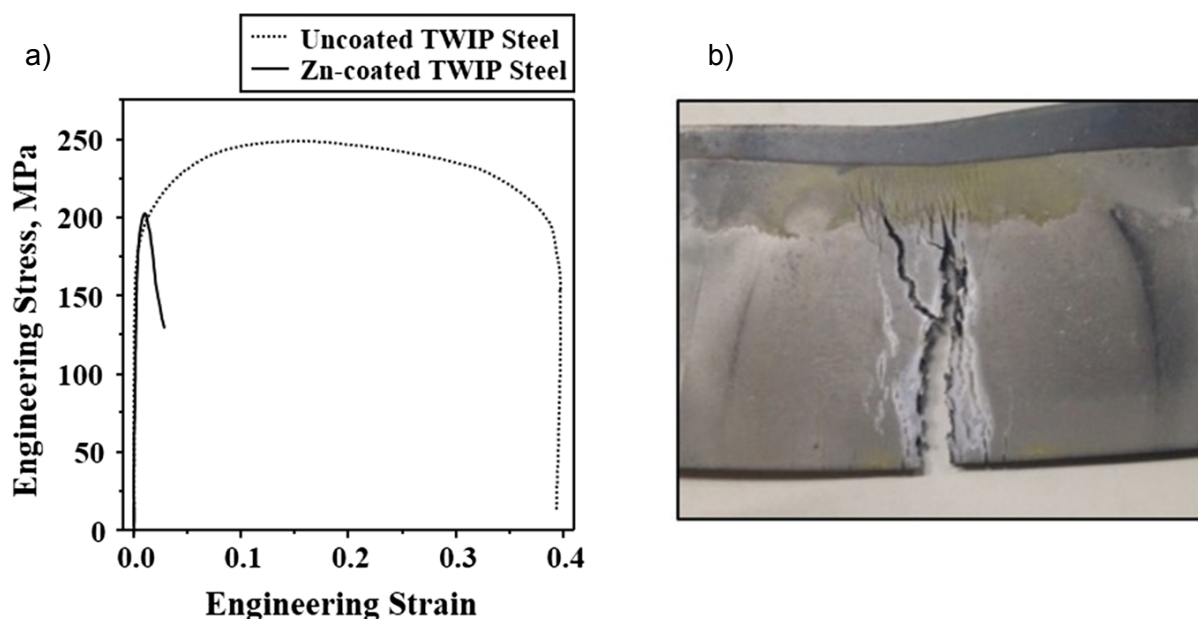
Figure 12: a) Engineering stress-strain curves of uncoated TWIP steel and Zn-coated TWIP steel. b) Zn-coated TWIP steel after the tensile test at 850°C [6].

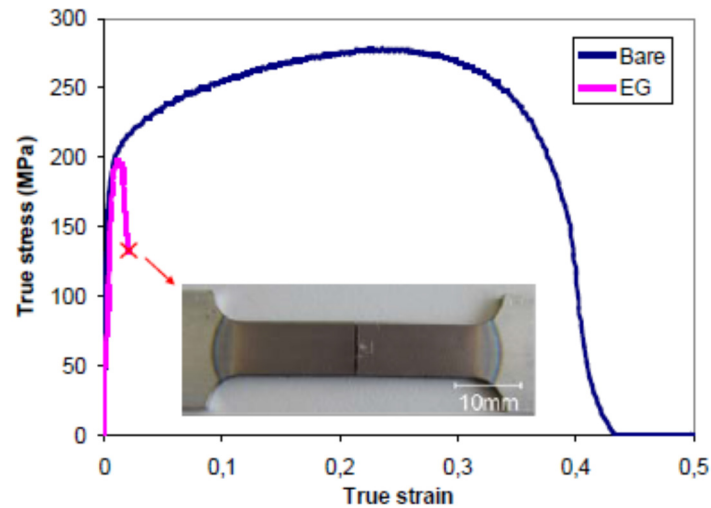
Figure 13: Interrupted tensile test on zinc coated austenitic steel [3]

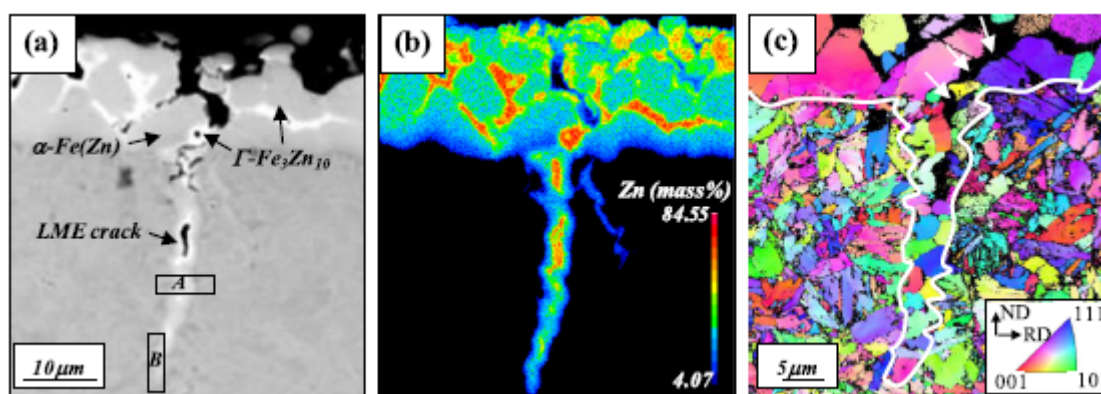
Figure 16: Micrograph of a LME crack formed on Zn-coated 22MnB5 PHS [5]: a) SEM image b) FE-EPMA of Zn distribution c) EBSD phase map for the bcc phase

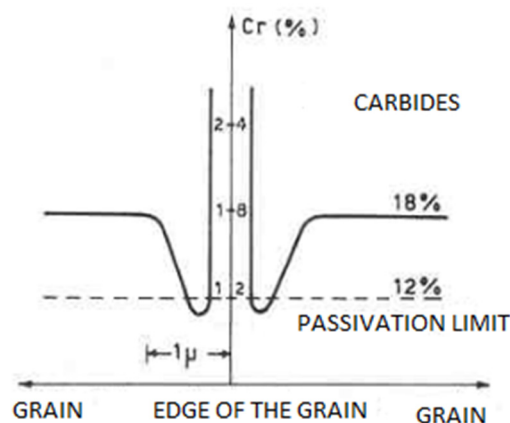
Figure 20: The chromium content trend close to the grain boundaries of a stainless steel [54]

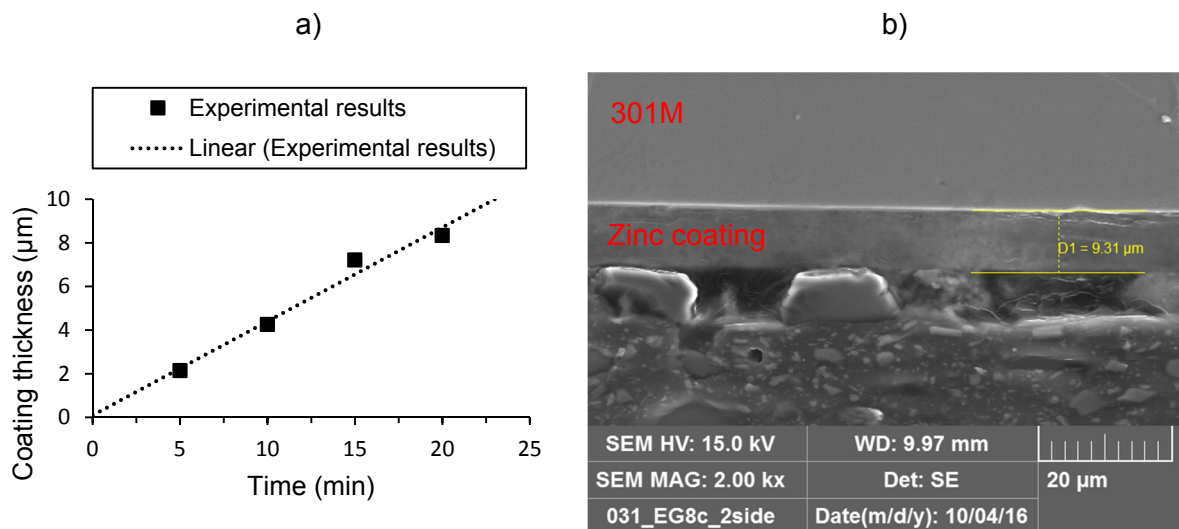
Figure 31 a) Linear growth of zinc coating on 301M by electro-galvanising b) SEM image of electro-galvanised coating on base material

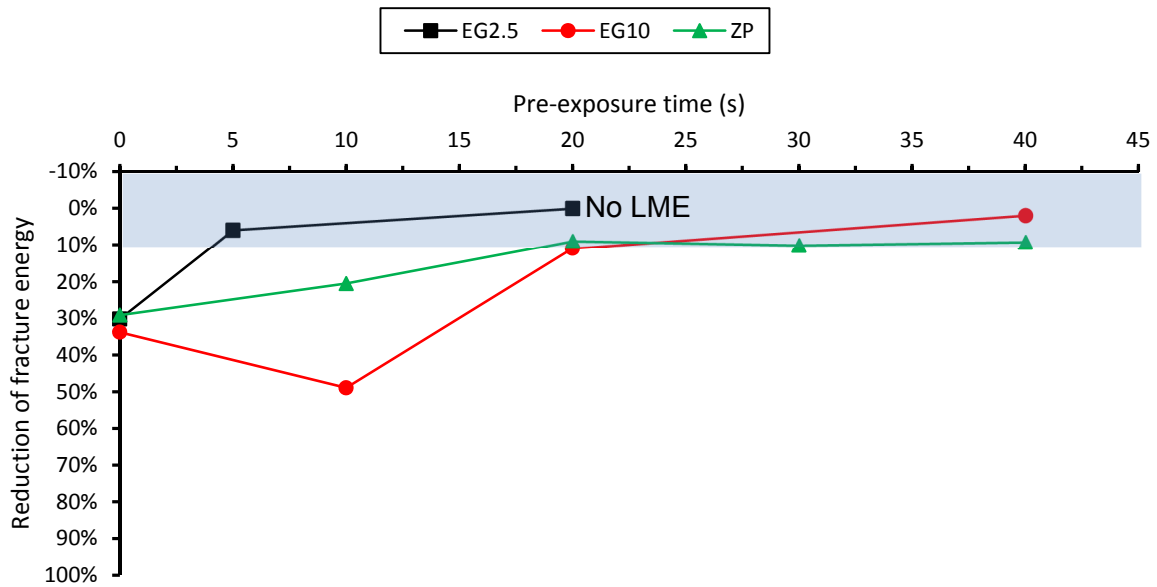
Figure 54: Fracture energy reduction of 301M at 800°C for 100 mm/s strain rate for samples coated with different coating thickness

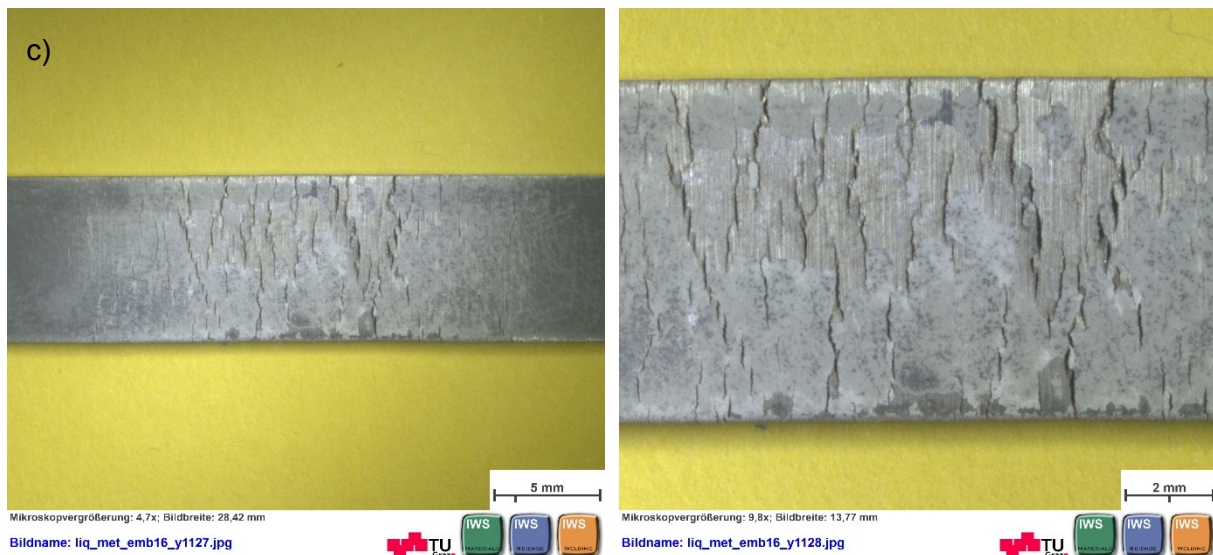
Figure 64: Stereo microscopy images of samples after RSW simulation test procedure at: a) 700°C b) 800°C c) 900°C

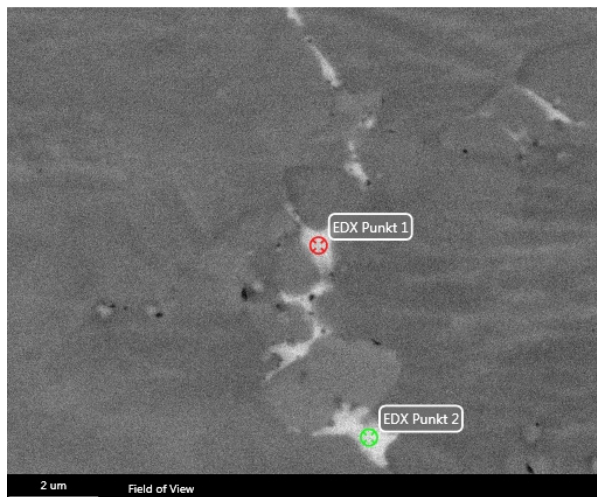
Figure 72: Filled crack of zinc-painted sample tested at 800°C showing the location of spot scans

Finally some EDX spot scans showed the composition of the filling material. Figure 72 presents the location of those spot scans and Table 8 lists the results. For EDX Punkt 1 remarkable is the very high zinc content which comes close to the content of Γ ($\text{Fe}_3\text{Zn}_{10}$) (shown in chapter 2.1.4.1) and the significantly higher nickel content than in the base material. EDX Punkt 2 confirms those results but with lower zinc content exchanged by higher iron content.

Table 8 Chemical composition of spot scans of zinc painted sample tested at 800°C

Element	Weight%	
	EDX Punkt 1	EDX Punkt 2
CrK	3.88	6.95
FeK	14.44	28.09
NiK	14.81	12.77
ZnK	66.14	51.02
