THE BENEFITS OF ENERGY REFURBISHMENT STRATEGIES ON AN ADAPTIVE REUSED INDUSTRIAL HERITAGE BUILDING

In this study, the effects of energy retrofit strategies on annual energy consumption are investigated through Derince Travers Injection Plant which is an example of an industrial heritage located in Kocaeli-Turkey assumed to be adapted to a social center complex.

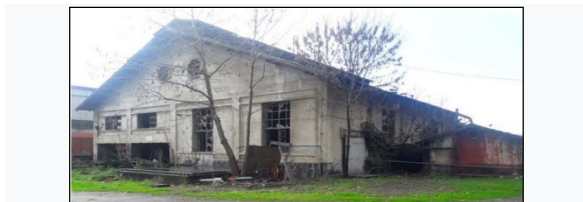
Figure 1: The non-functional Derince Travers Injection Factory

Derince Travers Injection Factory functioned as wooden traverse creosote injection factory until 2001 in a single block is located in Kocaeli province, Derince Port Area district. The construction of the factory was started in 1930 by a German company called Borsig. The factory started its operations in 1931 and was operated by German masters until its final acceptance (Berkel, 1954). Although the structure is subjected to deformations, it is still standing with its external and internal equipment (Figure 1) (Qi, 2016). There is a wagon maintenance workshop in the south of the building, a registered transformer structure in the east, Demirspor facilities with a single-story in the north, and open storage areas in the west (Bozdağ, 2013). Derince Travers Injectable Factory has been registered as an industrial heritage with the decision of Kocaeli Cultural Heritage Preservation Board of the Ministry of Culture and Tourism on 14.05.2013, due to its technical and historical features, as reflecting the industrial movements of the 20th century in the region, modernist facade layout, steel-wooden truss roof system, original site equipment and details, architecture. Although there are re-use planning and attempts, the structure is still obsolete.

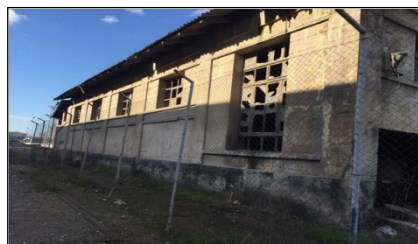
Figure 3: Derince Travers Injection Factory deformation on the facade

Diagnosis of the physical condition of Derince Travers Injection Factory was conducted by on-site observation and imaging studies with thermal cameras. Heat leakages from the cracks and thermal bridges at the junction points of the building elements have been identified on the building envelope (Figure 2). On the facade, there are efflorescences, cracks and salts caused by moisture. Although there is no serious structural damage, there are some deteriorations as plaster cracks, material loss and color changes in the plaster. All window glazings are broken on the facade of the building, and there are spatial cracks and spills (Figure 3). Wooden forehead boards of the structure without rain gutter are rotten in a structure which also increases the mould problems. Asbestos is used as the roofing material. The odor of creosote (tar oil), which was used to tighten wooden sleepers and to protect it from external conditions, still exists in the building. There is no mechanical-electrical system available in the building currently.

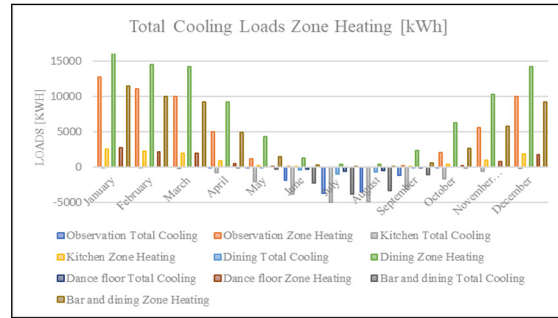
Figure 6: Comparison of zonal monthly cooling and heating loads

Especially the amount of solar radiation acting from the southern façade with greater window wall ratio compared to the other façades, is higher in summer. It was observed that the utilization of mechanical ventilation increased in the summer months. Mechanical and natural ventilation systems operate during the active period of the business. For summer days, the calculation was made according to the time when the cooling load was maximum in each thermal zone. Total consumption amount, indoor temperatures, sensible and non-sensible heat loss gains and cooling loads were calculated. The kitchen and surveillance zone seem to create the highest monthly cooling and heating loads (Figure 6). Although it orients to the south, it was observed that the cooling load was mostly in the surveillance room due to the large size of the space, the glass/wall ratio, and the number of doors. The amount of energy spent for heating and cooling is very low compared to the surveillance room, due to the low opening and floor height in the kitchen space added to the original structure in the southern facade in line with the new function (Figure 7, Table 4).

Considering the heating load distribution of the building, the highest heating load is observed in the surveillance room again due to the space volume. Under the comfort conditions suitable for the activity to be performed in each thermal zone, the heat loss occurs mostly in the circulation areas and in the places where the floor height is high. It was observed that the heating load calculated for the restaurant section was higher than the dance gallery with the size of the nearby space due to the type of activity performed.
