# Advanced Monitoring Systems for Infrastructures: Integrating 6D Sensors and Low-Cost High-Precision GNSS

**ABSTRACT:** Structural Health Monitoring (SHM) is vital for ensuring the safety and longevity of infrastructures, utilizing various sensor-based techniques to detect damage, assess performance, and monitor long-term deterioration. Traditional methods, such as visual inspections, lack precision and are prone to human error, whereas more advanced techniques like vibration-based monitoring, acoustic emission, strain gauges, and GNSS offer real-time damage detection and millimeter-level precision but often require complex planning and high costs. The presented 6D sensor, developed for infrastructure monitoring, accurately measures complex displacements and rotations, offering enhanced precision through a combination of machine learning and mathematical algorithms. When paired with low-cost, high-precision GNSS systems, it provides comprehensive real-time data on both localized and large-scale structural movements, improving insights into infrastructure behavior under various environmental conditions and loads. This paper explores the integration of 6D sensors with GNSS technolo

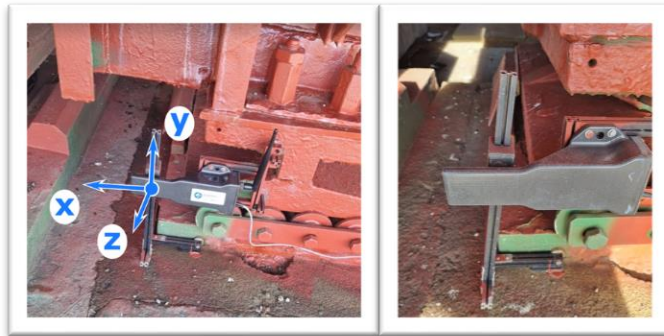
Figure 1. Images of the Monitored Roller Bearing: Left: Condition at installation with corresponding axes; Right: Sensor after maintenance work, displaced and sandblasted

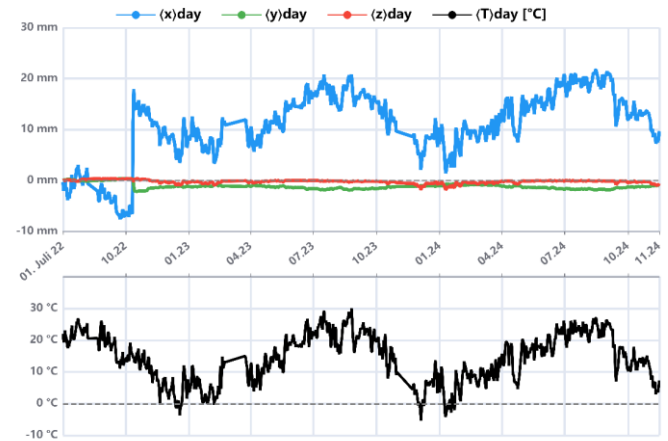
The diagram in Figure 2 shows, in the upper part, the sensor's positional displacements along the x-axis (blue), y-axis (green), and z-axis (red). The lower part of the diagram displays the internal temperature of the sensor. The measurements, recorded at 15-minute intervals, are presented here as daily average values.

Figure 2. Measurement data for monitoring a roller bearing: effects of unintended displacements during maintenance work and wildlife damage

As expected, significant fluctuations can be observed along the x-axis due to the thermal expansion of the bridge element. In October 2022, a sharp and abrupt change is visible, which can be attributed to a mechanical shift in the sensor setup (see Figure 1, right). During this period, the sensor was also sandblasted, but this had no relevant impact on the measurement results.

A disruption in sensor data in March 2023 was caused by wildlife damage—specifically, pigeons pecking at the cable. In December 2023, the sensor failed due to a hardware defect, which has already been resolved in the new hardware version of the sensor. Aside from these events, the data shows a very good correlation with the expected thermal expansion and only minor movements along the y- and z-axes.

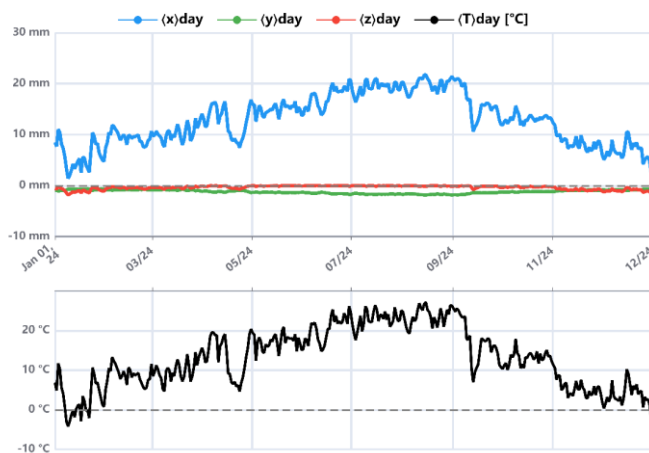
Figure 4. Daily Average Values Independent of the Sensor's Measurement Interval in Figure 1. The data shown is from the year 2024 and includes a flood event in September.

The diagram in Figure 4 illustrates how the bridge responds to seasonal temperature fluctuations and simultaneously shows the impact of exceptional events such as the flood disaster in September 2024. Monitoring data is essential for assessing the

structural integrity of the bridge during such extreme situations. The diagram presents the positional displacements of the sensor along the x-axis (blue), y-axis (green), and z-axis (red) throughout the year. The x-axis shows significant variation, with displacements increasing up to 30 mm, indicating thermal expansion of the monitored bridge element. In contrast, the y- and z-axes show only minimal movement, suggesting that the bridge remains largely stable in those directions.

The lower subplot shows the temperature trend over the course of the year. A clear seasonal pattern is visible, with temperatures falling below 0°C in winter and rising above 20°C in summer.

From September 13 to 20, 2024, the bridge was affected by a flood disaster, yet no significant anomaly is visible in the measurement data. The diagram clearly shows that while the displacements along the x-axis temporarily dropped during the flood event, the behavior was consistent with previous temperature fluctuations. Even after the flood, no significant changes in the measurement values were observed. This indicates that the bridge did not suffer any lasting damage from the flood and that its structural integrity remained intact.

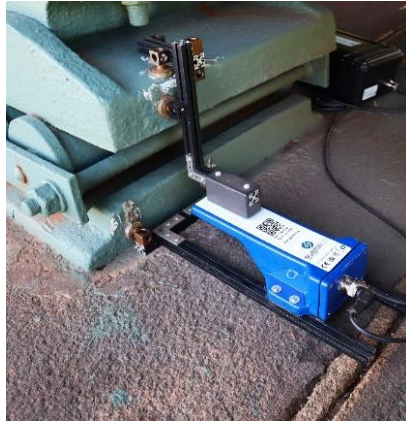
Figure 6. A 6D sensor installed on a roller bearing of a railroad bridge

In another bridge project, measurements were conducted at multiple points along a curved bridge located on a creeping slope. The results (Figure 6 and Figure 7) showed that individual bearings exhibited consistent but slow displacement along the y-axis—that is, transverse to the roller bearing's intended direction of movement.

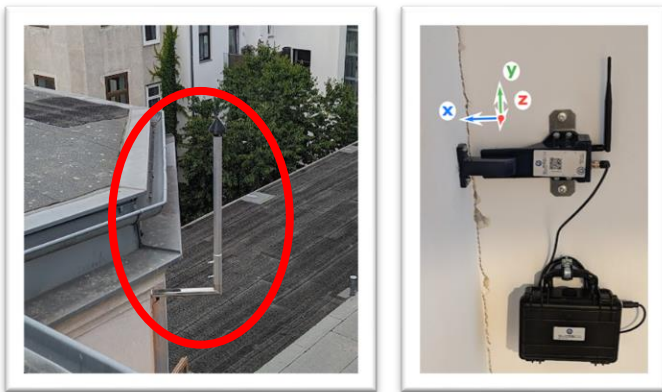
Figure 10. Left: Mounted GNSS antenna on the exterior wall of the residential building. Right: 6D sensor mounted in a building corner near the GNSS antenna.

By combining these two measurement systems, it was possible to precisely monitor the relationship between the cracks and the surrounding walls, while the absolute GNSS system additionally allowed for the detection of potential subsidence of the entire building or individual sections. This approach increases the significance of the measurements and provides the private property owner with reliable data to demonstrate to the construction client any potential effects of the construction work on their property. At the same time, monitoring enables early warning in the event of sudden significant movements, allowing the developer to intervene in time to prevent further structural damage.
