## 3D projection of AI-derived concrete cracks on a Hydro Dam outlet tower

**ABSTRACT:** In a Structural Health Monitoring (SHM) project, a hydro-dam's outlet tower in Northern Sweden required inspection and assessment. This was due to the lack of digital records regarding existing damage and the client's concerns about its progression. The tower's location in a lake made traditional inspection methods like scaffolding or skylifts extremely difficult. The concrete engineering expert hired for the evaluation was uncomfortable with rope access, making data collection an expensive and cumbersome task. The structure is significantly affected by fluctuating water levels in the lake, leading to suspicions of certain types of damage (e.g., freeze-thaw damage, erosion damage).

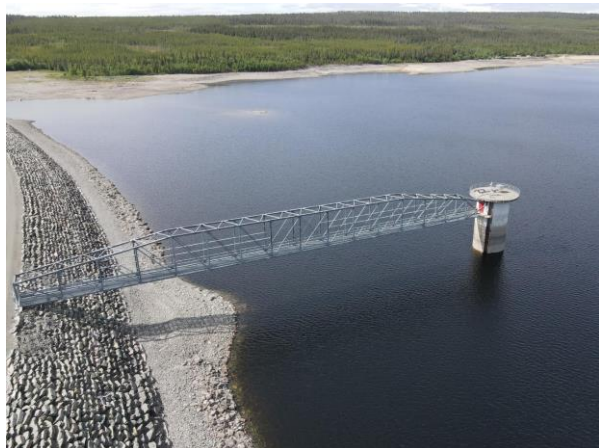
Figure 1. An overview of the tower structure

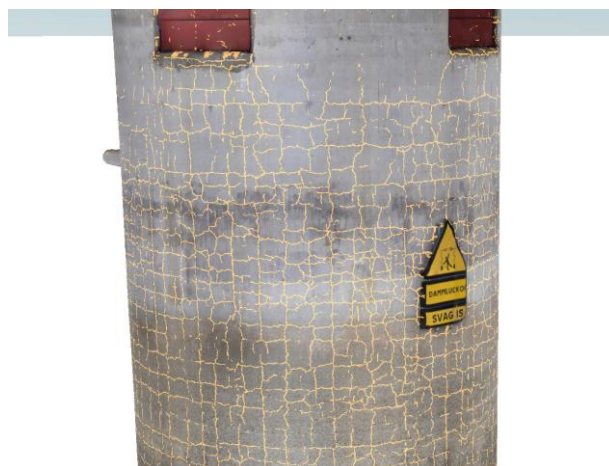
The final output was a detailed 3D model textured with detected damage patterns. The AI identified a prominent and recurring crack pattern, which was verified with a 98.7% confidence level when benchmarked against expert human assessments. Figure 2 illustrates the resulting damage map, with clearly visible areas of cracking and localized spalling. The damage texture allowed for both global overview and close-up inspection, enabling prioritization of critical zones for further manual investigation or remedial work.

Figure 2. Resulting 3D projected AI interpretation of crack pattern
