# Hangar Stressing on the 6th Street Viaduct Replacement, Los Angeles, CA

ABSTRACT: Spanning across Freeway 101, several rail roads and the LA river, the 6th Street Viaduct replacement project is one of the largest bridge projects in the City of Los Angeles. The original bridge was built in 1932 and became a backdrop to the film industry. The iconic bridge was demolished following the decision to replace it with the existing 6th Street Viaduct due to the structure becoming seismically vulnerable. At 3,060-ft-long and 100-ft-wide, the redevelopment of the new bridge – designed by Michael Maltzan, – includes 10 network arch spans, with a total of 388 hangers supporting the bridge deck. The bridge spans 101 Highway, the Los Angeles River. The hanger installation and stressing for the bridge was a complex procedure that would need careful attention to detail for loading the hangars before removal of formwork and for fine tuning the final load criteria. There were 18 load sequences per arch. The instrumentation and monitoring of the hangars while loading required a novel approach that started two years in advance of the works with development of a bespoke system, calibration and accept

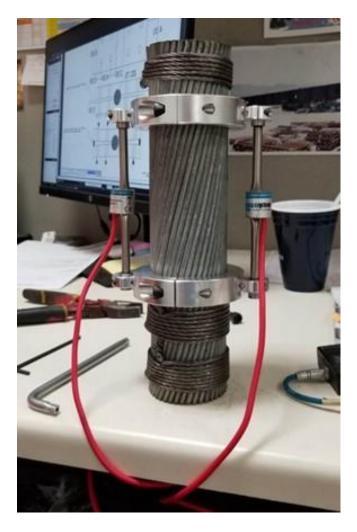
To ensure consistent and accurate strain measurements, each vibrating wire strain gauge was mounted on a custom-engineered aluminum clamp designed to securely interface with the prestressing strands. The clamp assembly was developed to prevent slippage or misalignment during strand elongation, thereby preserving measurement integrity. A secondary carrier clamp, positioned above the primary clamp, housed the strain gauge and enabled reuse across multiple strands without compromising performance or structural integrity. The prototype assembly was presented to the client for review and approval.

Figure 3. Prototype strain gauge assembly.

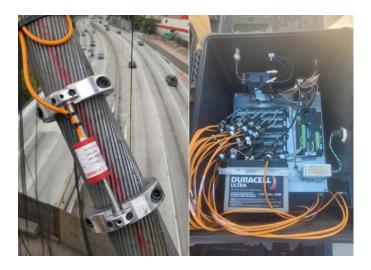
During the planning phase, the decision was made to utilize Campbell Scientific CR6 data loggers, equipped with the necessary number of multiplexers to accommodate strain gauge readings. The CR6 model was selected primarily for its integrated Wi-Fi capability, which enables real-time data visualization, an essential feature for the loading team during operations. Each arch structure required instrumentation of approximately 18 to 22 strands, with the optimal placement for the data loggers initially identified as the base of the arches, housed within secure enclosures.

Figure 4. Strain Gauge assembly and logger setup.
