# An EMI-based approach for Structural Health Monitoring of a Space Reinforced Concrete Frame Structure

**ABSTRACT:** The electro-mechanical impedance (EMI) method represents a promising approach to structural health monitoring (SHM), attributable to its ability to simultaneously employ piezoelectric transducers for both actuation and sensing purposes. As a result, an extensive volume of literature has surfaced recently, analyzing the efficacy of the EMI method in reinforced concrete (RC) structural elements subjected to quasi-static loading sequences. Nevertheless, the investigation into applying the EMI method in dynamic loading environments must be more robust within the current body of research. This study evaluates the effectiveness of the EMI method for SHM of a one-bay, one-story RC space frame structure under the influence of earthquake excitations. Therefore, a shaking table was used to excite the RC frame with progressively increased ground excitation, wherein piezoelectric patches are strategically embedded in meticulously chosen locations. The embedded PZT sensors facilitate promptly diagnosing earthquake-induced damage to the RC frame. The experimental outcomes reveal

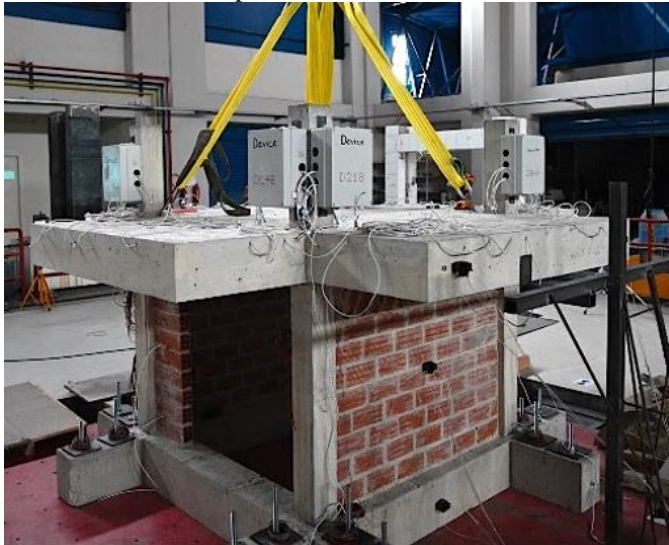
which possessed a maximum tested structure mass of 8 tons and a maximum overturning moment of 8 ton-m. Therefore, the mass of the specimens was adjusted to 4.3 tonnes, which is less than the maximum bearing capacity of the shake table. The clear span of the specimen's beam measured 1.24 meters, and the clear height of the specimen's columns was 1.0 meters. The concrete utilized in this study was of a C20/25 grade, and the reinforcement employed was referenced as B500C for the slab and foundation and for the longitudinal reinforcement of the columns and S220 for the column stirrup. The column cross-section was set to 13×13 centimeters, and the reinforcement of the specimen was four longitudinal reinforcement bars, each measuring 8 millimeters in diameter, strategically positioned at each corner. Additionally, a closed smooth steel stirrup measuring 5,5 millimeters in diameter was placed every 6 centimeters to serve as transverse reinforcement. A reinforced concrete (RC) slab, which incorporates four balconies and four hidden beams, was constructed with a thickness of 20 centimeters on top of the columns. This heavily reinforced slab was utilized to drive the potential damage in the RC columns and the brick infill panels as well as to allow for additional mass due to renovations involving greenery (with special reference to Thessaloniki metropolitan area). Although the occurrence of damage in vertical structural components is undesirable under current seismic regulations, it is prevalent in existing buildings constructed under older standards (strong slab or beams and weak columns). Figure 1 illustrates the specimen positioned on the shake table in the pristine condition.

Figure 1. RC frame test setup.

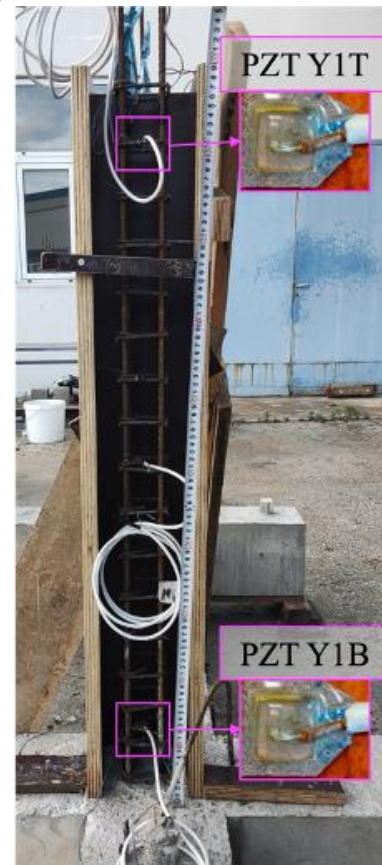
As mentioned above, this study investigates a PZT-enabled EMI-based SHM approach for the SHM of a one-bay, one-story RC concrete structure. Thus, several PZT transducers were embedded as smart aggregates in the RC frame specimen. The fabrication of smart aggregates involves several stages. Initially, two lead wires were welded to the two poles of the PZT patch, and the functionality of the sensors was duly verified before further action steps. Subsequently, the PZT transducers were coated with a waterproof layer of epoxy resin, as illustrated in Figure 2. Then, the smart aggregates were positioned in meticulously selected locations of the RC

Figure 2. Ready to implement Smart Aggregate.

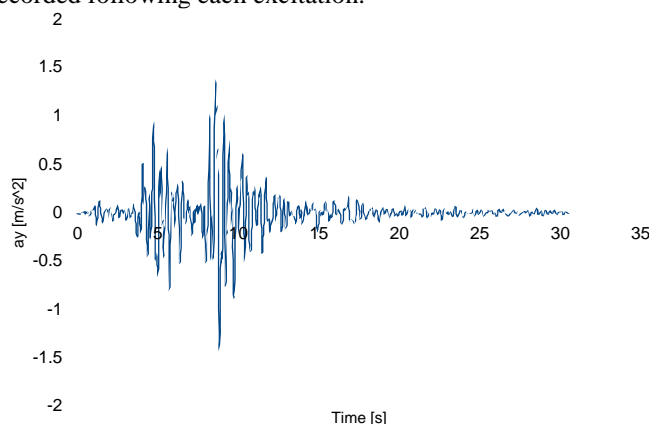
The dynamic loading involved the gradual increment of PGA levels up to 1.1g peak acceleration, based on the employed earthquake component from Thessaloniki in the north-south direction (peak acceleration of 0.14g with main excitation frequencies ranging from 2 Hz to 10 Hz and minor excitation frequencies beyond 26 Hz). The seismic event occurred on 20 June 1978 at 20:03:21 in the epicenter 30 kilometers east of Thessaloniki, revealing the susceptibility of urban centers to such natural disasters. According to Theodulidis et al., 4000 buildings experienced serious, 13000 moderate, and 49000 minor damage [30]. The north-south component of the strong ground motion record at the Thessaloniki-City Hotel station, situated 29 kilometers from the epicenter, offered the ground excitation time history utilized during the dynamic tests, as illustrated in Figure 3. Subsequently, this sequence has been meticulously adjusted to stimulate the specimen with peak accelerations of up to 0.1g, 0.2g, 0.5g, 0.8g, and 1.1g, following a dynamic pushover approach. The ultimate level of the first phase of testing of the as-built structure (presented herein) was characteristic of a structure with RC members at Serviceability Limit States (SLS), where no yielding of steel rebars occurred and brick infills with damage initiation but no collapse. Thereafter, the EMI response of all the PZT sensors was recorded following each excitation.

Figure 3. Ground acceleration time history.

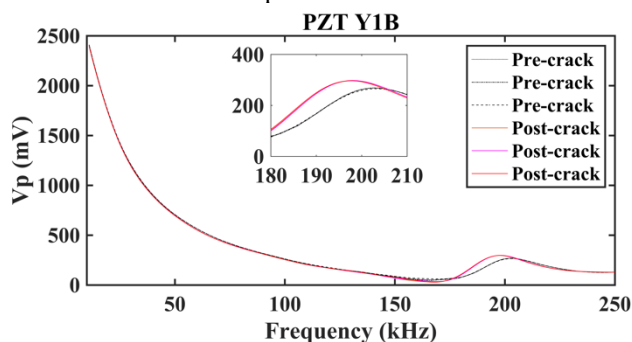
This sub-section presents the EMI response of each PZT transducer in terms of  $V_p$ —excitation frequency, as captured with the RC specimen at rest. The EMI responses were measured across a broad frequency spectrum from 10 to 250 kHz. Figure 6 illustrates the EMI response of PZT Y1B, which was placed in the lower region of column Y1. The EMI response of PZT Y1B demonstrated a leftward shift subsequent to the formation of a bending crack in its vicinity. Furthermore, the EMI response does not demonstrate any additional alterations, which aligns with the observed cracking pattern, where the crack width remains constant. Thus, the proposed SHM scheme promptly identifies the formation of the bending crack in the lower region of the column through the alterations of the PZT Y1B EMI responses.

Figure 6. The EMI response of PZT Y1B
