Long term monitoring of the Balladelaan bridge using smart Aggregates

ABSTRACT: The Balladelaan Bridge is a key bridge in the city of Amersfoort. The city has asked us to investigate the construction quality and remaining lifespan of this 5 span statically indeterminate cast-in-place concrete plate bridge, which was built in 1946. For this a pioneering long-term Structural Health Monitoring (SHM) initiative has been implemented in the form of a Field lab employing Smart Aggregates (SA's) using Coda-Wave Interferometry (CWI), augmented with extensive temperature measurements, and a short-term measurement using Acoustic Emission (AE) sensors. This study represents an extensive application of Smart Aggregates for continuous monitoring of a bridge's structural health over an extended period. The study aims to address the suitability of SA's for long term monitoring and accounting for environmental influences such as temperature and humidity on the wave speed in the concrete. Preliminary findings demonstrate a significant influence of temperature on wave speed readings, underscoring the necessity of temperature compensation in SHM analysis. After accounting for these environmental infl

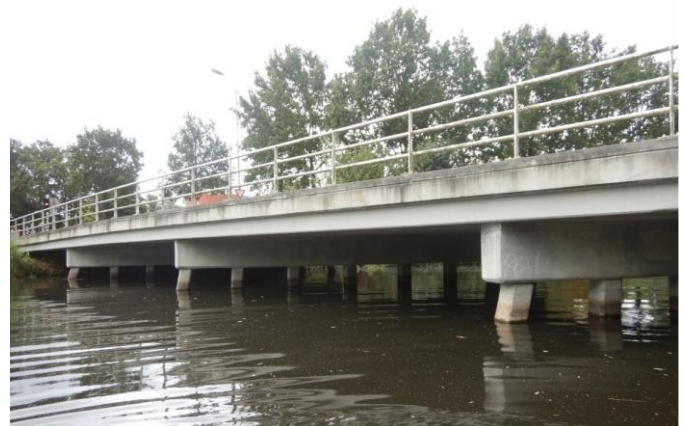
Figure 2-1 Side view of bridge (source: Google Streetview)

The bridge in the Balladelaan in Amersfoort was built in 1946. It is a cast-in-place concrete bridge with 5 spans, which together form a statically indeterminate deck system. The bridge has one bus lane (1 lane), a cycle path and a pedestrian path. The bridge was chosen for its suitability:

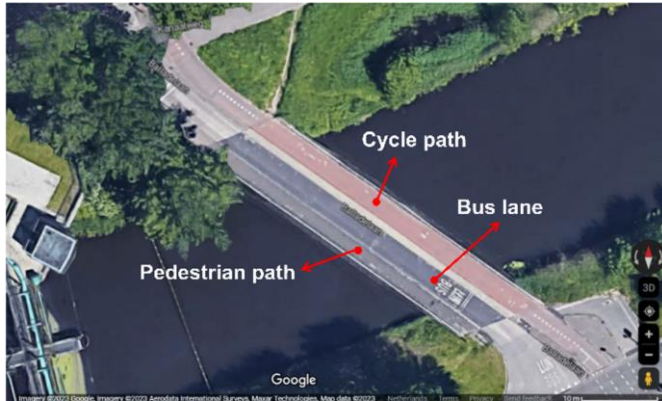
Figure 2-2 Top view of bridge (source: Google Maps)
