Master Thesis

Geological Conditions Favoring Extreme Scour of an Unlined Spillway at Ricobayo Dam, Zamora, Spain.

by Markus Kaspar

Graz, March 2012

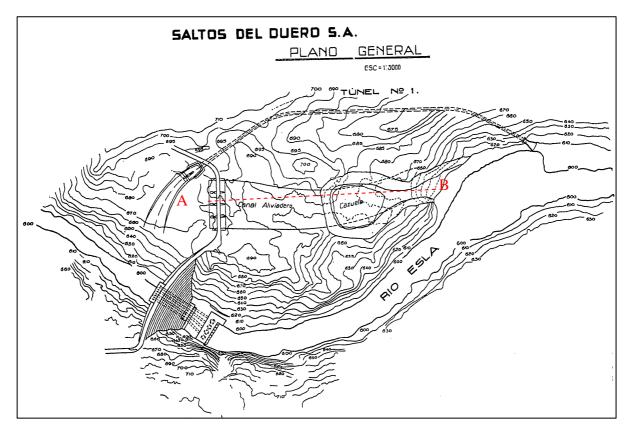
Fig.5 4: Map of the Ricobayo dam site showing the original topography of the area, the initial alignment of the spillway and the location of the consecutively formed plunge pool due to scouring. Scale 1: 3000. Section A-B is shown in Fig.5a. (modified after Rubio, 1940).

The asymmetric shape of the plunge pool could be explained by the initial curved alignment of the spillway on the right side. Here the slight curvature (Fig.5.4) created a point bar like feature to the flowing water, which attacked the right wall stronger than the left wall.

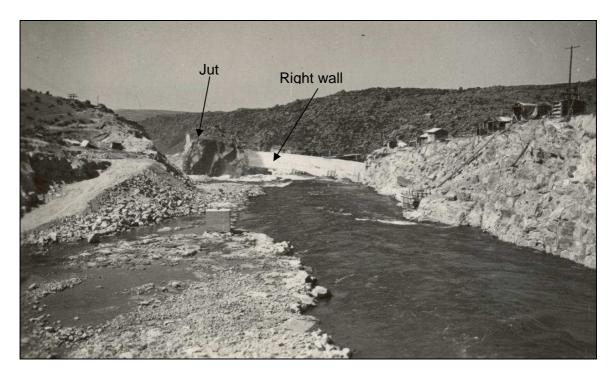
Fig.5 11: View downstream the spillway. The right curvature of the right wall at the end of the spillway was changed more to the middle of the plunge pool. The spillway surface was left unlined (Riesco Chueca, 2009).

- c) Construction of a steel concrete wall at the front slope of the spillway channel to stop the progressive advance towards the reservoir (Fig.5.12).

- d) Installation of a wall at the exit of the gorge to create a higher water level inside the plunge pool. This should provide a water cushion which allows the impinging water fall to dissipate its energy before reaching the bottom of the channel (Guia tecnica, 1997).

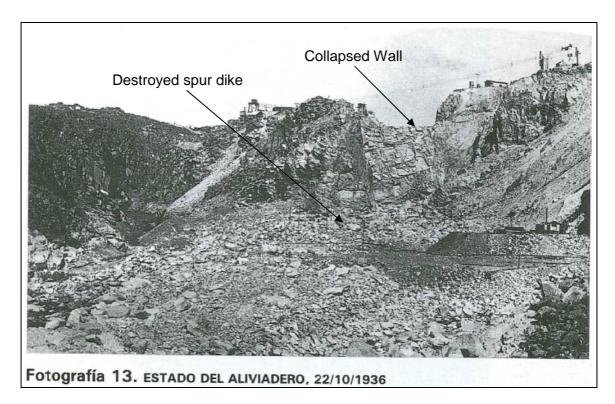
In winter of 1935/36 the plunge pool grew in diameter and depth, but no upstream regression occurred (Iberduero S. A., year unknown). At this stage the front wall collapsed, that had been constructed in summer of 1934 after the 2nd scour stage (Fig.5.15 & Fig.5.16). As a consequence upstream erosion was triggered again. Moreover the spur dike was destroyed. Up to 1280m³/s were discharged at this period (Annandale, 2006). Since the power station was already operating, the water table in the reservoir could be controlled to a certain extend over the intake making it not necessary to use the spillway.

Fig.5 15: Collapse of the front wall of the spillway. View upstream where the front wall and the spur dike were situated at. Note the huge amounts of crushed rock in the riverbed (Guia tecnica, 1997).

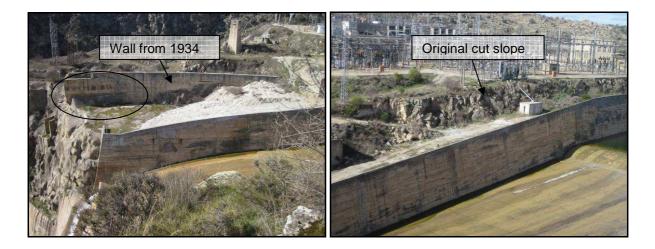
Fig.6 15: View to the right side of the spillway. End of the upper channel. The old wall is still visible in the back and was shifted towards the center of the spillway (left). Cut slope adjacent to the concrete wall of the spillway

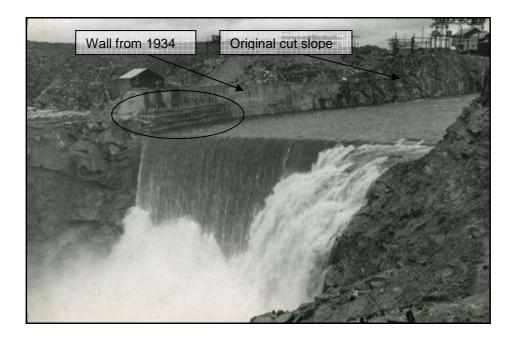
Fig.6 16: The original spillway from 1934. Note the slight curvature at the tip of the right wall to prevent the overtopping water to erode the right wall of the plunge pool (circle).

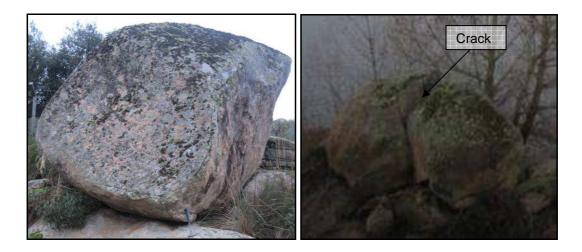
Some blocks exposed at the surface show spheroidal weathering features, which results in rounding of edges and corners. Also the upper few meters of the rock are subject to weathering and show therefore signs of strong discoloration due to iron oxide formation and disintegration. Single blocks are split in half (Fig.6.17). Some blocks are already isolated and, others are still in assemblage with the surrounding blocks showing initiations of spherical weathering where water can access the rock via joints.

Fig.6 17: Isolated blocks cropping out on the surface of the Ricobayo granodiorite. Both blocks shown above are weathered into a spheroidal shape. The block on the right is broken in half.

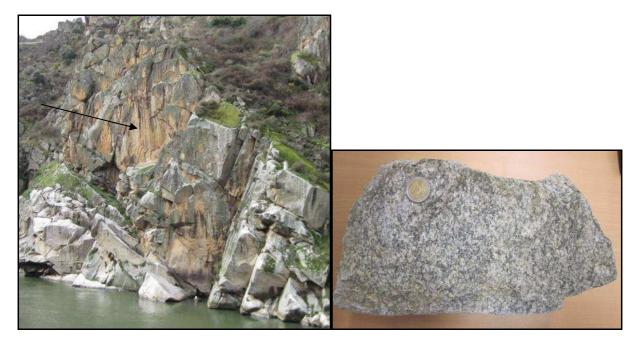
Fig.6 19: Outcrop of the granodiorite of Ricobayo with iron oxide altered surfaces(arrow) (left). Hand specimen of the granodiorite (right). The rock is mostly composed of Quartz (grey) and Plagioclase (white), Potash feldspar (reddish) and Biotite (black). 2€ coin for scale.

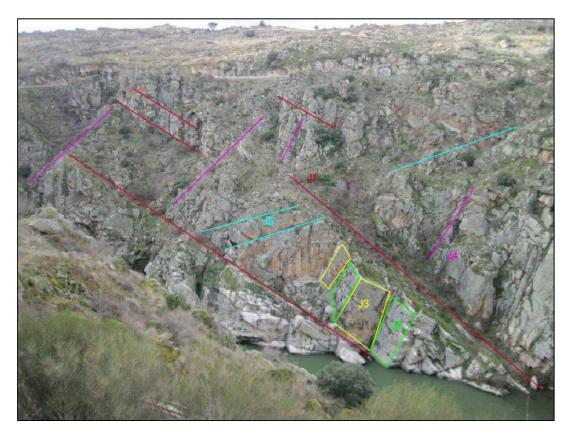
Fig.6 20: View to the right riverbank downstream of the dam, showing the appearance of the rock mass at the Ricobayo dam. Joint patterns of the five joint sets are illustrated. Numbers and colors correspond to the joint orientations in Tab.6.9.

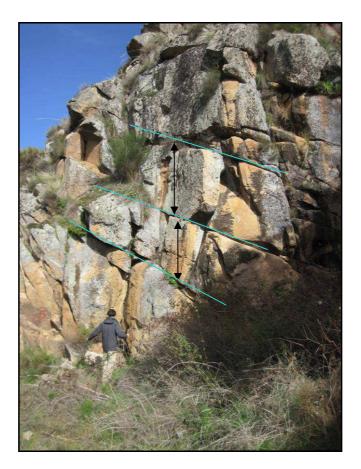
The joint spacing histograms are shown below for all sets together and for each set separately (Fig.6.21a-e). Only joint set one does not appear on this diagrams as it was encountered only once in the scanline survey. The data show that most of the spacing lies in the range of 0.2 to 2m with some up to 6m. The true spacing was determined from the scanline survey using Eq.6.1. Also the variation within the sets is not very strong implying that the resulting blocks formed by approximately equal spacing will be equidimensional (Tab.6.10). This is indeed confirmed by the general appearance of the rock mass on site, where blocky rocks are present (Fig.6.22).

Fig.6 22: Outcrop at the left side of the river. Intense jointing of the rock resulting in the formation of blocks. Spacing (arrows) is well visible in this picture. Lines indicate joint set 5. Person for scale in front.

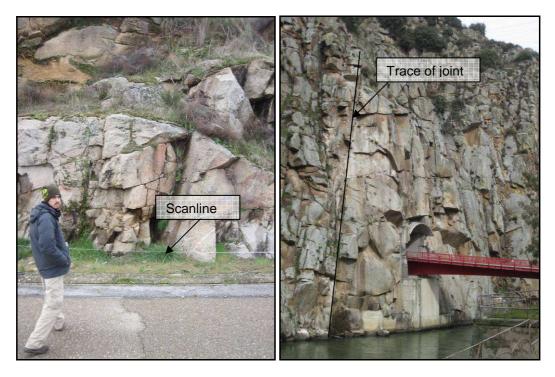
The outcrop situation also allowed only measurements or estimates, respectively, of the persistence in the apparent dip direction, but not along strike. The persistence at the scanline was considered as not representative, due to its small and scale and is therefore estimated by observations on a larger scale. (Fig.6.23). Although those areas had bad accessibility to directly measure the trace length, it could be estimated that the persistence was high to very high, in some cases over 100m. The observations of the persistence were combined with recording the type termination (Fig.6.24). The Termination Index (T_r) is estimated from these observations to get an impression of blockyness of the rock mass.

Fig.6 23: Outcrop situation at Ricobayo. Scanline along road cut (left). Estimates of the true persistence are difficult in this case. Large area of exposed rock along the river Esla right downstream of the dam (right). Some joints may be traced for more than 10 to 20m.

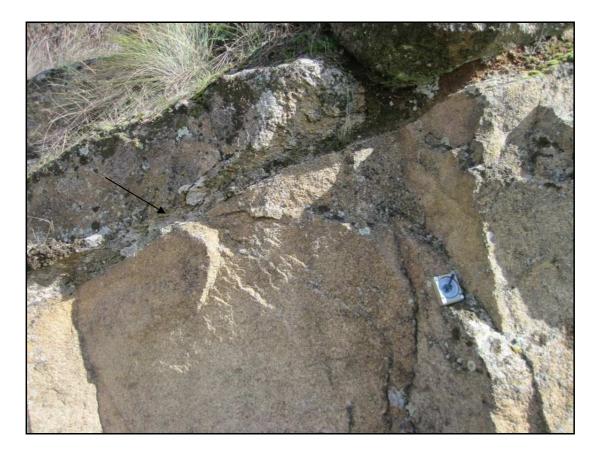
The joints at the investigated site are usually closed to gapped, in some cases open (Fig.6.30). Therefore filling is scarce or completely absent (Fig.6.31). Those joints that have material interfaces are typically characterized by a clayey to rock powder like material (Fig.6.32). Joints without filling are mostly characterized by surface staining. Few joints show minor water seepage.

Fig.6 32: Filling of joint (~3cm wide; arrow) along joint set 1. Slightly reddish discolorations on vertical rock wall. Compass for scale.

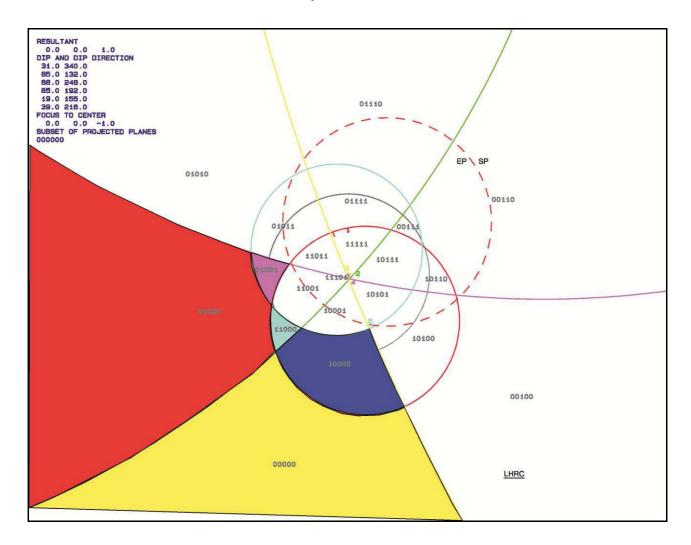
For the front slope 6 removable blocks have been identified. Eq. 7.10 also shows this. The JPs that are removable are highlighted in Fig.7.11.

Fig.7 11: Whole sphere stereographic projection for the front slope of the spillway at Ricobayo. The removable JPs are highlighted, slope (red dashed circle), reference circle (black circle). Orientations of joints (first 5 entries) and slope (last entry) are listed in the top left corner. The original slope orientation was estimated from old maps. The corresponding failure modes are shown in Fig.7.12.

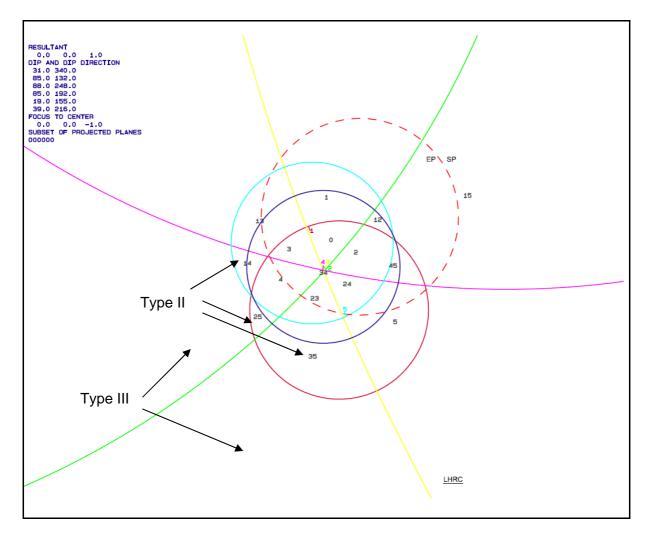
Fig.7 12: Failure modes for JPs shown in Fig.7.11. However, failure mode of a JP is distinct from the removability of a block. (note that some JPs that have a number assigned are not entirely within SP).

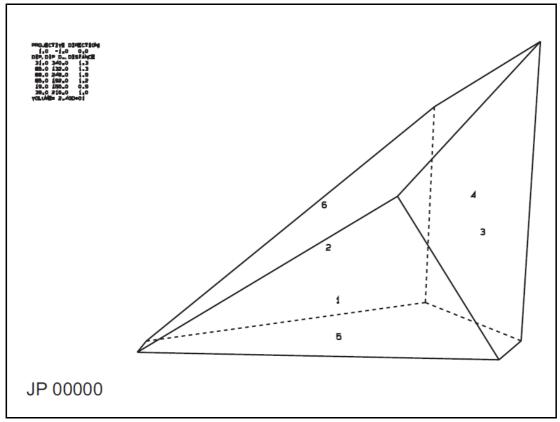
Fig.7 13: Shape of Block 00000. Numbers 1 to 5 indicate the joint planes, 6 the free surface.

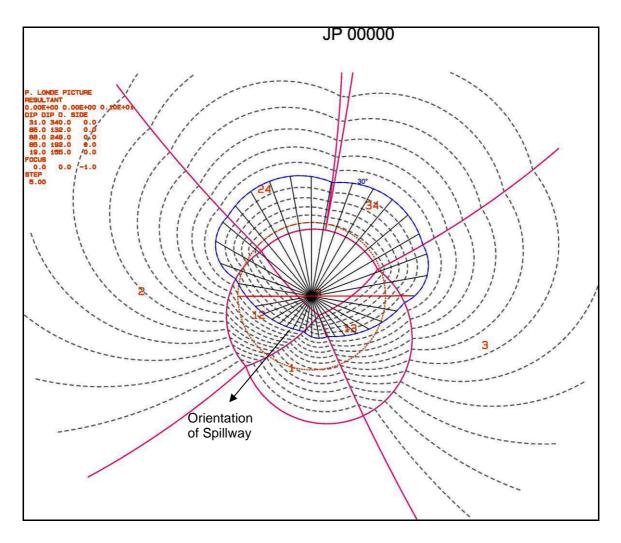
Fig.7 14: Compound friction cone for JP 00000. Blue line indicates the 30° friction line. Black dashed lines in 5° steps, reference circle shown as dashed orange circle. Orientation of spillway is indicated by arrow. The principle of obtaining the angles is shown in Fig.7.15 below, which is a cross section through the reference sphere along red line.

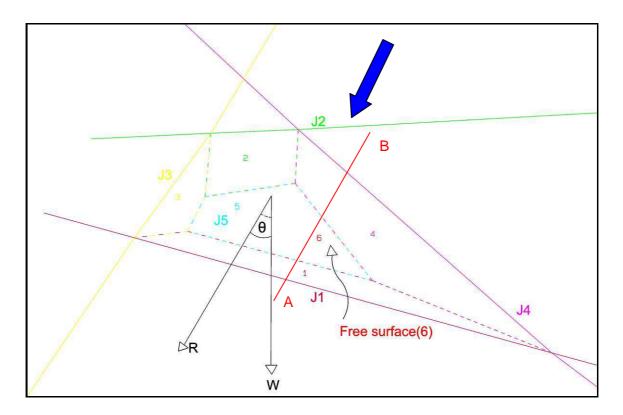
Fig.7 16: Block diagram showing Block 00000 on the spillway surface (6). J1 to J5 refer to the joints involved in forming the block. Blue arrow indicates direction of water flow. Red line AB indicates cross section shown in Fig.7.17. W (weight vector), R (Resultant after rotation), θ (Angle of rotation)

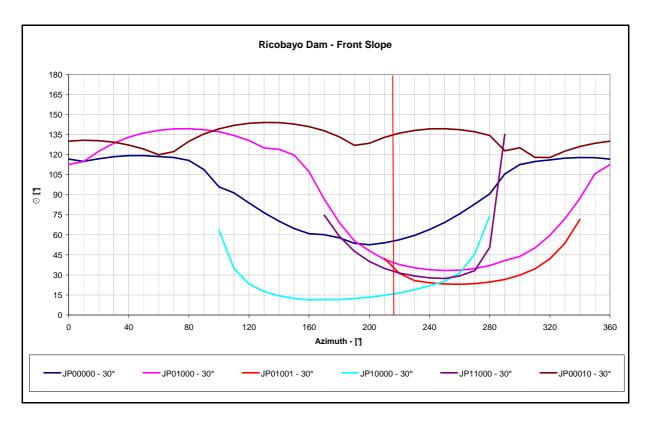
Fig.7 19: Block Erodibility Spectrum for the JPs of the front slope at $\phi = 30^{\circ}$. The spillway flow is oriented at 216 (vertical red line). Note that in this alignment the angle of rotation is close to its minimum for most blocks.

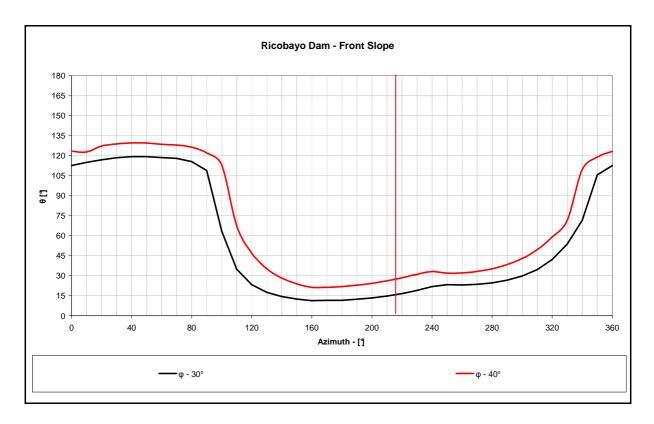
Fig.7 23: Block Erodibility Spectrum Envelope for the front slope for friction angles of 30° and 40°. Also here in the stability envelope it is visible how the angle of rotation drops to lower values in the orientation of the spillway at 216° (vertical red line).

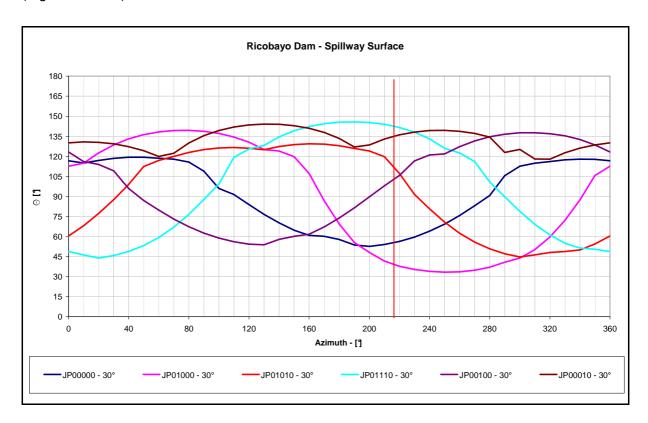
Fig.7 25: Block Erodibility Spectrum for the spillway surface. The minimum angle of rotation is not as critical as for the front slope. Vertical red line shows flow direction.

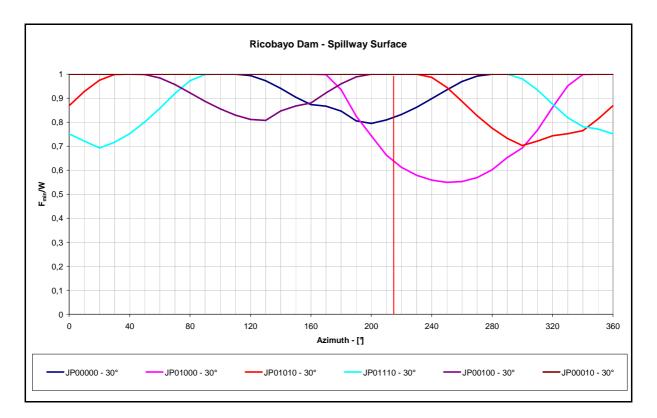
Fig.7 26: Block Erodibility Spectrum for the JPs of the spillway surface showing ratios of weight of individual blocks vs. the F_{min} at different azimuth orientations. Much more force is needed to mobilize blocks here than on the front slope. The spillway flow is indicated by vertical red line.

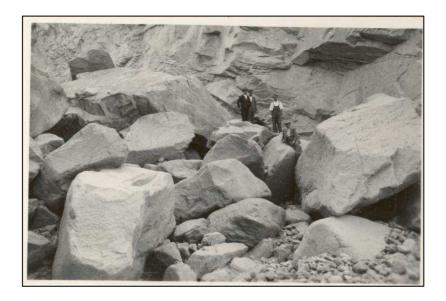
In the first scour stage in 1933, the inclined front slope started to develop rapids and cascades of its exposed blocks (Fig.8.2). Removal of near surface blocks commenced, leading to steepening and upstream migration of the slope via headcutting. Headcutting continued in scour stage 2 until the front slope, which turned into a head wall at that time, was protected with concrete. From the joint pattern observed in the field and removability analysis it can be concluded that blocks were activated along J4 and J5.

Fig.8 1: Photograph showing the size of scoured blocks after scour stage 2 in 1934.

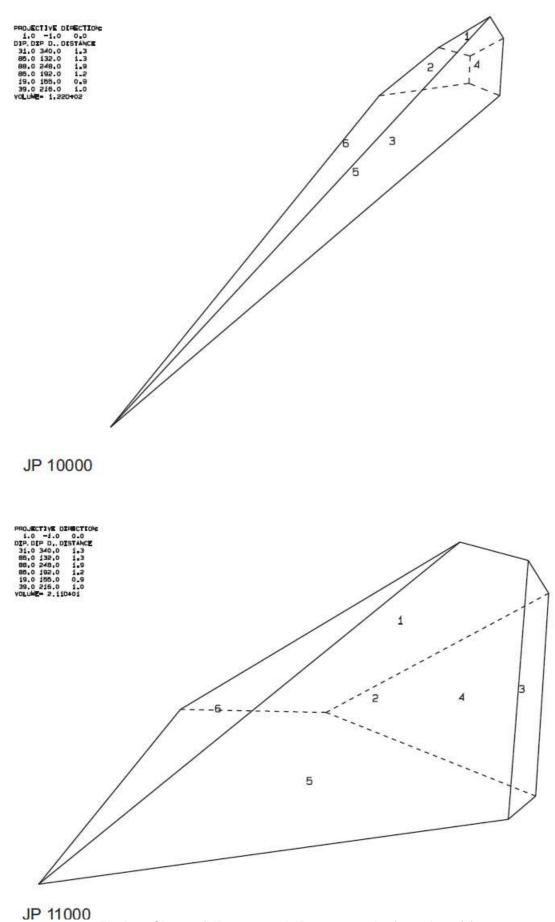
Fig.A27: Shape of JP10000 and JP 11000 on the front slope (6)

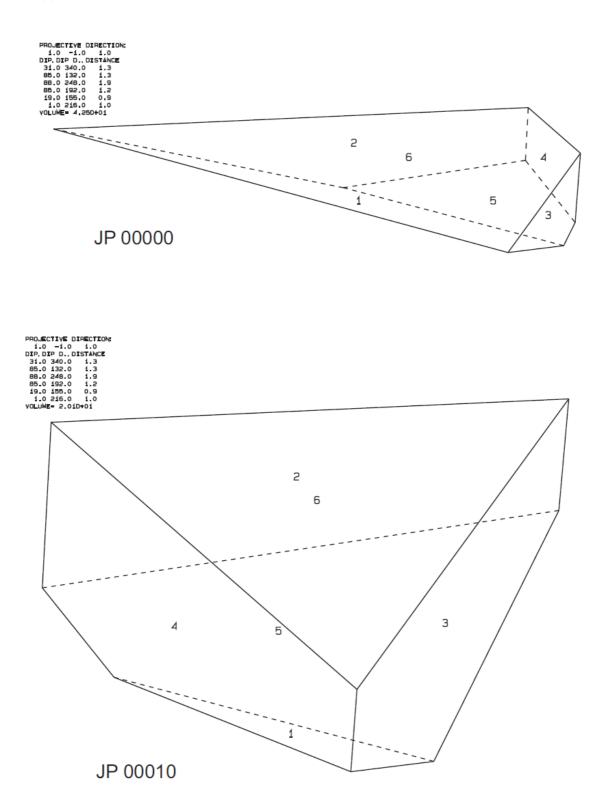
Fig.A28: Shape of JP00000 and JP 00010 on the spillway surface (6)

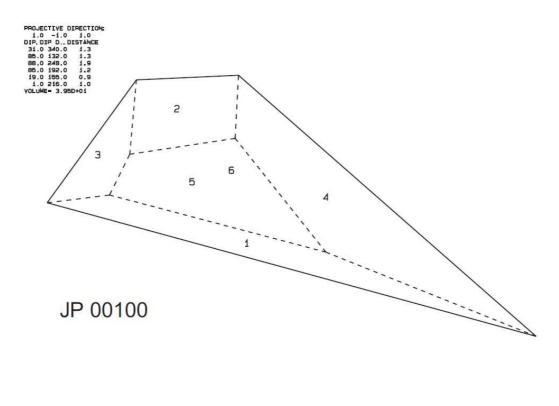
Fig.A29: Shape of JP00100 and JP 01000 on the spillway surface (6)

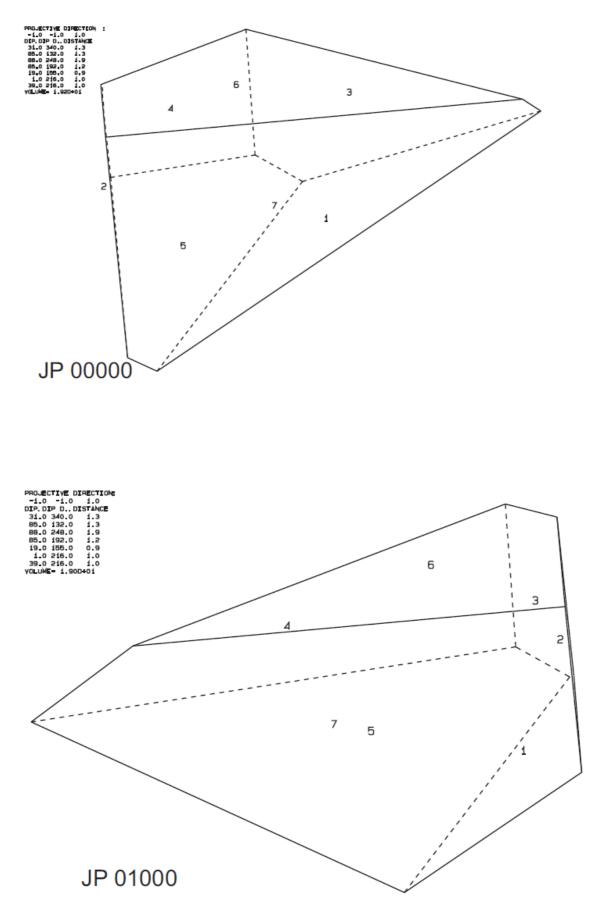
Fig.A31: Shape of JP00000 and JP 01000 on the compound slope (6+7)

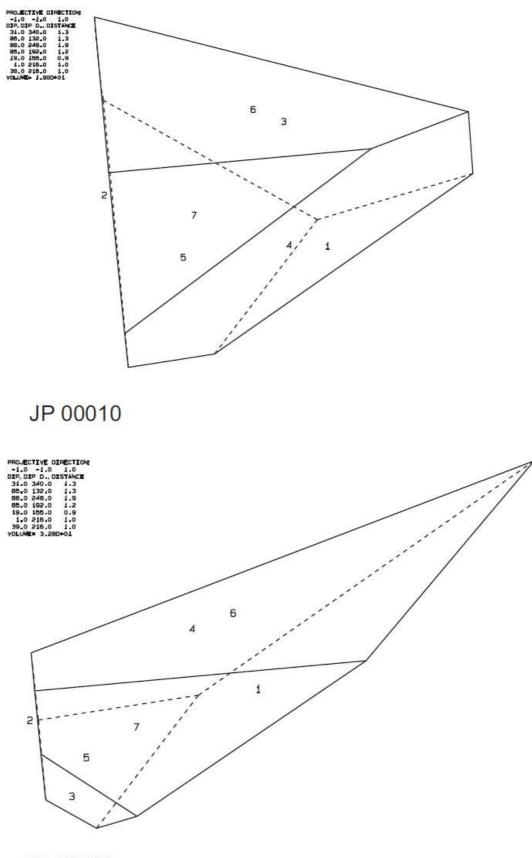
Fig.A32: Shape of JP00010 and JP 00100 on the compound slope (6+7)
