STAMP Modeling of the Accident

N4252G

MASTER'S THESIS to achieve the university degree of
Master of Engineering

Master's Degree Program: Traffic Accident Research - Aviation Safety

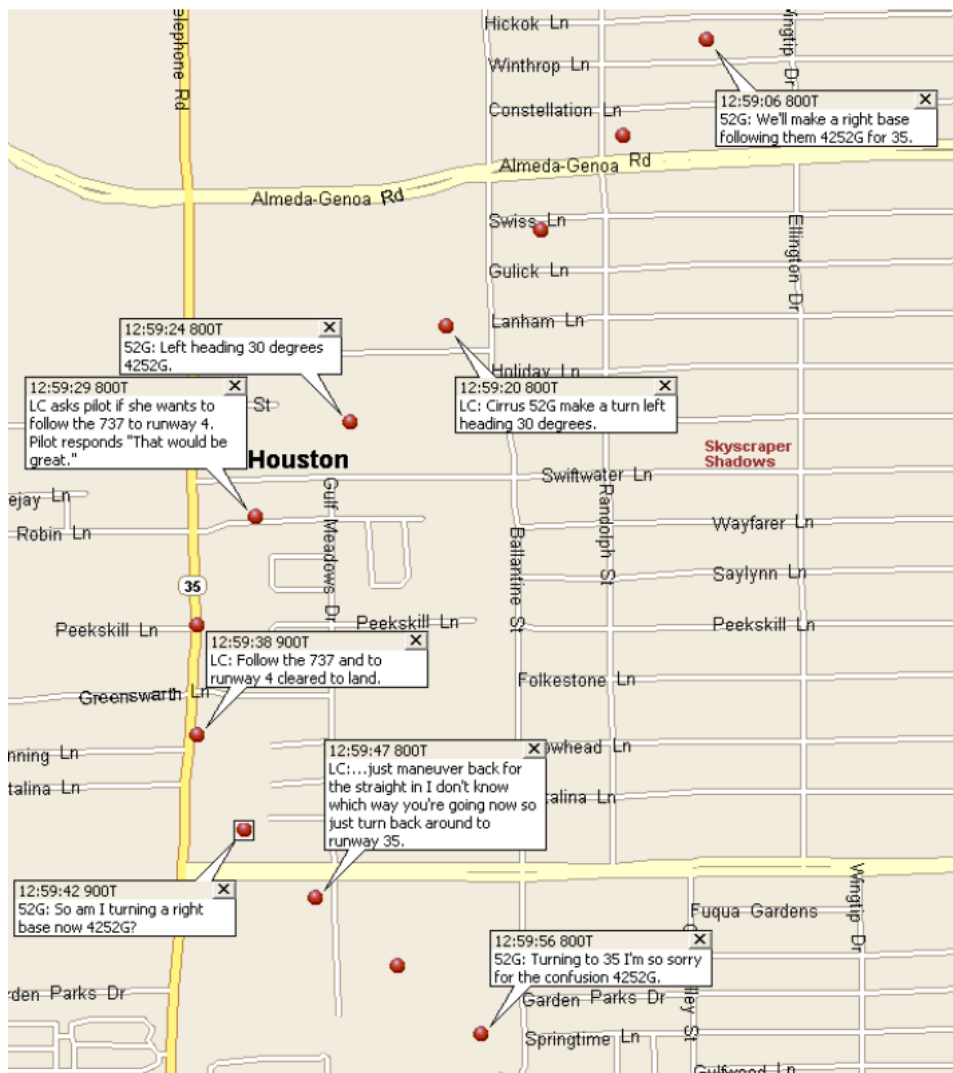
Figure 2-4 Continued pattern maneuvers

The detailed analysis of the flight data and the graphical presentations of the flight track with the associated ATC transcript in Figure 2-4 and the graphical presentation of the aircraft's flight parameters in Diagrams 2-7 (12:58:55 - 13:00:06 CDT) and 2-8 (12:59:05 - 13:00:00 CDT) for the continued pattern maneuvers of N4252G were analysed in detail.

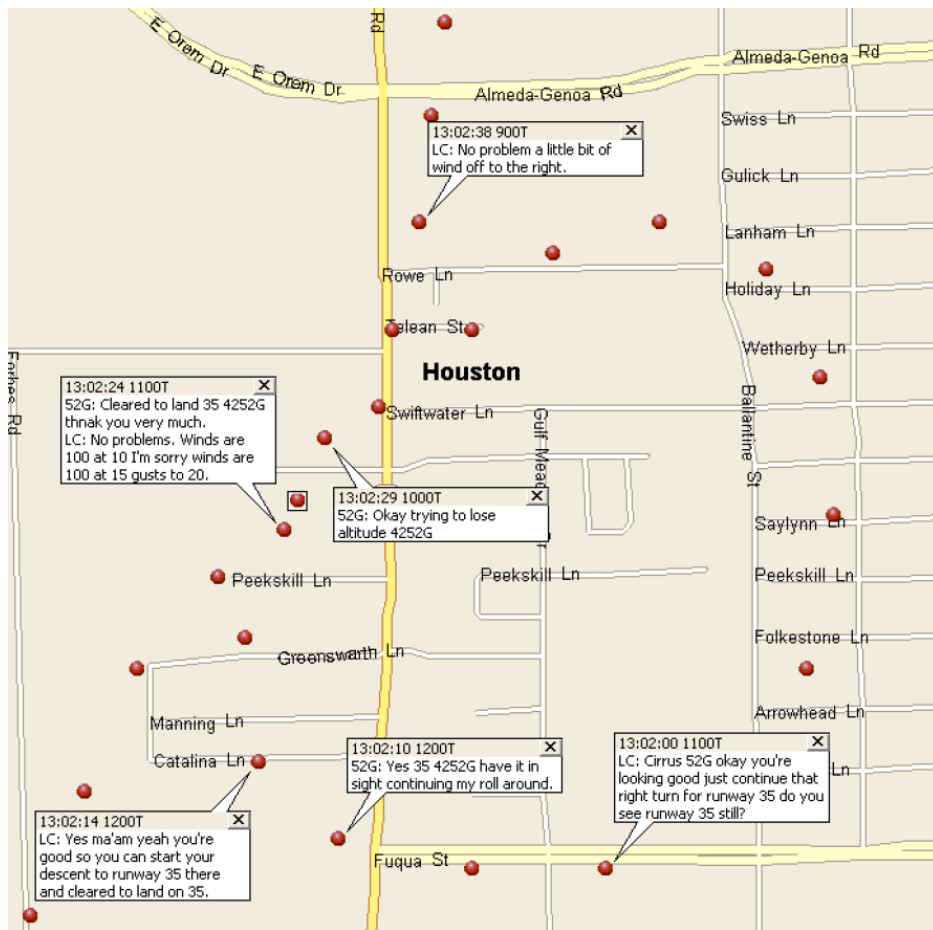
Figure 2-7 Setting up for initial straight-in approach to runway 35

The flight data and the graphical presentations of the flight track with the associated ATC transcript in Figure 2-7 and the graphical presentation of the aircraft's flight parameters in Diagrams 2-13 (13:01:42 - 13:02:54 CDT) and 2-14 (13:01:52 - 13:02:52 CDT) for the setup of N4252G for the initial straight-in approach to runway 35 were analysed in detail.

At 13:02:24 CDT, the power was reduced to idle within 5 seconds. Simultaneously, ATC advised the landing clearance and the actual wind of 100 degrees at 15 kts with gusts to 20 kts for runway 35. According to the Cirrus Envelope of Safety (refer to L Appendix, Figure 6-3 Envelope of Safety), the reported wind was exceeding¹⁰ the personalized x-wind limit (wind limit 15 kts, x-wind limit 5 kts, maximum gust 5 kts) according to the Pilot's Capability Category (for details, refer to D Appendix).

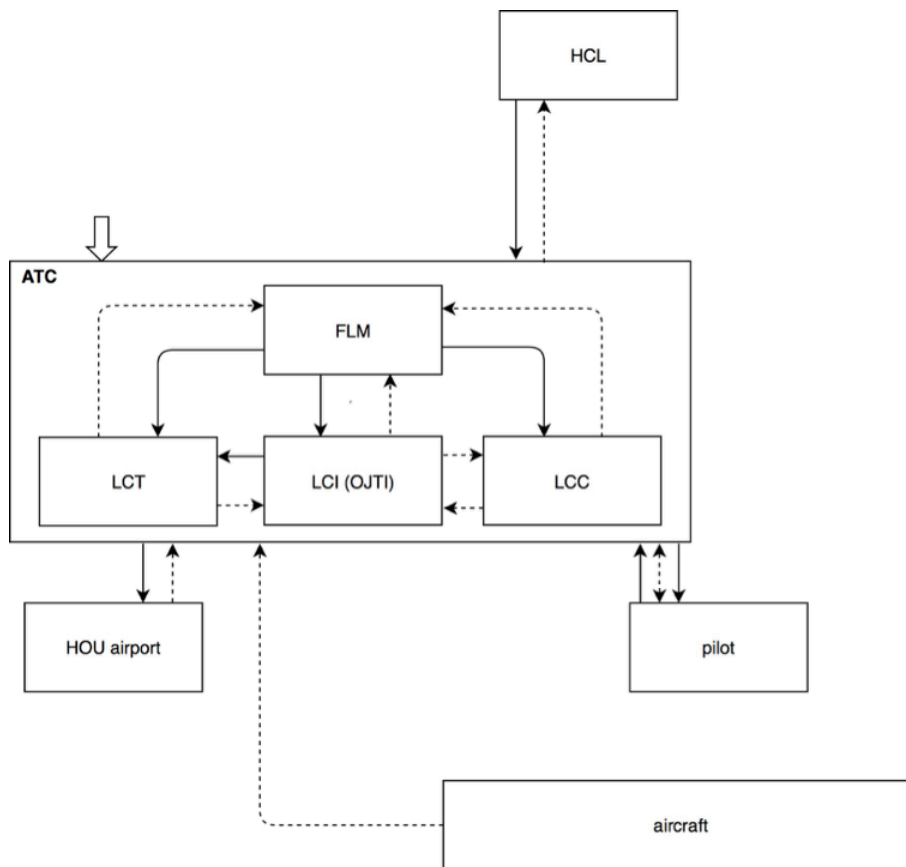
Figure 2-16 ATC - simplified control structure

ATC - CAST analysis				
Unsafe control actions	Dysfunctional interactions	Contextual factors	Safety constraints	Questions raised
	The FLM stated that communication throughout the facility in HOU had required improvement.			[QR-10] Which communication processes at the HOU ATC Facility require improvements?
		Reduced number of controllers, as one of the controllers assigned to the shift had been medically disqualified and another controller had already been approved for his annual leave. The activity level placed the facility right in the middle of the ATC 8 levels.	[SC-18_ATC] It must be assured that a minimum number of ATC controllers is available to avoid any degradation in aviation safety [H-7, H-8].	
	The LCT was not sure why the OJTI had taken over the frequency instead of just having him issue the clearance.	The frequency was handed over a few times between the LCT and the OJTI (LCI).	[SC-19_ATC] Operations with ATC trainees being supervised by ATC instructors must follow clear and consistent procedures [H-7, H-8].	[QR-11] Was peer pressure influencing the communication between the ATC trainee and his instructor?

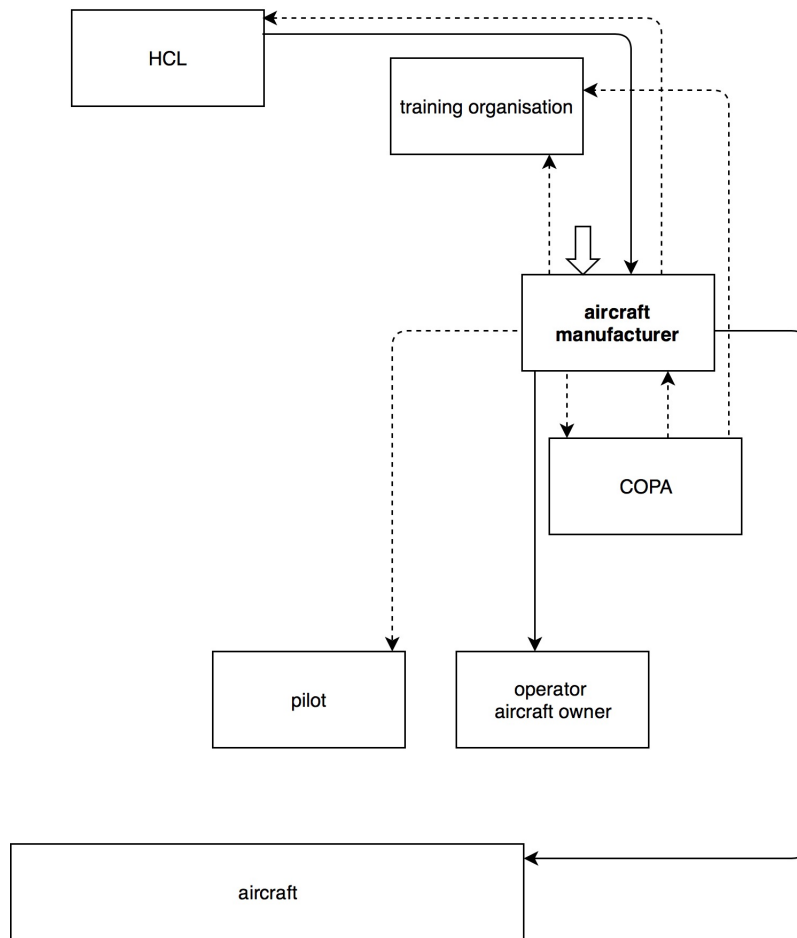
Figure 2-17 Aircraft manufacturer - simplified control structure

Aircraft Manufacturer - CAST analysis				
Unsafe control actions	Dysfunctional interactions	Contextual factors	Safety constraints	Questions raised
		The POH in Version A1 has been valid and unrevised since December 29, 2015.		[QR-21] What schedules the issue of new POH revisions?
[UCA-9] "The only approved and demonstrated method of spin recovery is activation of the CAPS" (POH-SR20, 2015, p. 3-28). Possible alternative procedures for spin prevention/ recovery are not provided in POH, resulting in limited mental process models for the pilot in case CAPS is not activated/ available.				[QR-22] What is the alternative procedure for pilots if the CAPS system cannot be activated in case of an unintended spin?

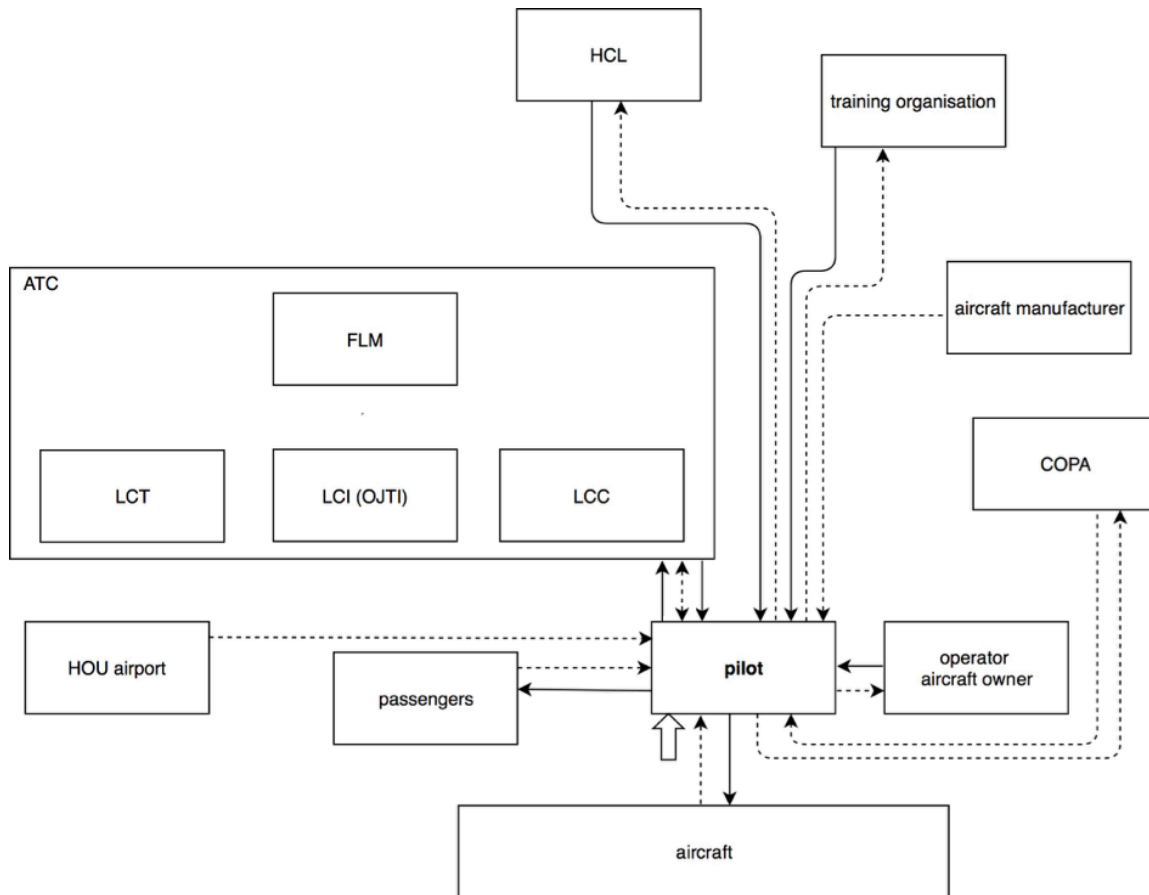
Figure 2-21 Pilot - simplified control structure

Pilot - CAST analysis				
Unsafe control actions	Dysfunctional interactions	Contextual factors	Safety constraints	Questions raised
		Pilot's general experience on the type and other types of aircraft. Note: The prevailing documentation does neither state details referring to pilot's flight hours/ landings (flight hours within the last 12 months, pilot's landings in total/ within 12 months/ within 3 months) nor to experiences on various types.		[QR-31] What are the details concerning the accident pilot's types of aircraft flown, flight hours and landings.
		Proper flight preparation. Note: No documentations about the flight planning package was found.		[QR-32] Did the pilot have a flight planning package including weather forecast and NOTAMs?

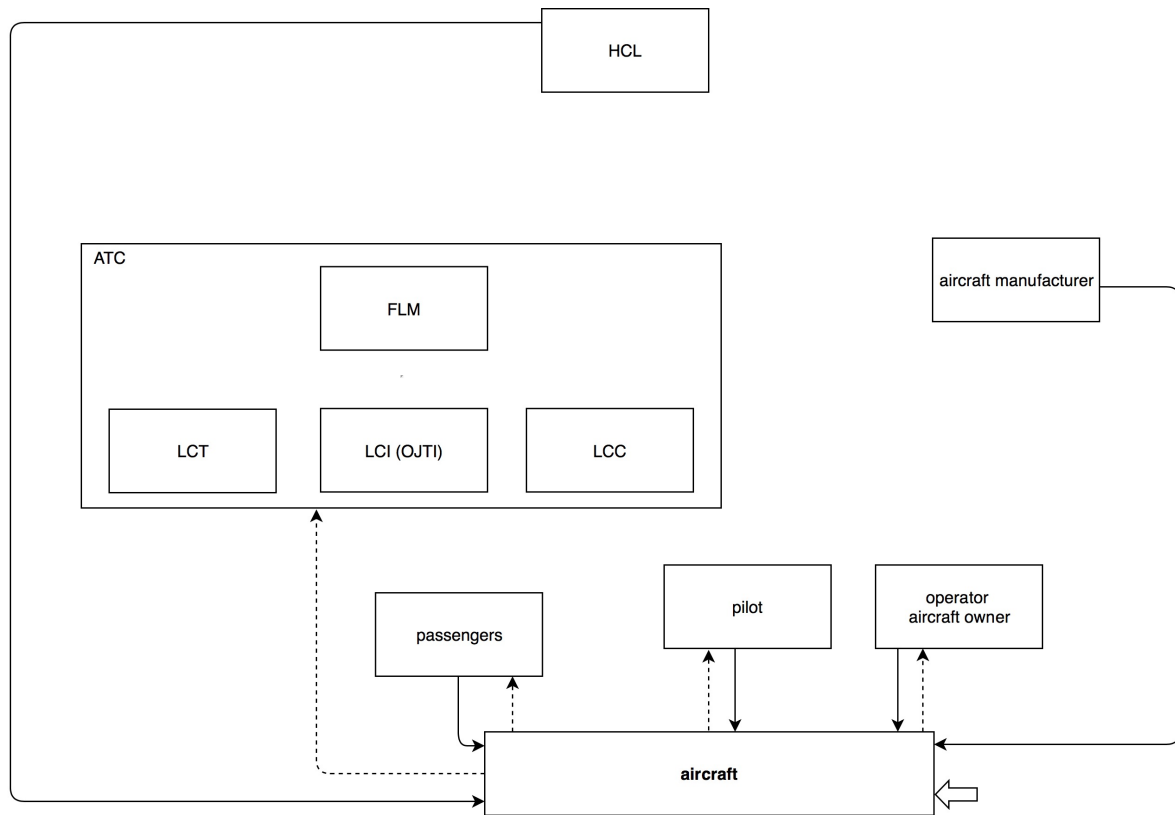
Figure 2-23 Aircraft - simplified control structure

Aircraft - CAST analysis				
Unsafe control	Dysfunctional interactions	Contextual factors	Safety constraints	Questions raised
[UCA-33] The stall warning system was neglected by the pilot, which resulted in further deceleration and actual stall of the aircraft.				[QR-59] Was the stall warning system functionable on the accident flight? [QR-60] Was the pilot aware of aerodynamic aircraft reactions when approaching stall conditions?
	Safe airspeed control was not achieved.	The inability to read the primary flight information data from the cockpit annunciations may lead to exceedances of the approved flight envelope.		[QR-61] Was there any failure of the primary flight displays logged by the RDM? [QR-62] Did the primary flight display fail or get in an unreadable condition? [QR-63] Did the accident aircraft have alternate indications of the primary flight information (speed, altitude, attitude)?
