**Engineering geological and geomechanical analysis of a rock
slope in the Ödenwinkelkees – Focus on the determination of the
discontinuity network and its characteristics**

Master's Thesis

Graz University of Technology

Graz, March 2021

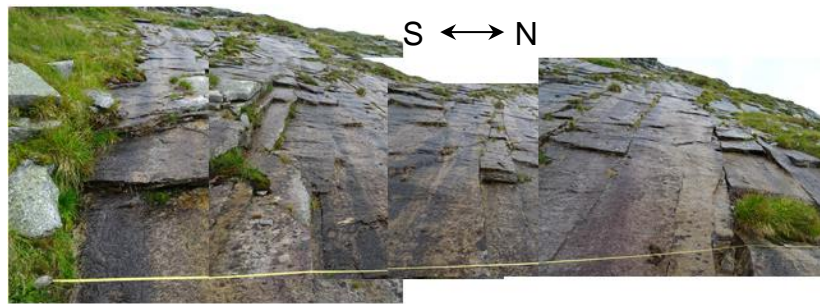
Figure 34 Set up of Scanline 4

During scanline mapping 4 joint properties of the roughly east-west striking, steeply dipping joint set is determined. 13 joint planes cross the scanline with a length of 10.5 m and the spacing varies between 0.1 and 1.55 m. The joints are persistent or intermittent as the joint plane surface is often stepped. The aperture varies between 1 and 10 mm.

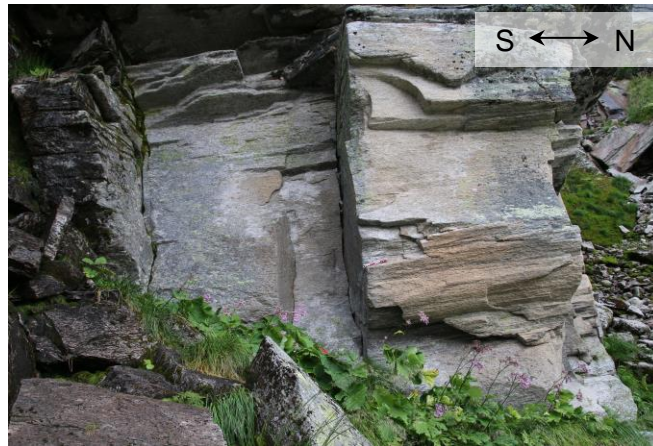
Figure 37 Outcrop at scanline 1.

The outcrop of scanline 1 is displayed in Figure 37. Properties of the vertical joint planes are determined using this scanline (in Figure 40 defined as Set 2). Five joint planes cross the scanline. The spacing varies between 0.3 and 2.1 m. The mean set plane orientation is 345/86. The joints are persistent, wavy, and rough as they often are stepped. Aperture was recognizable to be between 2 and 10 mm.

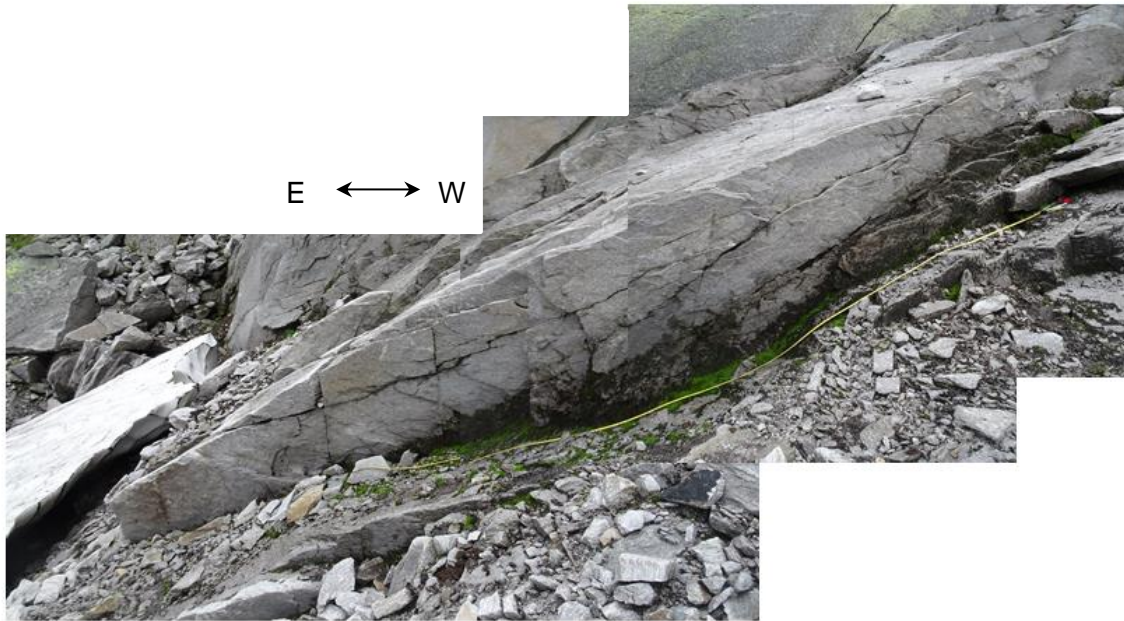
Figure 43 Set up of scanline 5.

In Figure 43 a photograph of the outcrop of scanline 5 can be seen. The scanline mapping aimed to characterize the steeply dipping joints roughly striking north-south (later defined as JS4). Seven joint planes cross the scanline with a length of 7.6 m and the spacing varies between 0.6 and 2.1 m. The mean orientation of the joint planes is 281/86. The joints are persistent as they run across the whole outcrop, which has a height of 2 m. The joint surface is planar.

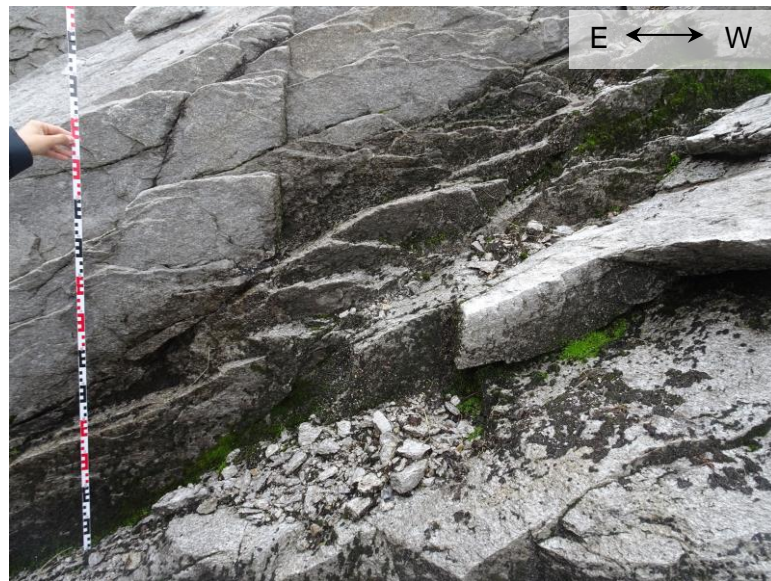
Figure 44 Setup of scanline 6, which is vertically oriented.

In Figure 44 the setup of scanline 6 is illustrated. The scanline is vertically oriented and therefore aims to characterize the joints, which run parallel to the ground surface. The scanline has a length of 1.25 m and the spacing of the joints varies between 0.15 and 0.5 m. The mean orientation of the joint set is 086/36 and the joints are persistent and are wavy.

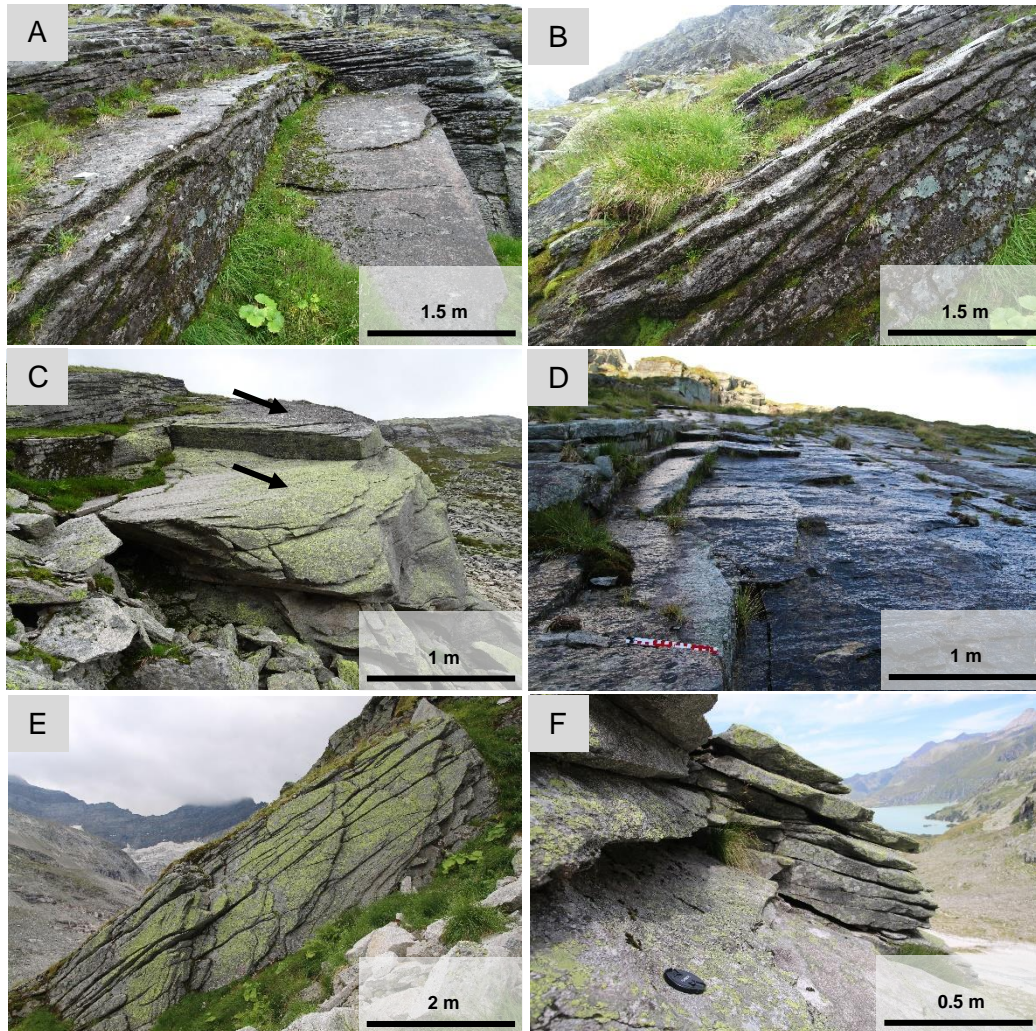
Figure 47 Photographs of Joint Set 1 characteristics.

Joint set 1 is moderately dipping to ENE with a mean dip direction and dip of 078/31. The joints are parallel or nearly parallel to the ground surface of the valley. The spacing is relatively low with a few cm to 0.3 m (Figure 47 A, B and F) and it seems to decrease while getting closer to the surface. The persistence ranges between a few decimetres. After visual assessment, the persistence can be up to 30 m (Figure 47 D). The joint set is therefore very persistent. The joint surface is curved (Figure 47 A), has a high roughness and is undulating in a cm scale. Aperture between the joint surfaces is often visible with a length of up to 1-2 cm. Most surfaces are weathered, but some fresh surfaces could be detected were planar

sliding probably just exposed the rock surface (Figure 47 D). At some locations, water flow through the joints is recognizable. JS1 is the most frequent joint set and therefore very dominant in the landscape scenery. The joints cut most other geological structures and seem to have a high impact on the landscape evolution.

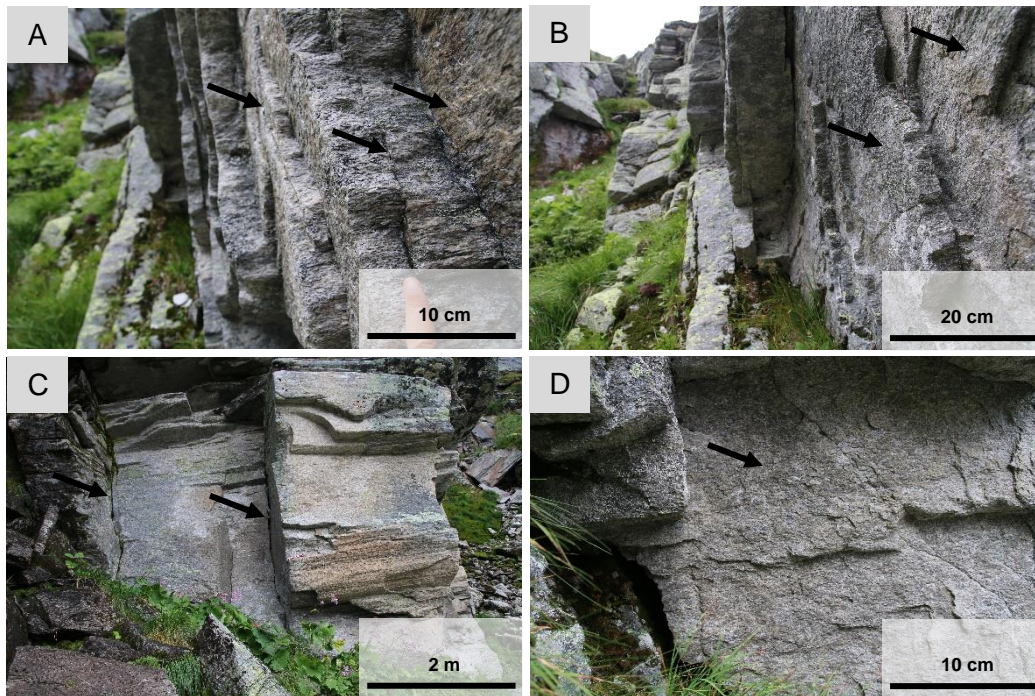
Figure 48 Photographs of Joint Set 2 characteristics.

Joint Set 2 is perpendicularly oriented to the valley axis (and JS 1) and steeply dipping with a mean dip direction and dip of 190/89. The persistence ranged between a few decimetres to 15 m. After visual assessment, the persistence can reach up to 40 m. The spacing is very variable. Sometimes the set occurs in clusters of several joints with an interval of a few cm (Figure 48 A), but in other locations a single joint is recognizable with a spacing of 2 m (Figure 48 C). The surface is rough and often stepped (Figure 48 D). The joint surface is weathered and often covered with lichens. The aperture is variable in a range of 1 mm (Figure 48 A and B) to 1 cm (Figure 48 C). JS2 also (like JS1) cuts most of the other

geological structures. Further, water flow through the joints was noticeable in some locations.

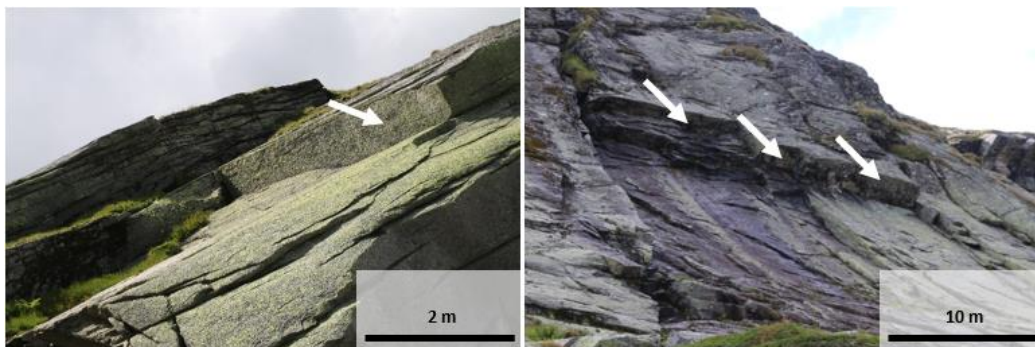
Figure 49 Photographs of Joint Set 3 characteristics.

Joint Set 3 has a mean dip direction and dip angle of 259/33 and is oppositely oriented to JS1. The fracture surface has a lower roughness compared to the other joint sets. It is also less persistent, and the aperture is small (approximately 1 mm). Compared to JS1 and JS2 the joints are not curved and JS3 is generally less frequent. The measured spacing is between 0.5 to 1.5 m. The joints are terminating mostly into other joints. This joint set was less prominently recognizable and therefore less fractures were measured. Not enough measurements of spacing and persistency were made to be able to consider these as representative. After visual assessment, the spacing is assumed to be up to 5 m.

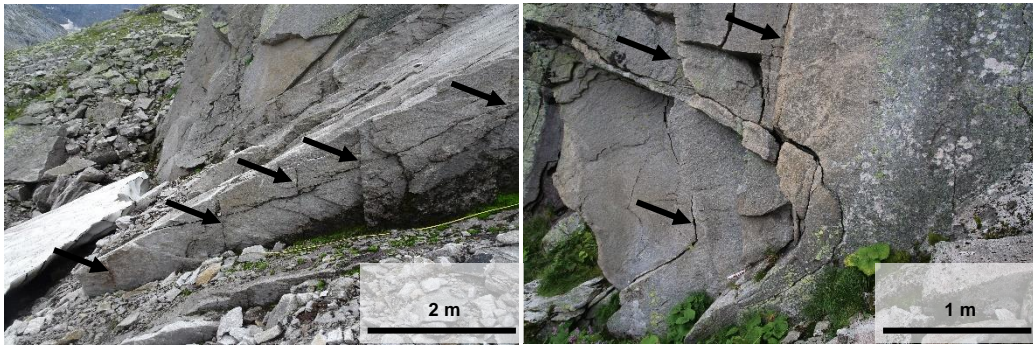
Figure 50 Photographs of Joint Set 4 characteristics.

Joint Set 4 is parallel to the valley axis and steeply dipping to NNE. The mean dip direction and dip is 276/81. The persistence ranges between 0.1 m to 1.5 m and termination of the joints is either obscured or in another joint. The spacing varies from 0.1 to 2 m. The surface is planar and slightly rough. Aperture was visible and ranged between 1 to 10 mm. This joint set was only at some rock exposures noticeable, also because of its orientation parallel to the valley axis.

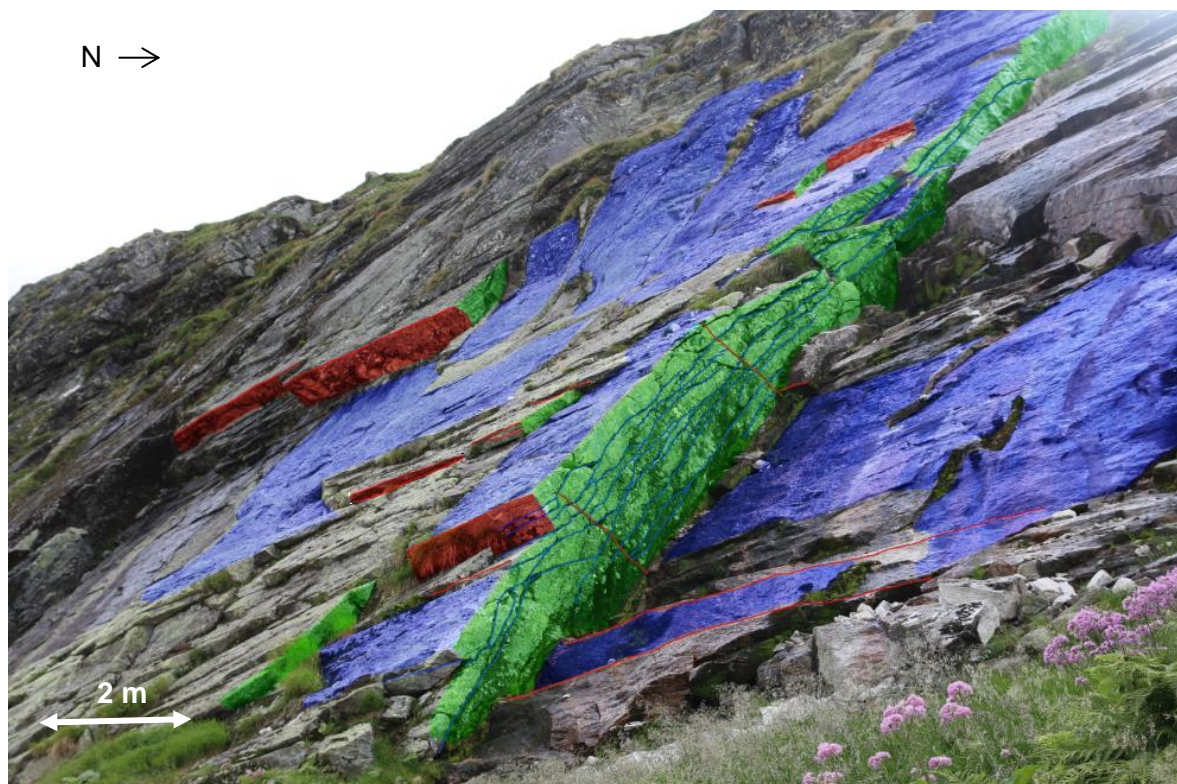
Figure 52 Local pattern of Joint Sets displayed in the 3D plot (same color).

In Figure 52 a slope facing NEE is displayed. The location is marked (red dot: P1) in the map of Figure 30. JS1 (blue) is the most dominant joint set, running roughly parallel to the ground surface. The curvature and the stepped joint surface can be seen on the photo. The joints are cutting the rock mass in elongated rock slabs, which are irregularly shaped. JS3 (red) includes more planar joint surfaces and is less frequent. JS2 (green) is cutting the joint sets perpendicularly. JS1 and JS2 are very persistent with up to 50 m. The lowest spacing corresponds to JS1 with an average length of 10 cm. The spacing of JS2 is on average a bit larger with around 1 m.

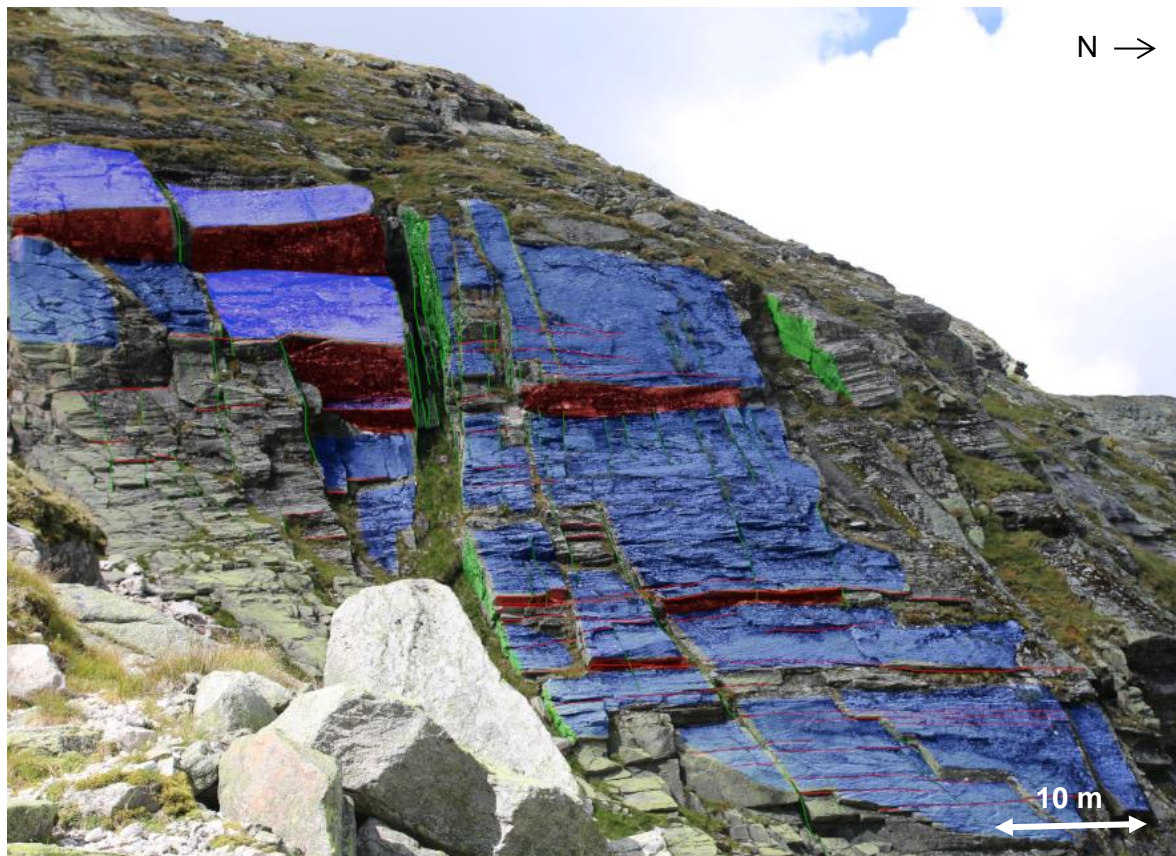
Figure 53 Photographic analysis of the joint network.

The slope shown in Figure 53 is marked in the map (P2) in Figure 30. It is located further south and closer to today's glacier, facing east. The landscape scenery is dominantly embossed by JS1 (blue) and JS2 (green) with JS1 forming the cross-profile shape of the valley and JS2 cutting the rock mass vertically. Many steps are recognizable on the surface of JS1. Changing frequency of JS2 can be noted with higher frequency in the middle part forming thin vertical layers. The frequency is decreasing in the direction of both sides.

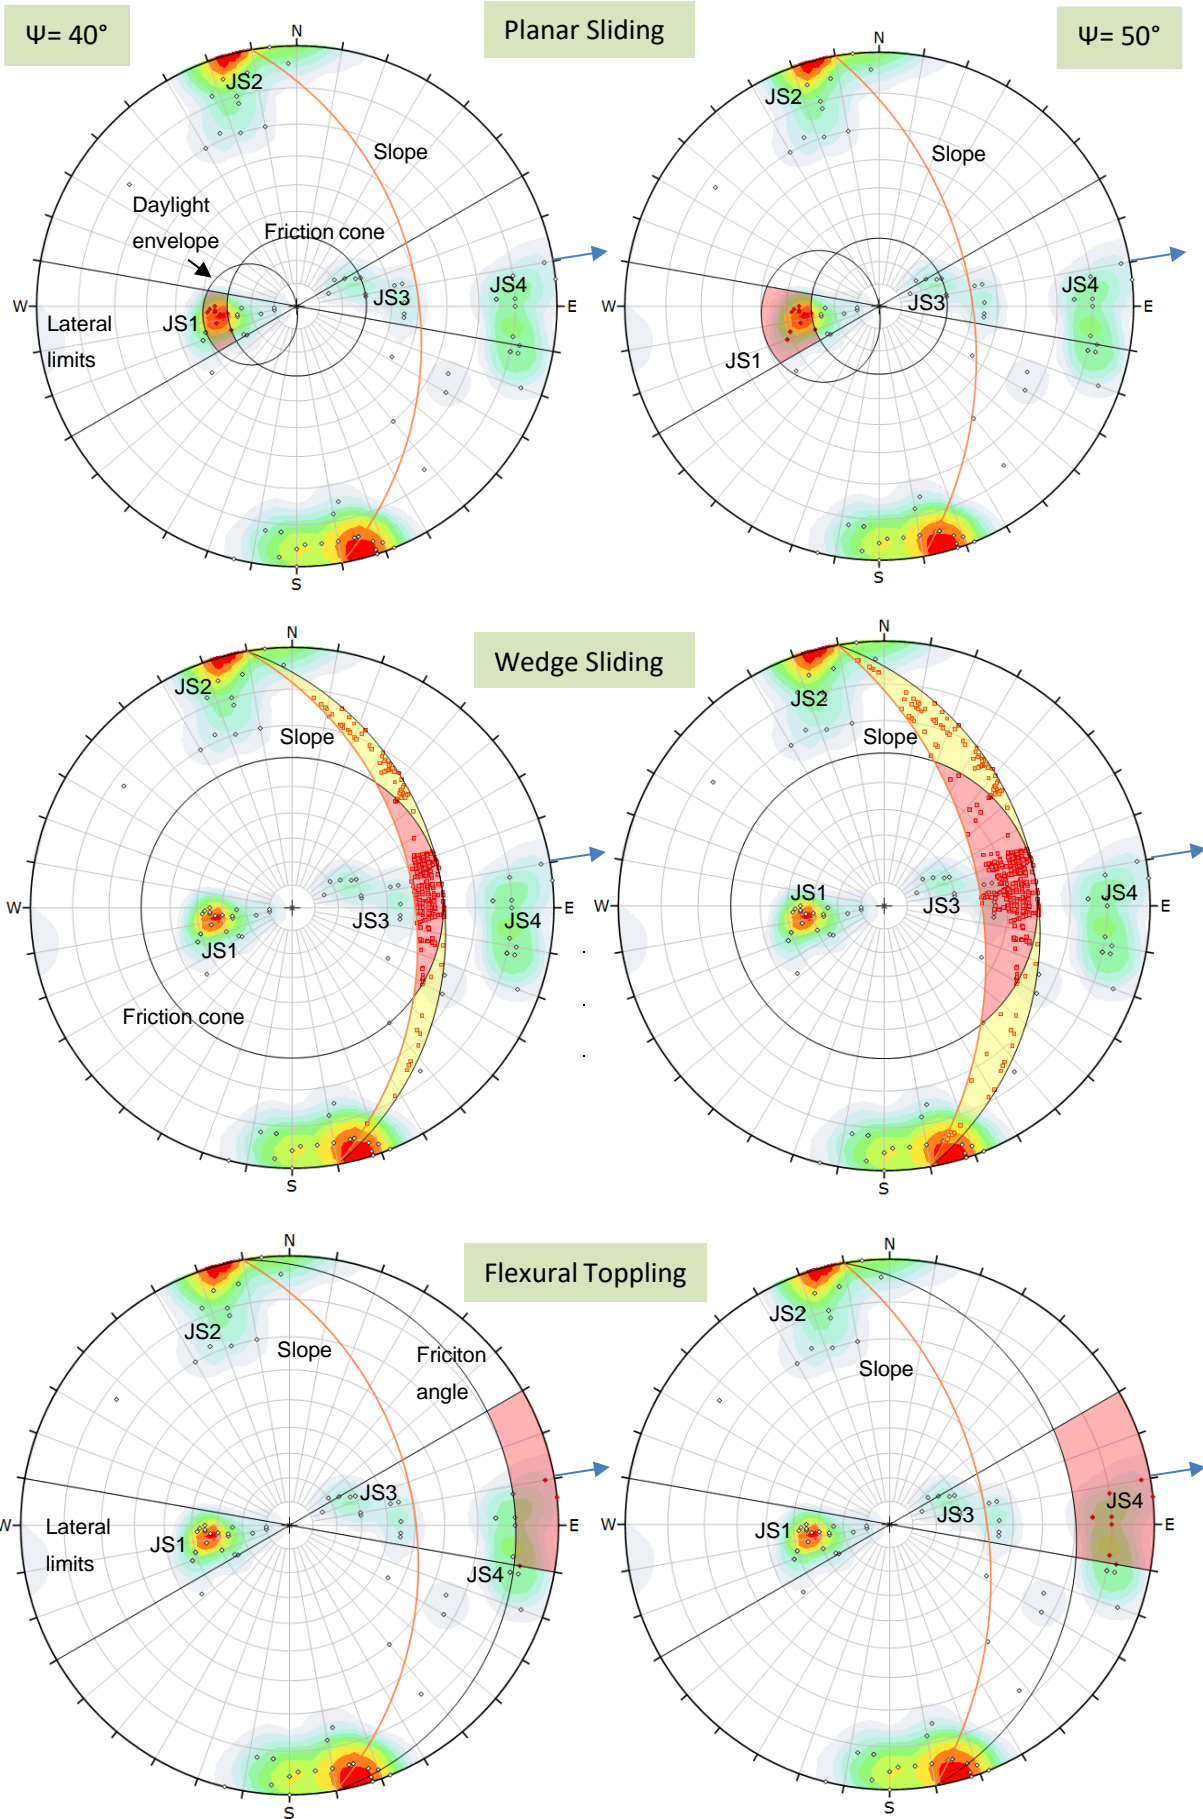
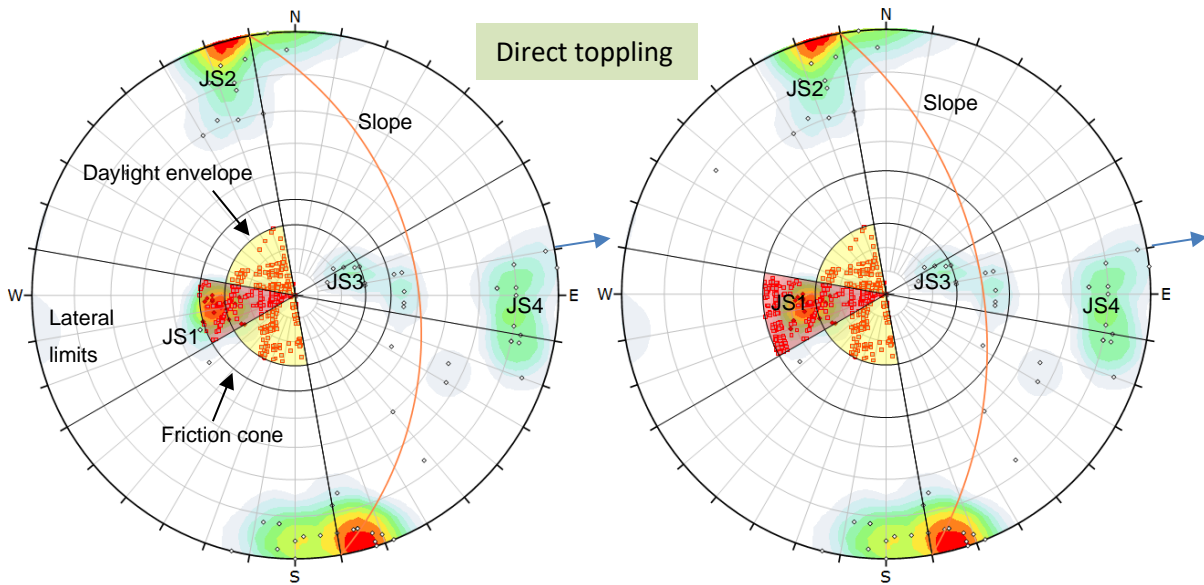
Figure 57 Kinematic analyses. With a slope dip direction of 80° and dip angle of 40° and 50° . A friction angle of 30° and lateral limits of 20° is assumed. The projections are lower hemisphere and equal angle. Critical zones are highlighted. The direction of movement is marked with the blue arrow.

Table 9 shows that there are no critically oriented discontinuities for planar/wedge sliding and flexural toppling with an average slope angle of 30° . For direct toppling 4.86 % of the discontinuities are critically oriented. JS1 builds the base plane and 11.76 % of its discontinuities are critically oriented. Assuming a slope dip of 40° the number of critically oriented joints is increasing. For planar failure it is 10.59 % and only discontinuities of JS1 are critical base planes. Under the assumption of a slope dip of 50° it is further increasing with a maximum of 15.29 %. For wedge failure the critically oriented discontinuities are increasing by 13.05 % using a slope angle of 40° and by 18.95 % for a slope angle of 50° . It is noticeable from the stereoplot that wedge sliding occurs on the intersection plane from JS1 and JS2 (Figure 57 B). The intersection points of JS1 and JS4 are critically oriented for

direct toppling. The percentage is slightly increasing for a slope angle of 40° by approximately 1 %. Joint planes from JS1 are working as base planes for this failure mechanism. 22.35 % of JS1 are favourably oriented for direct toppling. The number of critical discontinuities for flexural toppling is increasing by 3.58 % due to the orientation of JS4. For a slope angle of 50° it is further increasing to a maximum of 10.59 %.

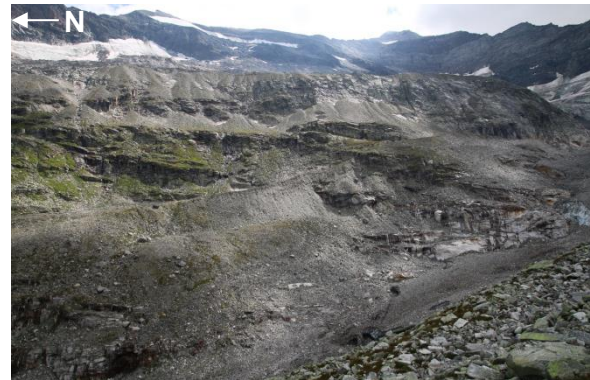
Reaching the opposite side was difficult during the field work. Therefore, the comparison of the valley sides is based on photographic analysis even though the rock slope was mostly covered by debris (Figure 61).

Figure 61 The opposite side of the valley is mostly covered by debris.

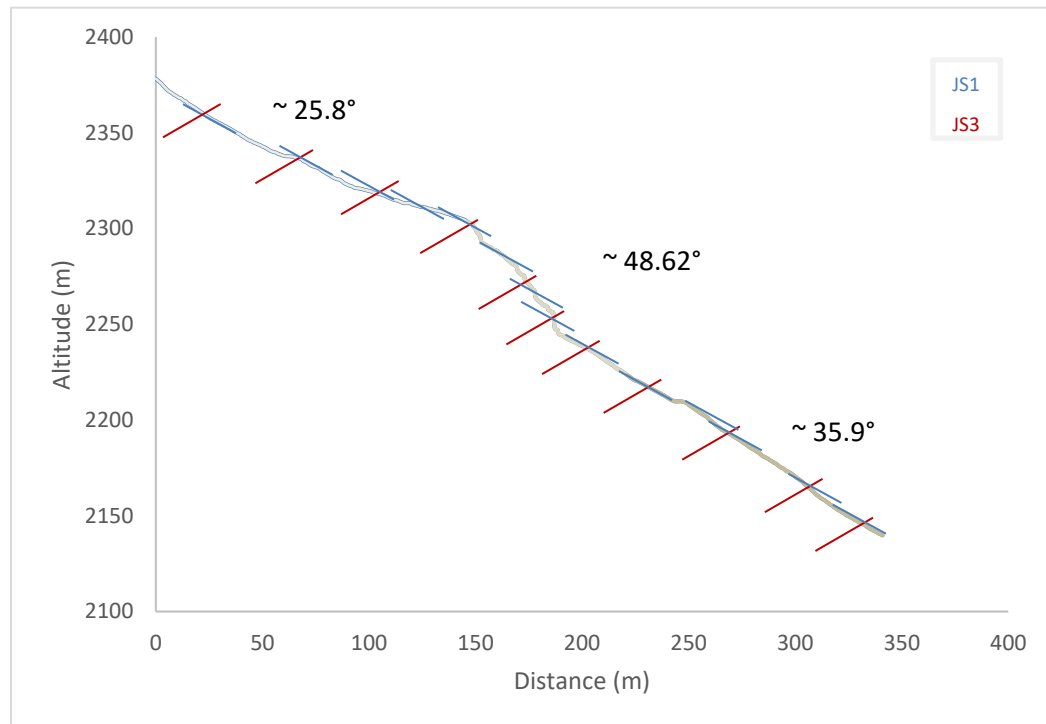
Figure 64 Cross Profile of the slope with the mean orientation of JS1 (blue) and JS3 (red) relative to the slope.

There are also daylighting joints from JS1 recognizable (which can also be seen in Figure 63), where failure haven't occurred yet. These rock blocks might be stable due to intact rock bridges. The stepped surface of JS1 is, especially on the left side, visible, which is an indication of rock bridge failure. After failure the amount of rock bridges initially stabilizing the rock mass can be assessed. JS1 sets up the base for release planes of potential rockslides and rockfalls. Thus, JS1 modified the general shape of the valley morphology. JS3 builds the tear-off edge of rock masses during planar sliding failure along JS1. The intersection plane of JS1 and JS2 is most critical for wedge sliding.

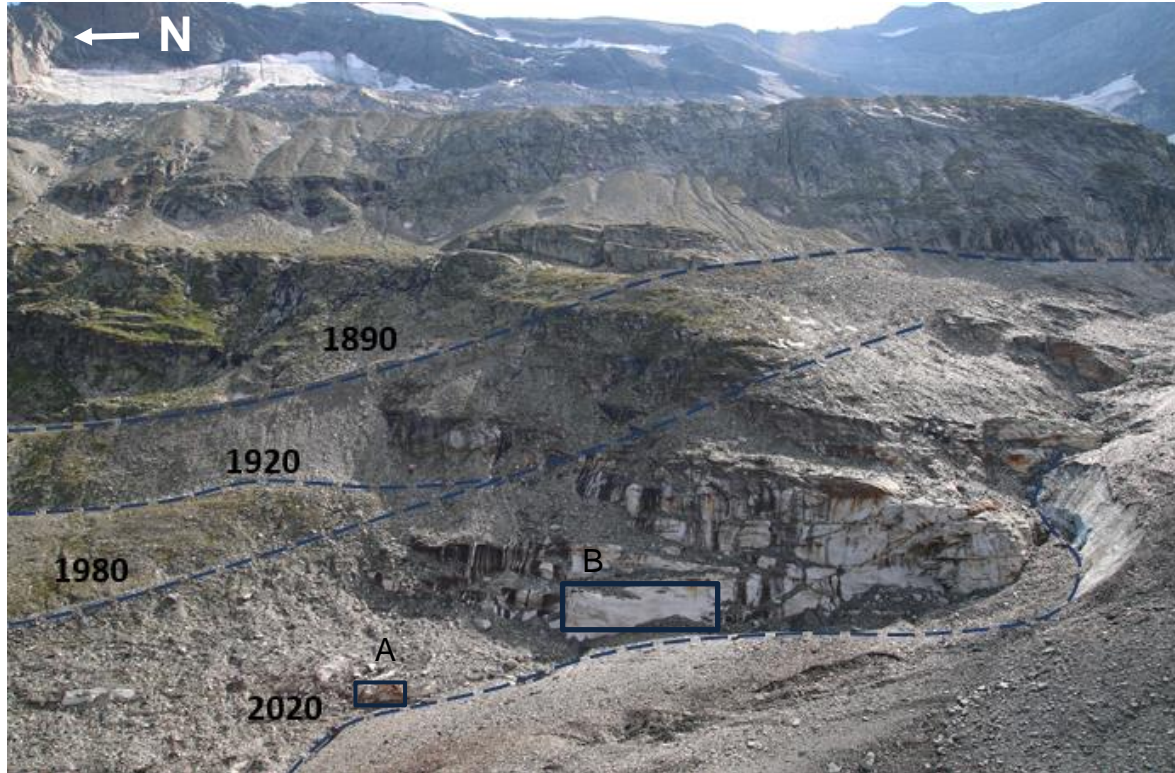
Figure 67 The different moraines and the corresponding times are marked. The white rock mass is exposed from the glacier during the last 40 years. A and B mark locations where glacial marks can be seen on the rock surface.

For the assessment of time needed for the propagation of the exfoliation joint network, photographic analyses were conducted. The rock mass that is illustrated in Figure 67 became ice-free during the last 40 years. Glacial marks are recognizable on the surface of the rock wall (Figure 68), which indicates an even shorter ice-free time period of a few years

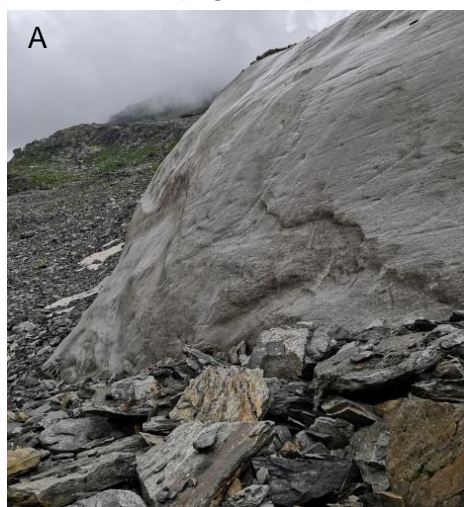
at the bottom of the rock wall. No discontinuities are recognizable on the rock mass surface.

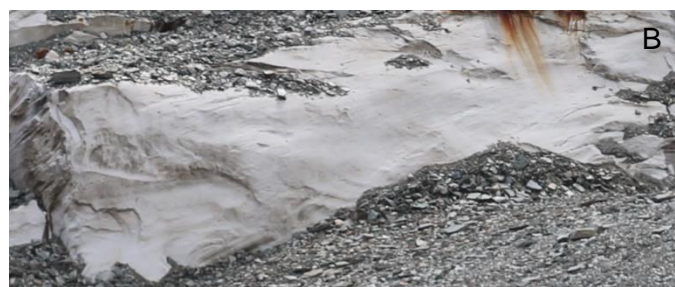
Figure 68 Glacial abrasion marks on the rock surface.

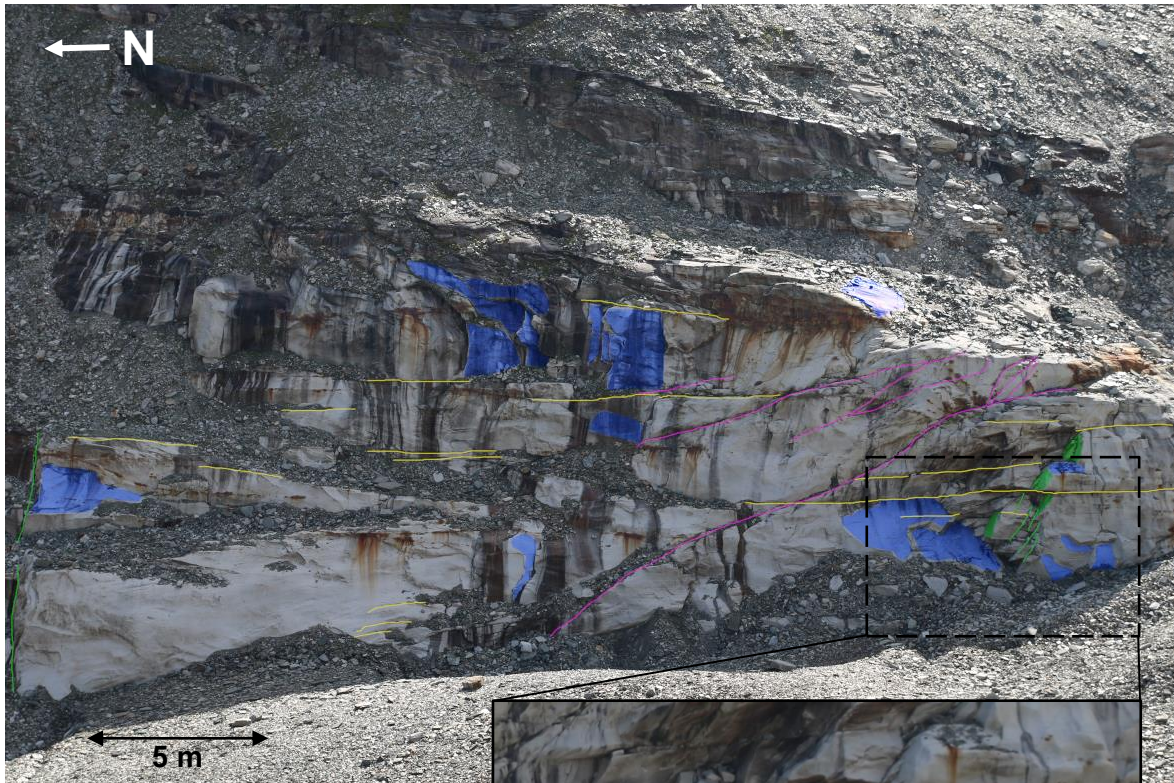
Figure 69 Photographic analysis of a rock mass that is deglaciated since a few years (approx. 5).

The rock slope in Figure 69 is located on the eastern side of the valley and deglaciated since a few years. There are not as many discontinuities recognizable in the

In the detailed photograph, joints, which are presently forming can be seen. On the left side

a joint terminates in the rock and small fissures bent downwards are forming (white arrow). The small rock blocks cut by the joint network fail along the slope parallel joint plane and slide down. These rock blocks may fail soon. On the right side two rock blocks may slide down soon on the slope parallel surface (black arrow). In the middle section several rock blocks formed due to crosscutting joint sets that are horizontal, parallel and perpendicular to the valley axis. Beneath the horizontal joint (yellow marked joints) rock blocks detach from surface parallel joint planes (blue marked), cut by the horizontal joint and the surface parallel joint. There is probably a lower joint spacing in this area because of a high load that was applied by the glacier. The rock mass is curved there, and the glacier flow direction is in the left direction so that the glacier may have squeezed against this part of the rock mass. High stresses are therefore applied on the stoss side (right side of the picture) and the part on the left side experiences very low stresses, where a cavity between the glacier and rockwall might have formed. High stress ratios evolve and fractures develop in the low pressure zone (Carol, 1947).

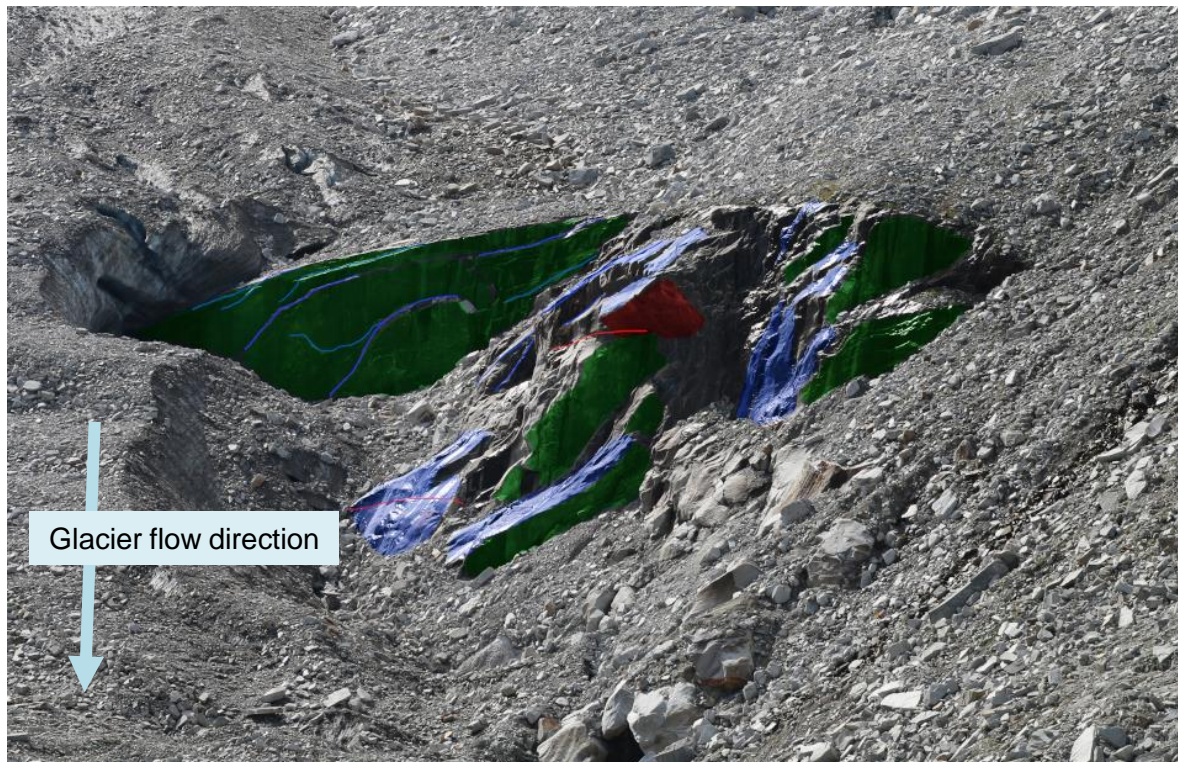
Figure 70 Photographic Analysis of a rock mass which recently became ice-free.

In Figure 70 a photograph of a rock mass that recently became ice-free, is illustrated. The different joint sets are coloured to assess the time needed for the joints to develop. JS1, parallel to the slope, and JS2, perpendicular to JS1, developed already. It can be noted that the spacing of JS1 is larger compared to the higher altitude observations close to the hiking trail. It can be assumed that the rock mass became ice free during the last 20 years. The time seems to be enough to develop the first joints of each JS but during the next year more joints may develop to reach an equal spacing to the pattern further up. Even more fractures

may develop because the load of the glacier is larger than it was at the measurement points at the hiking trail. If more load releases, more exfoliation joints form. Glacial erosion like plucking may play an important role in this location. The joints may develop because of local pressure applied by the glacier flow direction. High stresses evolve at the stoss side of the rock mass and low on the lee side, which leads to fracture propagation in the low pressure zone as explained in section 3.4.3. High pressures beneath a glacier also leads to a thin water layer between the glacier and bedrock. The water may infiltrate into the fractures and as soon as the pressure is released it refreezes again. This might drive further fracture propagation detaching rock blocks, which are then carried away by the glacier. Afterwards new fractures are built within the bedrock (Carol, 1947).
