A damage screening method of the concrete slab focusing on correlation of mode shapes

KEY WORDS: Damage screening method; Mode shape; Concrete slab bridge; Maintenance.

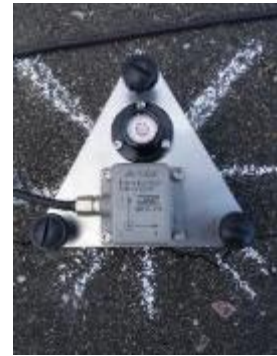
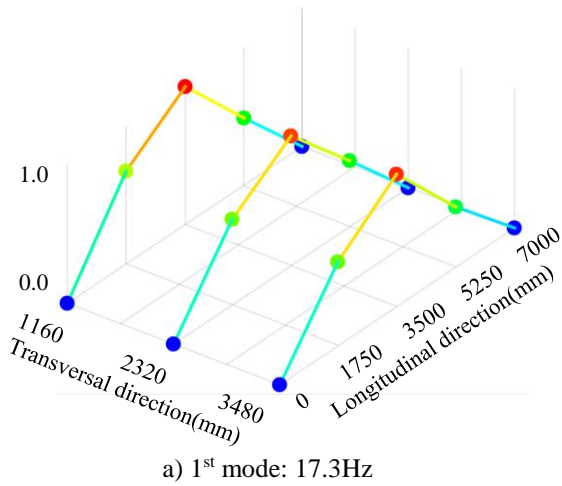
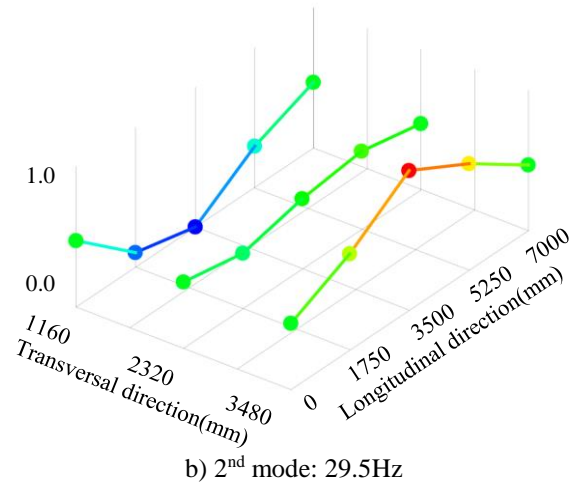
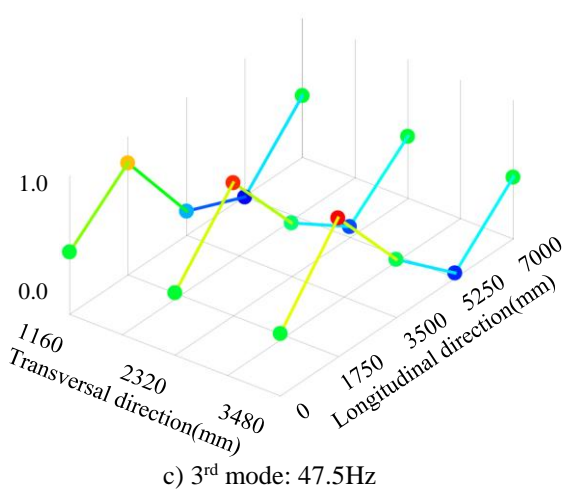
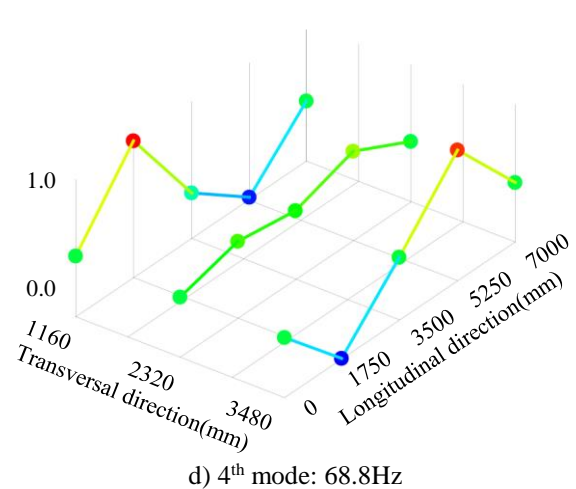
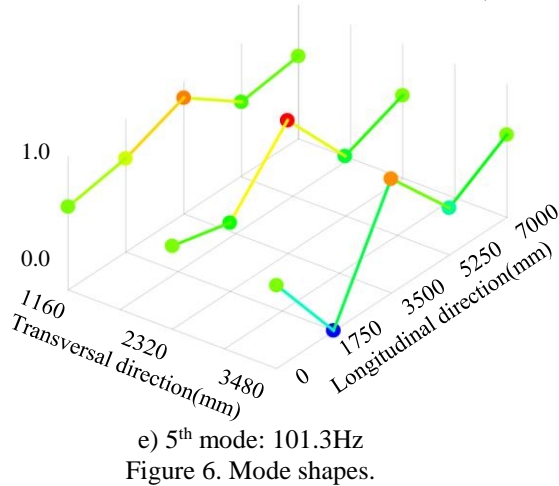
Figure 6. Mode shapes.

As shown in Figure 6, the five vibration modes were identified from the experiment. In addition, the points at both ends where no accelerometers are plotted as zero value to make the mode shape easier to understand.

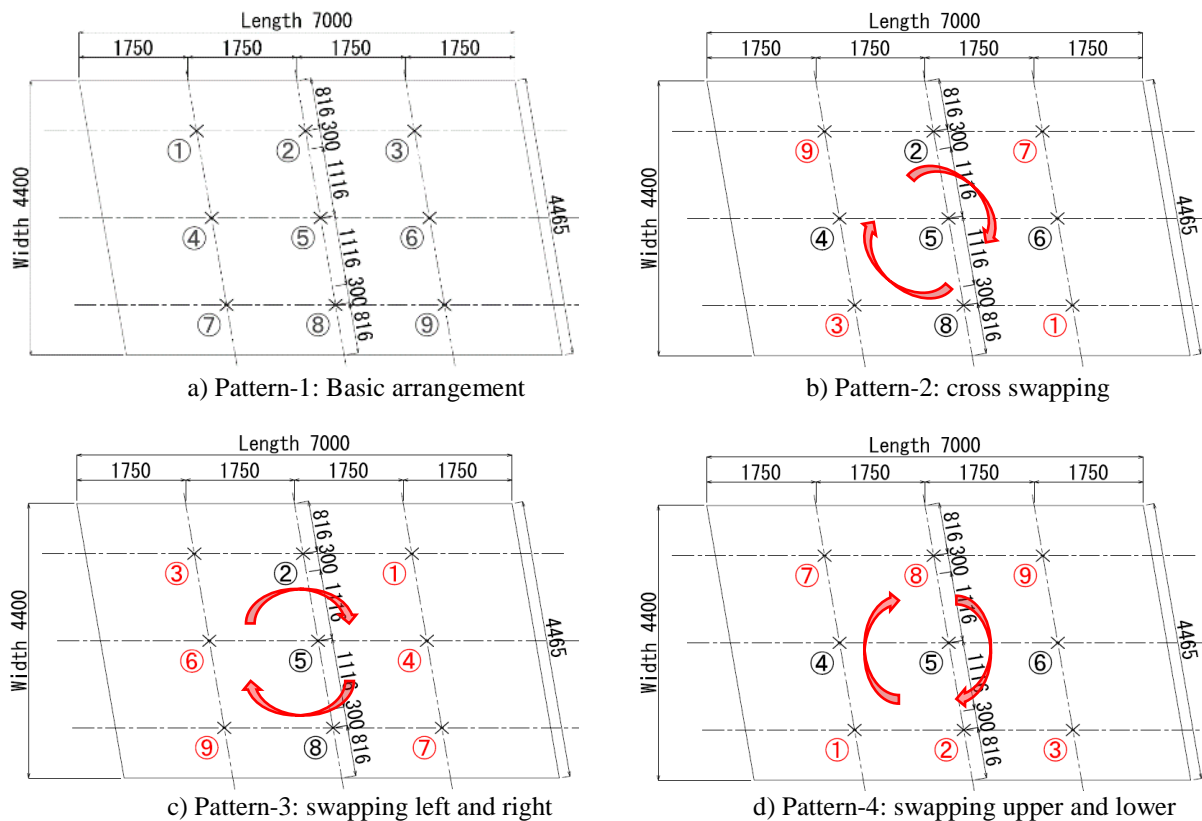
Figure 8. Swapping mode vectors.

calculate the COMAC. Therefore, the following assumption was assumed. Since the planar shape of this bridge is biaxially symmetrical, it was assumed that the mode vectors at the measurement points on the diagonal line can switch each other as shown in Figure 8b). The same assumption was also assumed for the axes at the center of the span and the center of the width as shown in Figure 8c) and Figure 8d). Hence, the COMAC was calculated by the four patterns combination as shown in Figure 8. However, since the sensor number 5 is located in the center, it cannot swap. And even numbered sensors are limited to only two patterns. Here, considering bridge shapes of small span concrete slab bridges that were managed by Kitami City. Since many of these bridges are almost symmetrical shape include skew angles, this swapping approach method is widely applicable. Many of bridge located on suburban routes with little traffic and cracks do not tend to occur on the underside of the slab. In addition, the cross section of the pavement has a 2% drainage gradient, and the ends of the girders are prone to damage due to pooled water. Therefore, simply identifying damaged areas at the four corners of the slab provides extremely useful information for maintenance.
