Redundant Monitoring Strategies for Structural and Geohazard Assessment Using Wireless Tiltmeters and LiDAR on Linked Highway Bridges in Colombia

ABSTRACT: The bridge system composed of Los Grillos, Puente Nuevo, and Chorro Blanco, located along the roadway connecting Sogamoso and Aguazul, near the municipality of Pajarito (Colombia), is founded on an active large-scale landslide in shale bedrock. This mass movement exhibits variable displacement rates depending on rainfall frequency over time. On August 20, 2023, the Los Grillos Bridge collapsed as a result of cumulative ground displacements that compromised its foundations and piers. Between July and December 2024, an integrated monitoring system was implemented, combining observations from an Automated Total Station (ATS), distance measurements using LiDAR, and tilt data obtained from inclinometers. The primary objective of this system is to establish correlations and track both ground and structural displacements, thereby supporting local stakeholders and decision-makers in the operational management of the remaining bridges still in service for civilian traffic. This paper presents the principal findings and illustrates how t

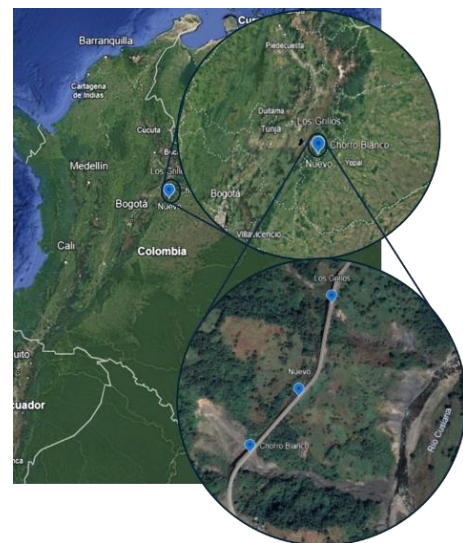
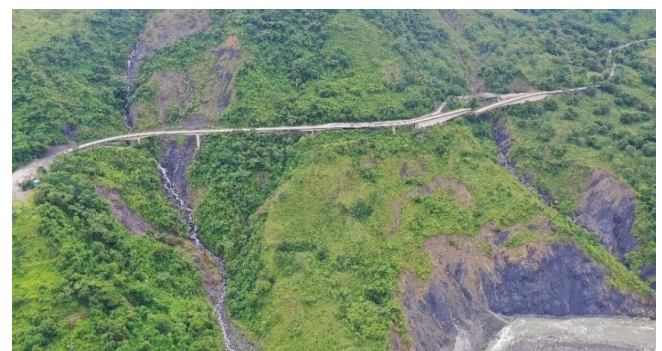
Figure 1. General location and panoramic view of the study area.

In the area located at station PR81 of the Sogamoso–Aguazul corridor, also known as the Cusiana Transversal, mass movement processes and geomorphological activity have been observed for more than two years and continue to occur to this day. These processes affect both the upper and lower zones of the surrounding slopes.

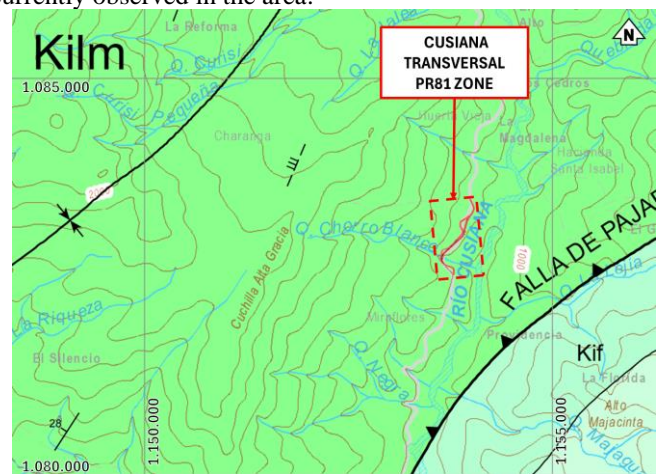
Figure 3. Regional geological map of the study area PR81 [1]

According to Sheet No. 192 of the regional geological map corresponding to the surroundings of Lake Tota, Department of Boyacá, Colombia, at a 1:100,000 scale [1], the sector known as PR81 lies within a geological unit referred to as the Macanal Shale Formation (Kilm), as shown in Figure 3.

The shales of this formation are fine-grained, rich in organic matter, and exhibit well-developed foliation, making them particularly susceptible to weathering processes and deformation under load or saturation conditions. These geomechanical characteristics significantly affect slope stability, subsoil behavior beneath structures, and the design of foundations or roadways that traverse such materials—factors that may account for the various active geotechnical processes currently observed in the area.

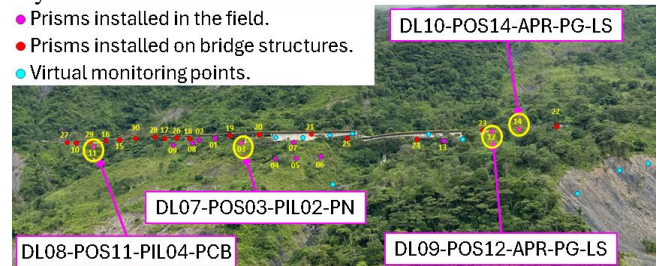
Figure 7. General location of measurement targets with GMS

This dual system consisted of an automated total station based on LiDAR GMS technology, which conducted three-dimensional tracking of thirty (30) topographic prisms strategically installed in various sectors within the area of analysis.

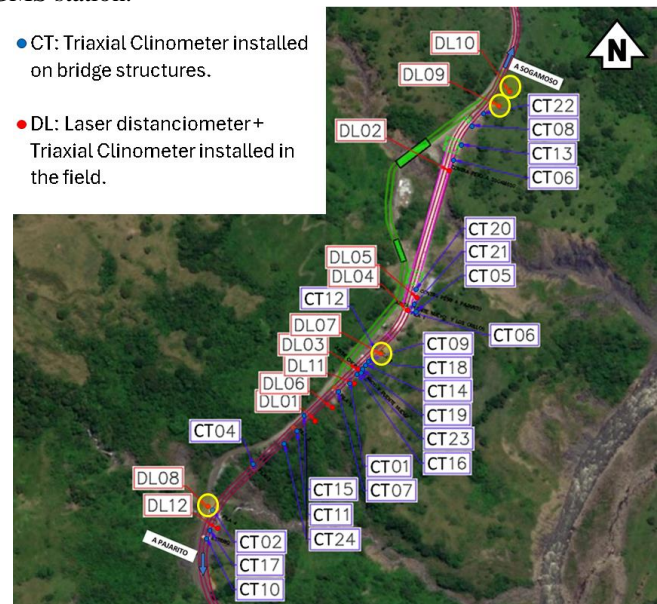
Figure 8. General location of wireless sensors

Additionally, thirty-six (36) wireless sensors were installed. Of these, twenty-four (24) are triaxial clinometers used to monitor tilting at strategic locations on the viaduct bridges. The remaining twelve (12) sensors are laser distance meters equipped with triaxial clinometric sensors, designed to monitor relative displacements and inclinations.

These devices were mounted on poles located near exposed surfaces of the bridges, where topographic prisms were also installed to provide redundant data, monitored by the robotic GMS station.
