Laboratory Testing of Old Bridge Girders: Preliminary Results

Maja Kreslin¹, Mirko Kosič¹, Aljoša Šajna¹, Andrej Anžlin¹, Doron Hekič¹, Vladimir Požonec¹, Petra Triller¹

¹Slovenian National Building and Civil Engineering Institute, Dimičeva ulica 12, 1000 Ljubljana, Slovenia
email: maja.kreslin@zag.si, mirko.kosic@zag.si, aljosa.sajna@zag.si, andrej.anzlin@zag.si, doron.hekic@zag.si,
vladimir.pozonec@zag.si, petra.triller@zag.si

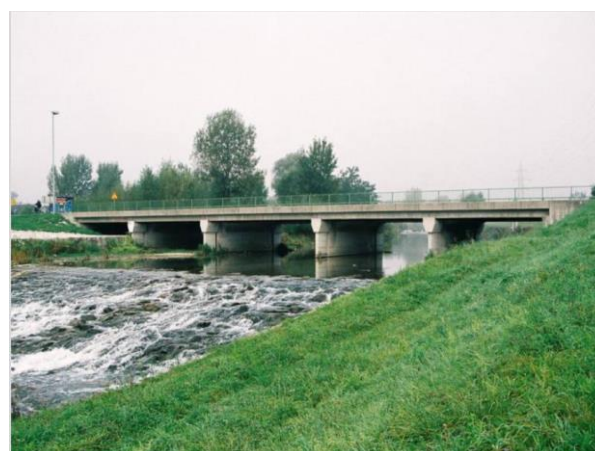
Figure 1. Existing bridge before the collapse (downstream).

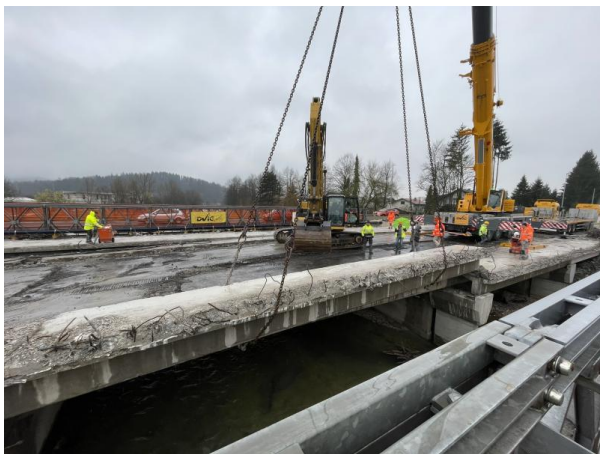
Following the catastrophic 2023 floods in Slovenia, the bridge partially collapsed, as shown in Figure 2 from the downstream side. While the intermediate supports were damaged, an inspection confirmed that the longitudinal girders remained in good condition. In agreement with the infrastructure manager and demolition contractor, selected girders were salvaged for laboratory testing (Figure 3).

Figure 3. Lifting the girders with cranes.

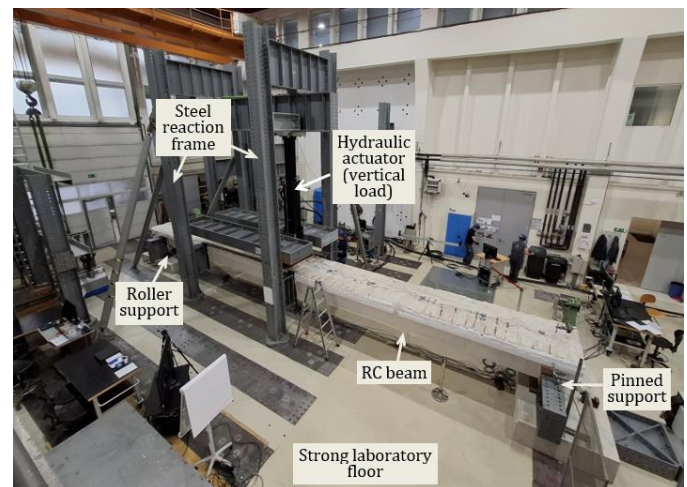
The test setup is presented in Figure 4. The girder was simply supported, with a pinned support at one end and a roller support at the other side. Both supports were rigidly anchored to the laboratory's strong floor. Lateral stability of the girder was ensured using a rigid steel frame. The load was applied by means of a hydraulic actuator, which was clamped into the steel reaction frame.

Figure 4. Experimental setup at ZAG's Laboratory for Structures.
