Investigation of the causes of the unusual gap between the bridge and abutment using long-term monitoring

KEY WORDS: Unusual expansion gap; Expansion-Gap Measurement System; Long-term monitoring; Girder bridge.

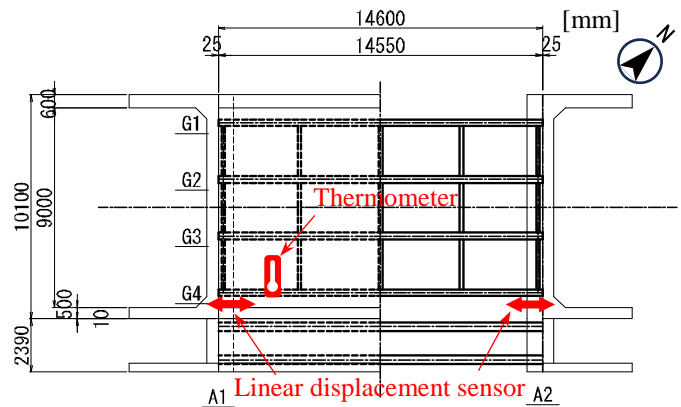
Figure 4. EGMS installation locations.

Figure 4 illustrates the installation locations of the EGMS for girders. The linear displacement sensors were installed at both the upper and lower sections of the girder ends on the north-side main girder (the G4 girder), with one sensor placed at each location. These sensors exhibited a measurement range of 50 mm, with an accuracy of $\pm 0.3\%$ at full scale. Figure 5 shows the installation of the linear displacement sensors. Additionally, a thermometer was installed on the web of the G4 girder to measure the temperature of the main girder. Various devices, including the data logger, were installed on the bearing seat surfaces of each abutment.

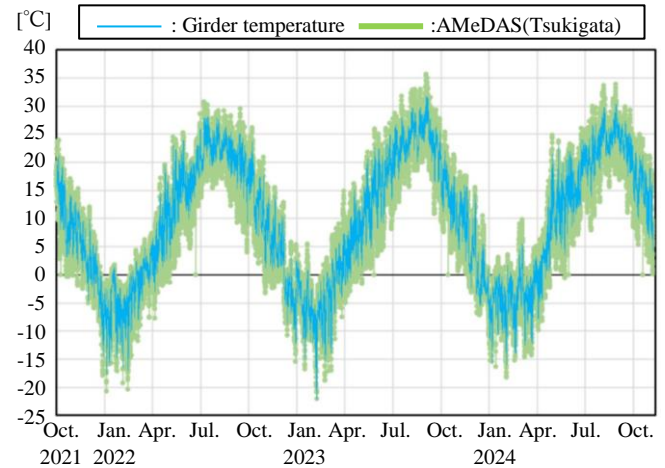
Figure 8. Comparison of temperatures measured at the main girder with those measured by nearby thermometer.

As shown in Figure 8, the temperature measured by the thermometer on the main girder closely approximates the temperature recorded at the AMeDAS station. However, the temperature variations observed on the main girder are smaller than those recorded by AMeDAS. This is likely due to the fact that the main girder is made of steel, which takes time to

respond to changes in ambient temperature. Since the measured values were generally consistent with the nearby temperature data, the measurement results are considered valid.

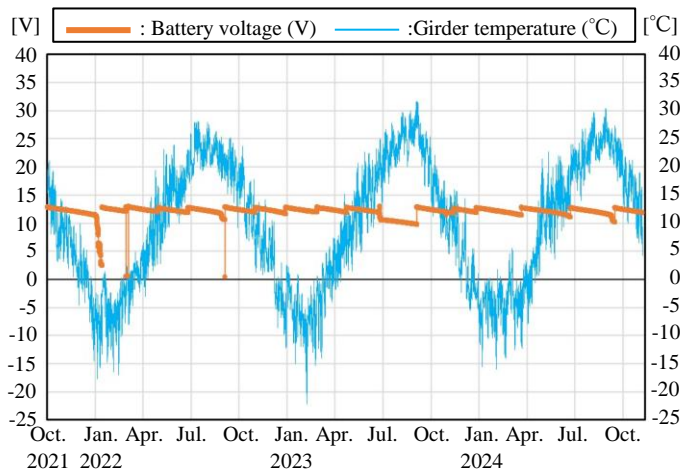
Figure 9. Battery voltage variation (A1 abutment).

The battery used for the displacement sensors may experience voltage drops at low temperatures. Since the displacement sensors output data based on voltage, a drop in input voltage makes accurate displacement measurements difficult. Therefore, the battery voltage was also monitored. Figure 9 shows the changes in the voltage of the battery installed in the system at the A1 abutment.

The battery voltage decreases due to system operation, so periodic replacements were planned. However, at the end of 2021, the battery voltage dropped sharply, causing the system to shut down. This was attributed to power consumption by the system and to the cold temperatures. Therefore, from 2022 onward, the battery was replaced approximately every two months to prevent system shutdowns.
