Master Thesis
Institute of Applied Geosciences
Graz University of Technology

**Impact of geological structures on rock mass
characterization ,Giba reservior, NW Mekelle,Ethiopia**

by: Asefu Gebremariam AREGAWI

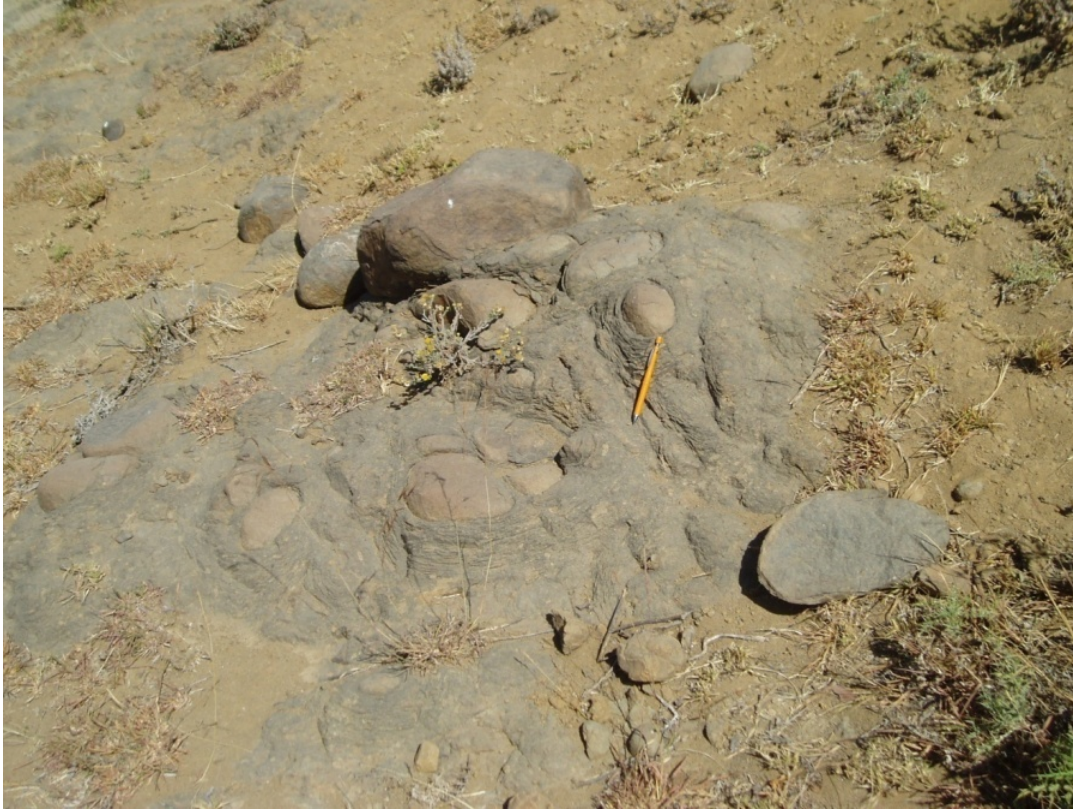
Fig. 6: Dolerite showing spheroidal weathering with a fresh core at the center.

The dolerite outcrop is dark greenish, fine to medium grained, crystalline, forming dykes and sill networks that intruded boulders or cross-cut the sedimentary succession. They are highly weathered, jointed and show spheroidal weathering. The core of the weathered body contains hard, relatively fresh dolerite rock (Fig. 6). WNW-ESE aligned faults and NNE-SSW aligned fractures are identified in this area mainly bounded by the Mekelle fault in the north.

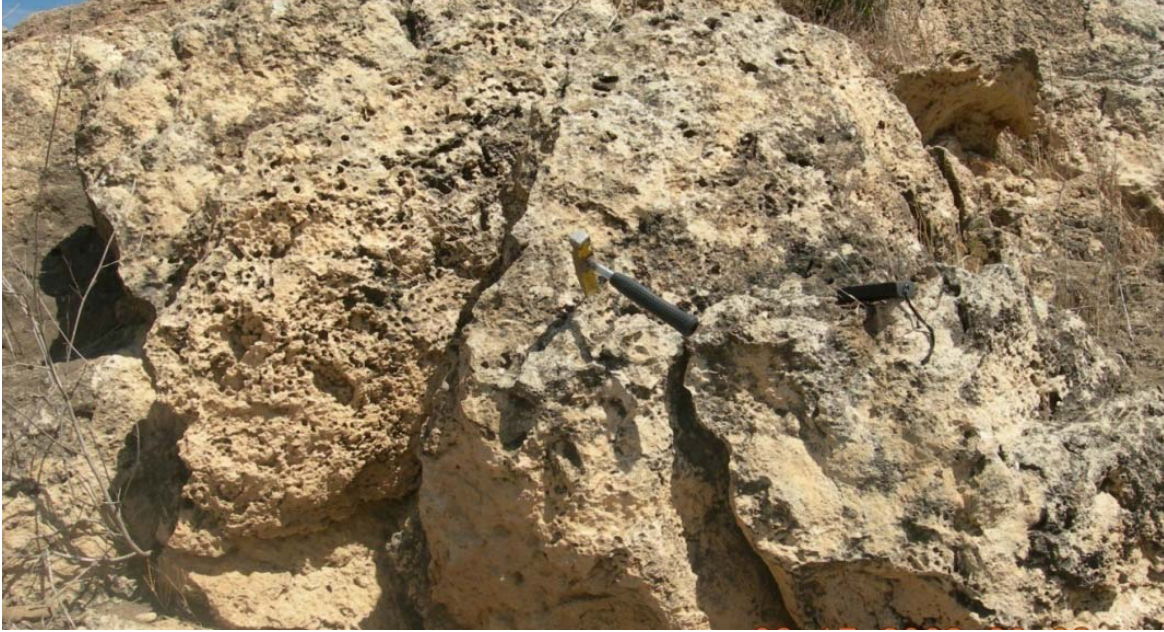
Fig. 7: Travertine along the dam axis.

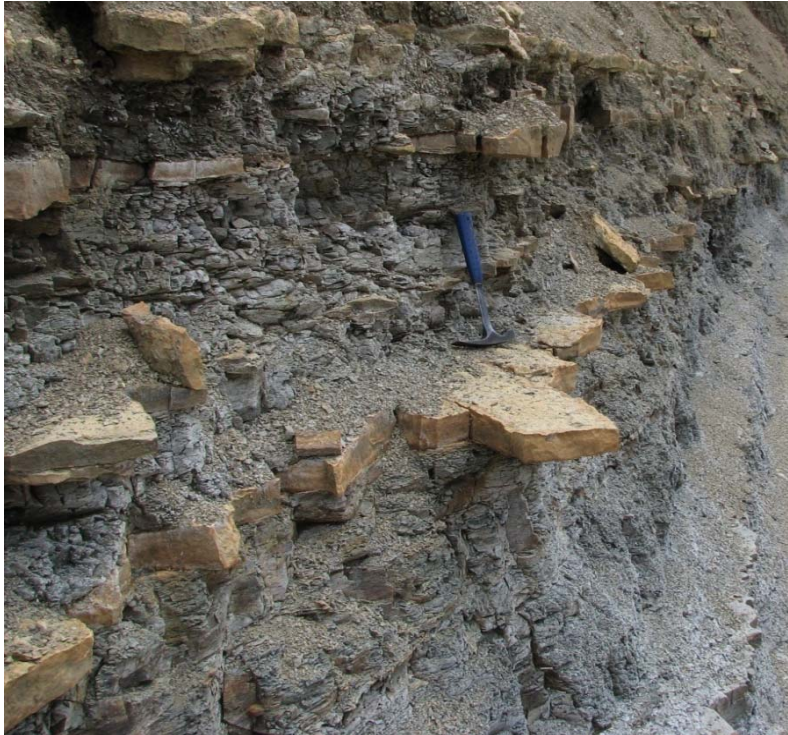
Fig. 8: shale with thin beds of limestone.

This rock unit was found on the downstream part of the dam site. This unit is dominated by the shale layer with thin beds of limestone and marl. Its color varies from light yellowish to greenish gray, fine grained, shows fissility and some fractures (Fig.8).

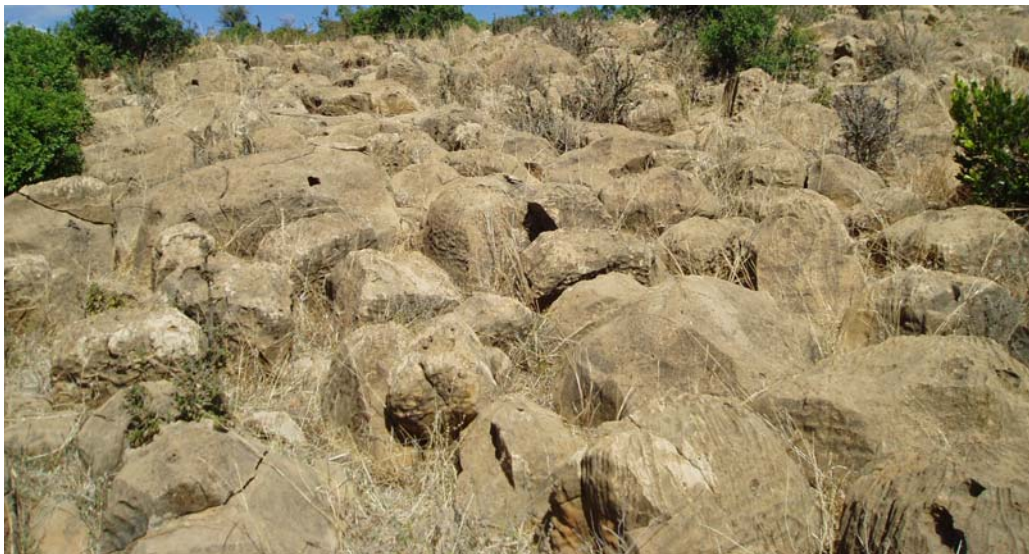
Fig. 9: Karstified limestone exposed on the west side of the reservoir.

This unit is wide-spread in the north-western part of the reservoir area and is not cliff forming. It rather lies flat on the surface forming gentle slope landforms (Fig. 9). It is bounded in the north by the Adigrat sandstone and in the south by gentle slope forming landforms overlain by steep cliff forming limestone units. The southern boundary is marked by a stream draining to the east. The stream valley is underlain by stream sediments, travertine and bedrock at certain places. The bedrocks exposed in the stream bed show gentle to steep dip. Close to the junction of the stream with the Giba River, the karstic limestone is bounded by gravel with boulder size rocks. It is light gray coloured, crystalline, with interconnected voids or cavities with rough and sharp edged surfaces and networks of joints. Moreover, this unit is highly faulted and tilted, having bedding with a dip of 15° and orientation of 265° .

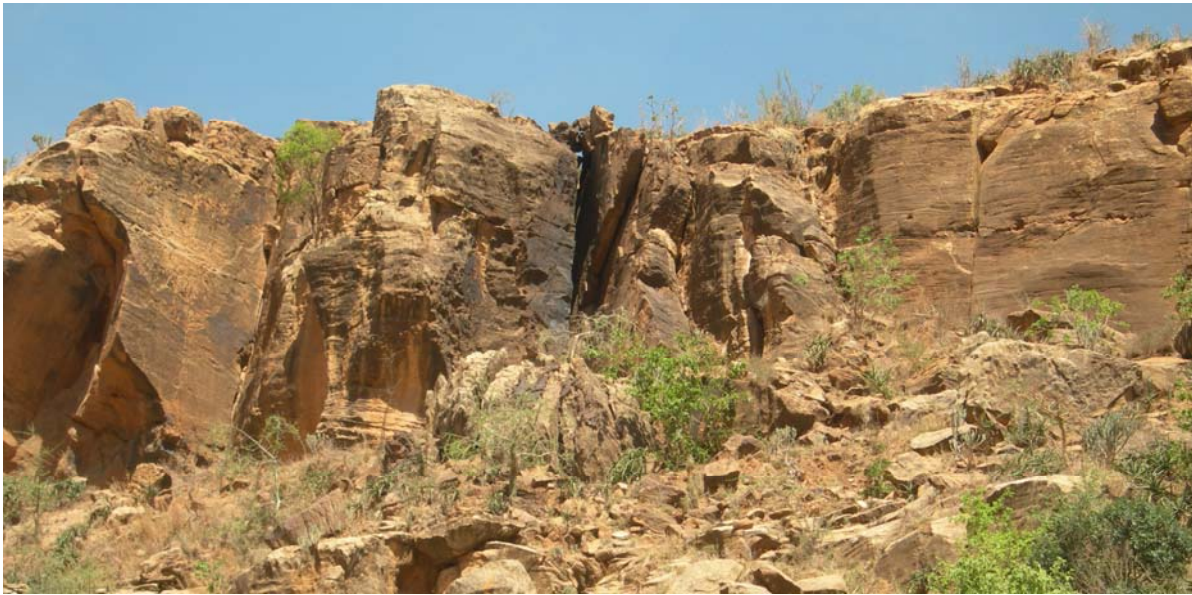
Fig.10: Adigrat Sandstone (from photo collection) on the western part Subuh River.

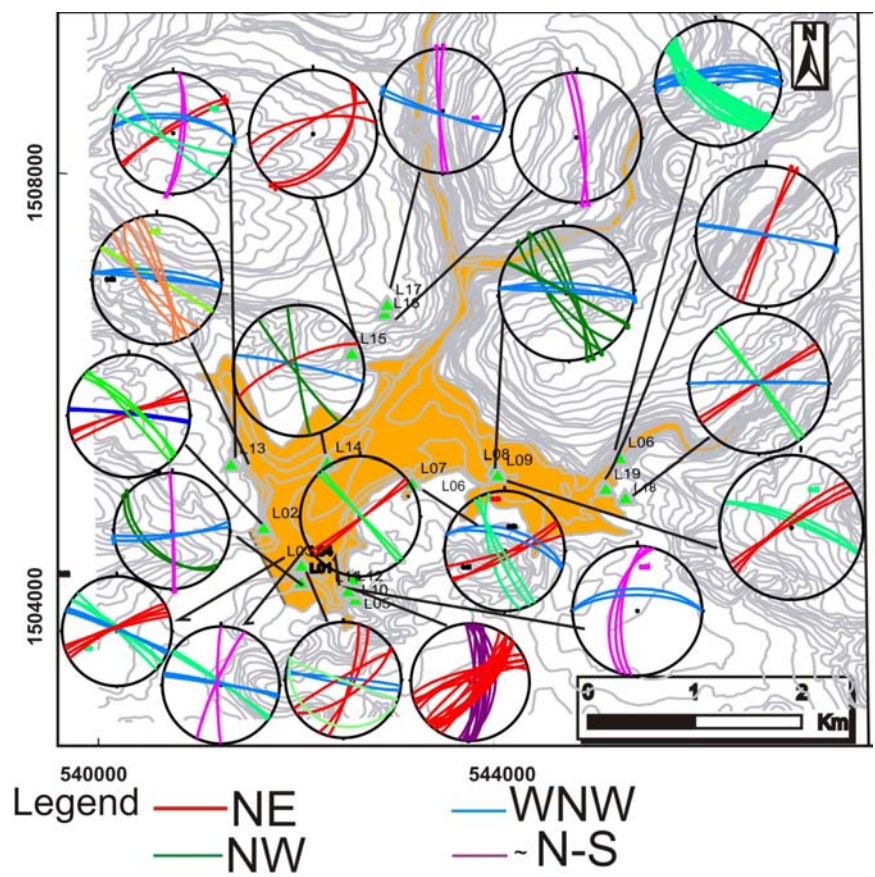
Fig.18: Stereographic projections of the orientation of fractures and distribution on the Giba dam reservoir from 19 different locations. Opening fractures and suggesting extension directions varied from NE-SW to NW-SE .

Along the central part of the reservoir area the dominant joint sets are the ~N-S and the NE-SW striking ones. On the Agulae river quarry site of Mesebo cement factory the dominant joint sets are NW-SE and WNW –ESE (Fig.18).

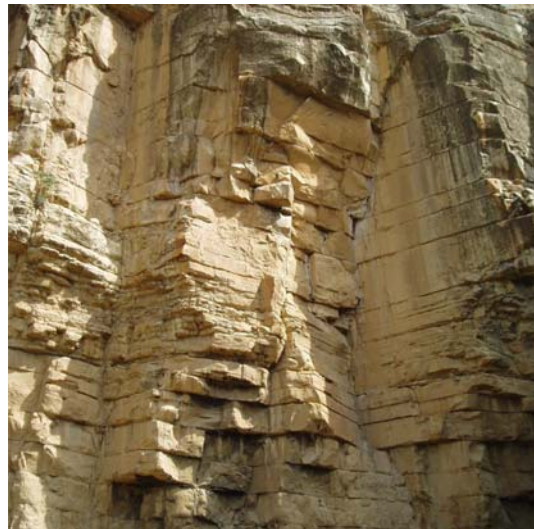
Fig. 20: Yellow color limestone with almost horizontal bedding.

The bedding plane orientation of the Giba reservoir shows consistencies throughout the region. Based on the field measurements, the bedding planes are almost horizontal except in few areas, which are locally faulted and are steeply inclined towards southeast. The dominant orientations from field measurements and shape matrix results show 020/26. The bedding thickness varies from place to place from 0.15 cm -2 m (Fig.20).

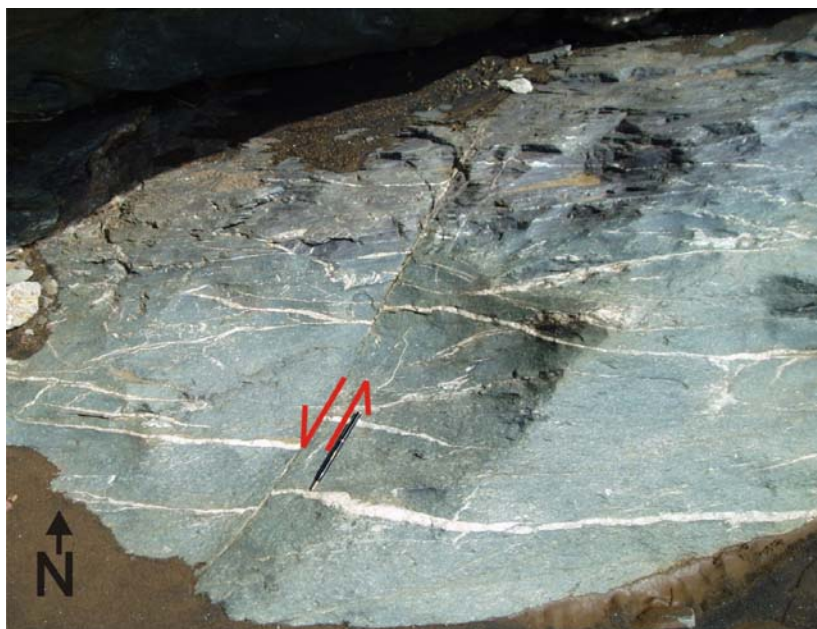
Fig. 25: Small strikes slip faults exposed on the river outcrop in the Shegalu River, on the Giba Dam reservoir. Limestone joints filled with quartz are cut by the faults which offset the veins in a left-lateral sense.

The second evidence for the strike slip fault was also found in the field from Shogalu River around the Agulae River, which shows the exposure of small faults along the river outcrop, where limestone joints filled with quartz are cut by faults which offset the veins in a left-lateral sense as shown in Fig. 25.

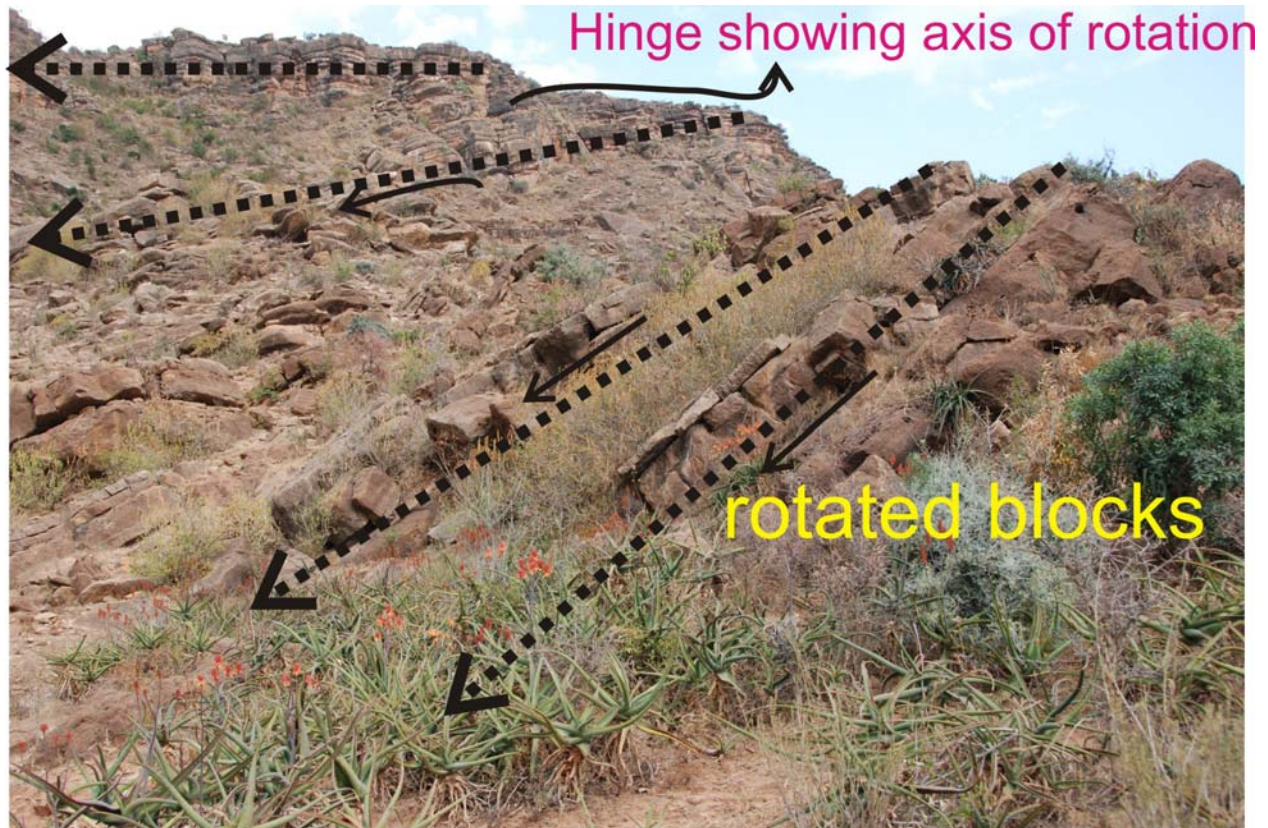
Fig. 27: Hinge showing axis of rotation of blocks along the Mekelle fault.

This strike slip displacement with subsequent block rotations induced local zones of contraction and extension. The strike orientation of the rotated blocks from field observations were NW-SE (110/285) (Fig. 27). These rotations are about $40^{\circ} + -50^{\circ}$ from the Mekelle fault, documented from the field measurement along the Mekelle fault (Fig.

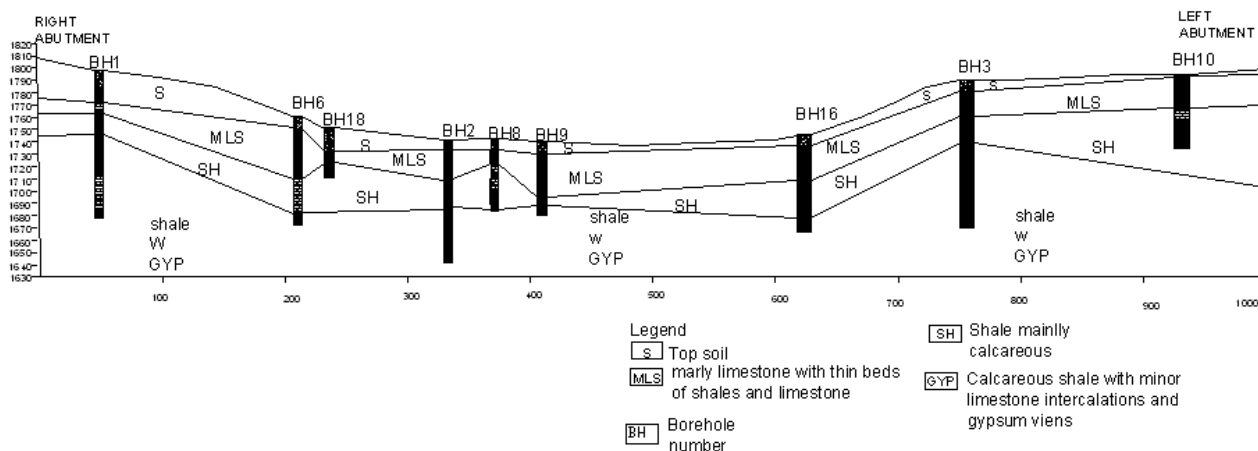
Fig. 30: Geological cross-section of dam axis

From the cross section available (FIG. 30) on the dam axis which was made from drill logs, the dam axis foundation is underlain by marly limestone and then very thick shale (mostly compact, calcareous and karstified) and this unit is underlain by shale dominated by jointed thinly bedded layers of limestone and gypsum layers.

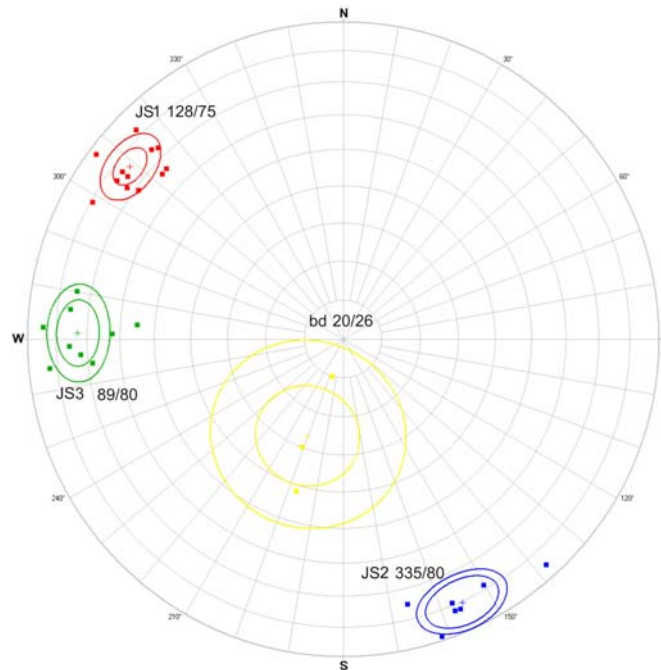
Fig 32: Lambert projection with structural data of different discontinuity sets.

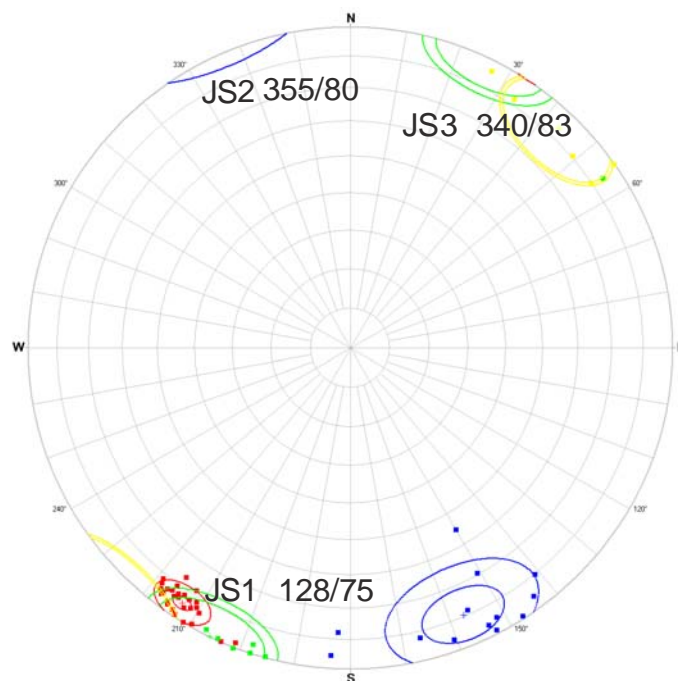
Fig 34: Lambert projection with structural data of different discontinuity sets.

The joints are slightly weathered and rough, opened up to 15 cm and partially filled with clay. Three dominant joint sets were observed from field analyses and shape matrix results (Fig. 34).. These are WNW, NE and NW striking with joint spacing ranges from 1-3 meters. The joints end with the rock mass.

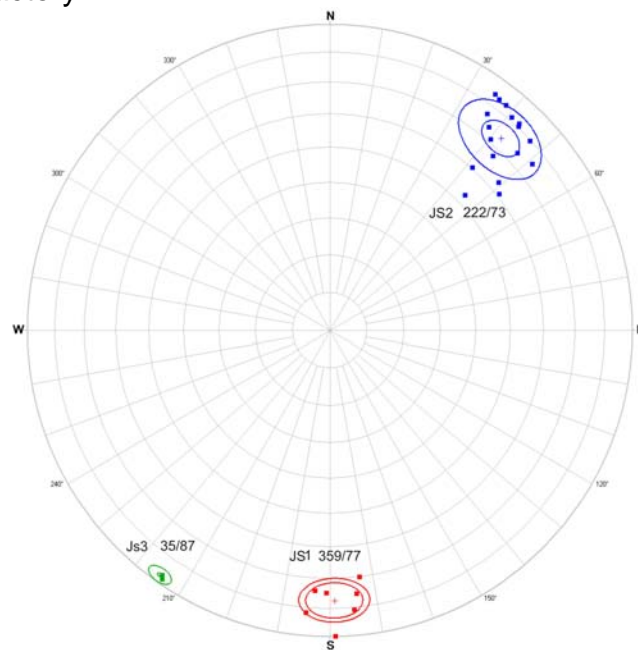
Fig. 36: Lambert projection with structural data of different discontinuity sets of the sand stone from query site of Mesebo cement factory.
