Study on the suitable sensor locations for tilt monitoring of power transmission tower

T. Kurihara¹, M. Saeki²

¹Tokyo Electric Power Service Co., Ltd, Tokyo 1350062, Japan

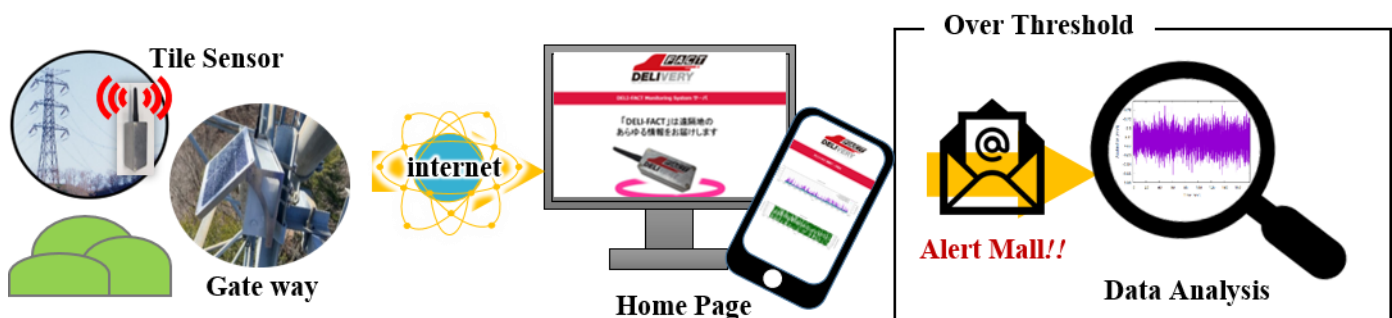
Figure 1. Operational image diagram

The management of towers where landslides are a concern is conducted once a year to check the progress of base displacement by surveying. However, there is a risk of on-site attendance and delay in detection. Therefore, the authors propose tilt monitoring to remove these risks. Figure 1 shows the operational image proposed by the authors. In the proposed method, tilt sensors are installed on the four legs of a transmission tower and single pipe piles driven near the collapsed soil surface, and the measured values are monitored remotely. When an abnormality is detected, an alert is sent out and the risk is assessed by analyzing the observed data.

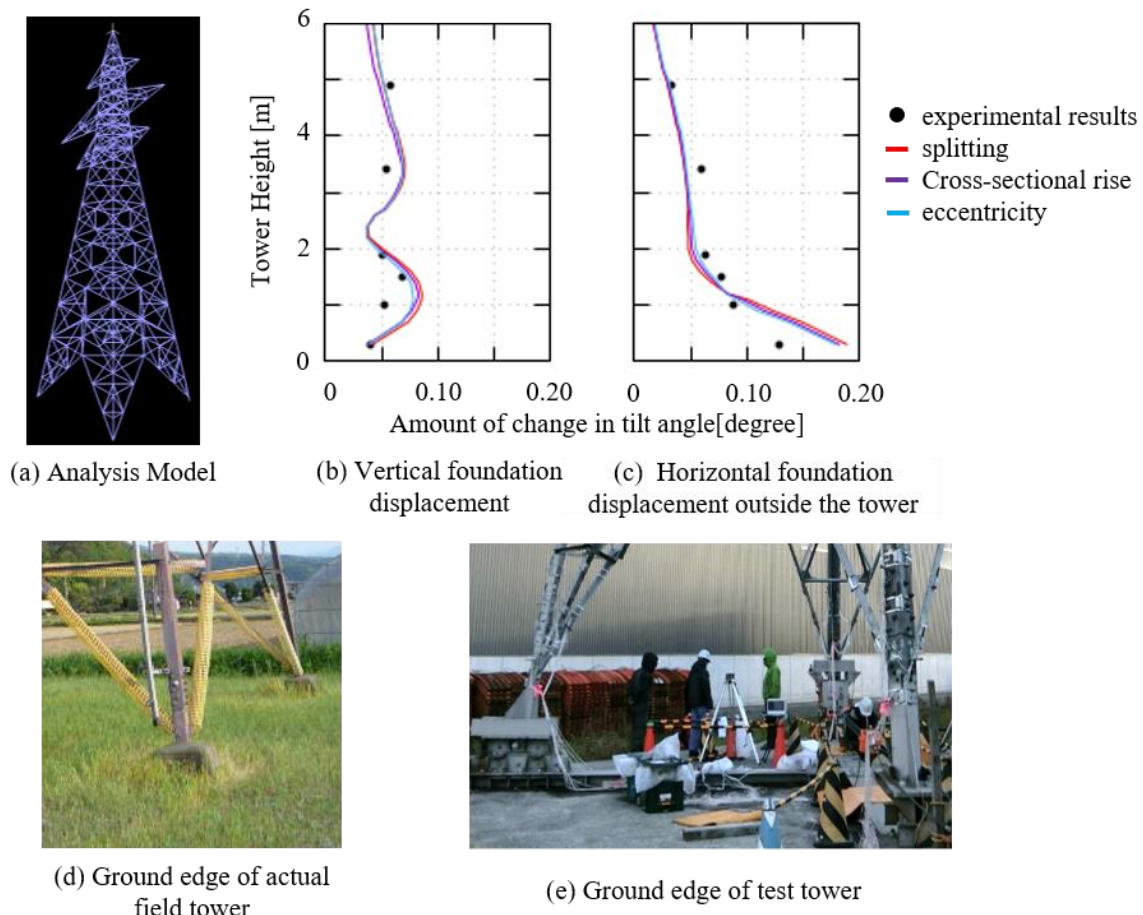
Figure 4. Analysis Model and Results

The change in tilt of the lowest part due to base displacement be confirmed by analysis. The analytical model was created using ADINA (ver. 9.4). The analytical model created is shown in Figure 4 (a). The analytical model was made up of nodes at the member intersections and a beam element between the nodes. The analytical model was subjected to the same forced base displacements as in the test, and the member stresses, displacements of the member nodes, and member tilt were calculated and compared with the test results. The test tower

The above analytical model was used to perform the analysis, and Figure 4 (b), (c) shows a comparison of the analytical and experimental results at the allowable base displacement. The vertical axis is the steel tower height, and the horizontal axis is the vector composite change in tilt angle. Figure 4(b) shows that the eccentric model has the smallest error of 0.001 degrees in the range of 1.5 m to 1.9 m from the lowest point of the analytical model. Figure 4(c) shows the comparison results for the horizontal displacement outside the tower. As with the vertical displacement, the eccentricity model had an error of 0.004 degrees at 1.5 m to 1.9 m from the lowest point. Both vertical and horizontal displacements showed a large change in tilt and sensitivity at the lowest point. This analytical model is a simplification of the actual structure. Therefore, the accuracy of the model should be improved by refining the model in accordance with the actual situation. In this model, it can be said that the experimental data can be almost explained by refining the model up to the joints of the main column members. However, the model was not able to represent changes in tilt near the bottom of the tower. This is due to the shape of the base of the tower. As shown in Figure 4(d), there are areas near the base of a transmission tower in actual operation where only the main member is present. This area is called the bottom main leg. In general, the bottom main leg of a transmission tower in actual operation is about 300 mm. In contrast, the bottom main leg of the test tower was conducted is indicated as 500 mm on the drawing. In addition, the test tower has no concrete base. Therefore, the boundary between the tower and the base is ambiguous, and the length of the bottom main leg is also ambiguous. From the above, the authors believe that the difference in tilt change near the ground is due to the effect of the bottom main leg. In addition, a comparison of the case in which the eccentricity of the main column joints and the cross-sectional characteristics of the main column joints were taken into account showed that the maximum difference in tilt change was only 0.004deg.

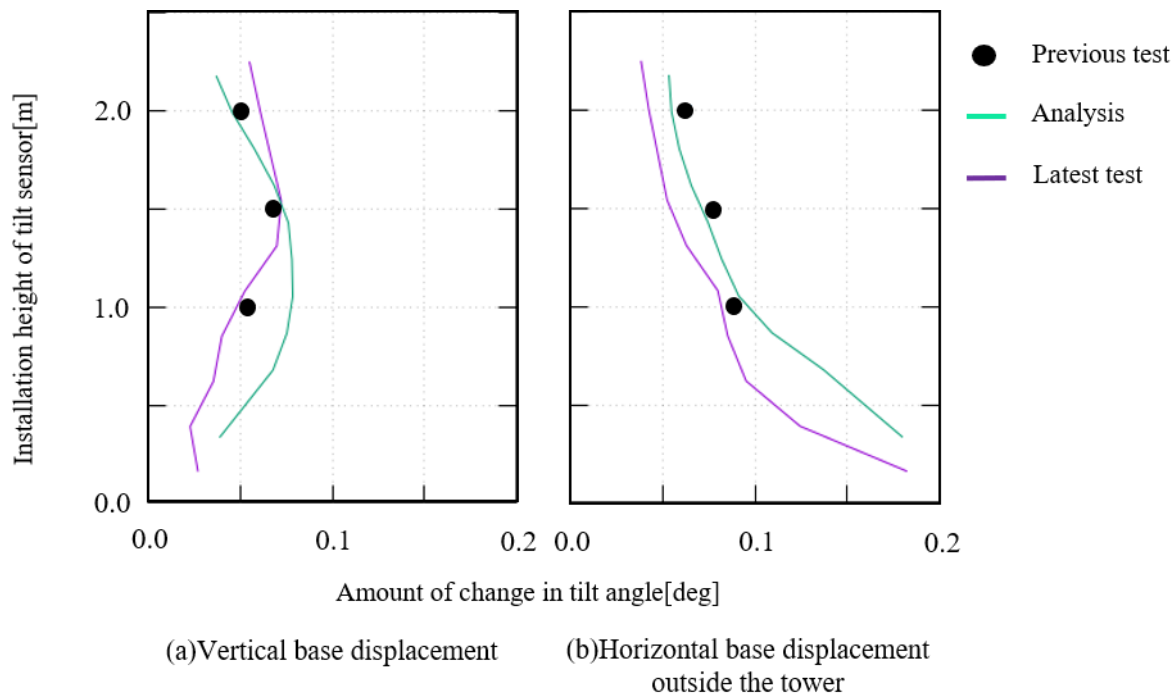
Figure 6. Re-comparison with analysis

results are shown in Figures 6(a) and 6(b). In Figures 6(a) and 6(b), the vertical axis is the steel tower height and the horizontal axis is the tilt change. The tilt change was assumed to be a vector in the line direction and in the direction orthogonal to the line. Figure 6(a) shows the comparison results of vertical base displacement and Figure 6(b) shows the comparison results of horizontal base displacement outside the tower. The black dots are the results of the previous test, the green line is the results of the analysis, and the purple line is the results of the latest test.

Figure 6(a) shows that the trend of tilt change was consistent with the previous test results. However, there was a difference of about 0.01deg at 2.0m. The retest was conducted two years later. Therefore, the authors consider it to be the effect of rust and other factors that were not present last time. Also, the last test was in October and the current test was in May. The difference in temperature may have affected the expansion of the materials. Compared to the analysis results, the overall trend was similar, but the height directions did not match. However, the locations between 1.4 m and 1.6 m were in general agreement with the analysis.

Figure 6(b) shows that the overall tilt change was smaller than the previous result, but the trend of tilt change was consistent. The trend was consistent with the analysis results. The factors contributing to the overall small change in tilt are considered to be the same as for the vertical displacement. From the above, it was found that the trend of tilt change due to base displacement was generally consistent for the 1.4 to 1.6 m point.
