# Advanced and Efficient Monorail Facility Inspections Using Optical Measurement Technologies, Including Laser and Imaging

Motoki Nakamura<sup>1</sup>, Hirotohi Kurashige<sup>1</sup>, Hiroshi Yamazaki<sup>2</sup>, Ryohei Hayashi<sup>2</sup>, Kousuke Inoue<sup>2</sup>

<sup>1</sup>Keisoku Research Consultant Co., Creative Division, 665-1 Fukuda 1-chome, Higashi-ku, Hiroshima 732-0029, Japan

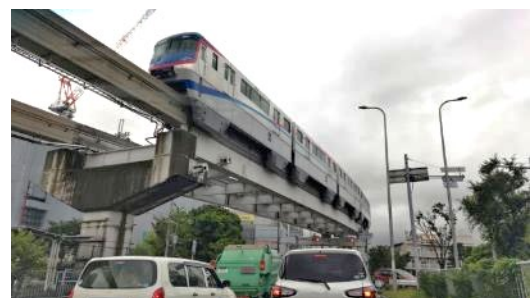
Figure 1. Photograph of a monorail

Monorails are widely used as a key part of transportation infrastructure in urban areas and tourist destinations. Figure 1 shows a photograph of a monorail train traveling along the track beam above automobile street traffic. In proper maintenance management of this track structure, appropriate maintenance (line maintenance) is demanded from the viewpoints of safe operation and long service life. However, several issues arise in inspections of monorail systems.

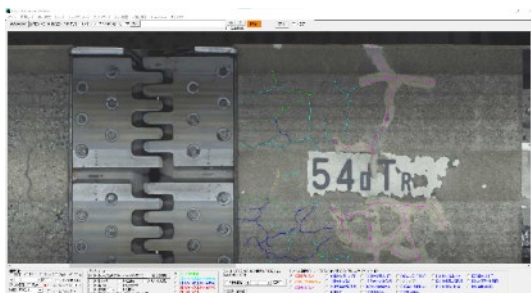
Figure 7. “k-TRACE”: crack drawing support software

Damage is extracted using the crack drawing support software “k-TRACE” (Figure 7), which was developed by this company (KRC: Keisoku Research Consultants Co.)[4][5]. When the inspector clicks the line of a crack with the mouse, k-TRACE analyzes the shading of the color around the line joining the clicked points and automatically outputs the shape and width of the crack. Application of this tool is not limited to cracks, as the software can also extract the positions of peeling, water leaks and free lime at the same time. This processing makes it possible to obtain a comprehensive understanding of the exact position and scale of the damage from images, without going to the site, thereby securing “Safety” and “Quantifiable Results.”

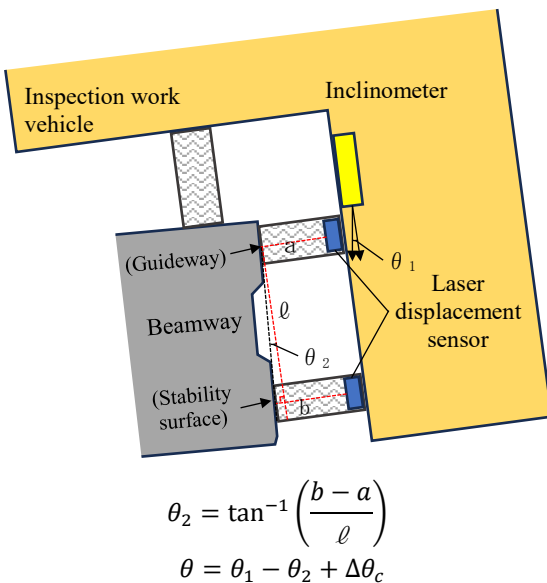
Figure 11. Relationship of inclinometer and beam side surface

The inclination (cross level) of the beamway is measured by using an inclinometer and laser displacement meter. If the beam and the vehicle are parallel, the cross level  $\theta$  can be measured using only the inclinometer, but there will be a slight variation in the inclination. Therefore, displacement is measured by using laser displacement sensor installed on the guideway and the stability surface of the beamway side surface to correct for the difference in inclination, and the difference in the inclinations of the track beamway and the vehicle is obtained from the respective measured values of  $a$  and  $b$  and positional relationship  $l$  between the displacement meters. Since the measured values of the inclinometer are also affected by centrifugal force, the cross level  $\theta$  of the beam can be calculated by adding a corrected value  $\Delta\theta_c$ , which is calculated based on the beam linearity and speed values. An image of the relationship of the inclinometer and the beam side surface and the numerical expression are shown in Figure 11.
