## 2D sonar techniques for monitoring the canal bed morphology of entrances to navigation locks

**ABSTRACT:** Navigation locks are essential components of inland waterways. They enabling vessels to traverse sections with differing water levels. These structures are increasingly vulnerable to damages caused by (1) scour i.e., erosion of sediment due to natural water flow and ship-induced currents, and (2) sediment or debris obstructing lock gates. Scour-induced damage threatens the structural integrity of locks, leading to costly maintenance, prolonged closures, and economic and environmental consequences. Traditional monitoring methods, including visual inspections and fixed instrumentation, are often hampered by water turbidity, high costs, and susceptibility to debris damage. Sonar technologies provide a non-invasive, cost-effective alternative for detailed underwater imaging, even in challenging environments. This paper explores the application of 2D sonar imaging for monitoring navigation lock approaches, with a focus on bed morphology and scour progression. Using the Prinses Beatrix Lock in the Netherlands as a case study, the paper demonstrates the effectiveness of 2D sonar

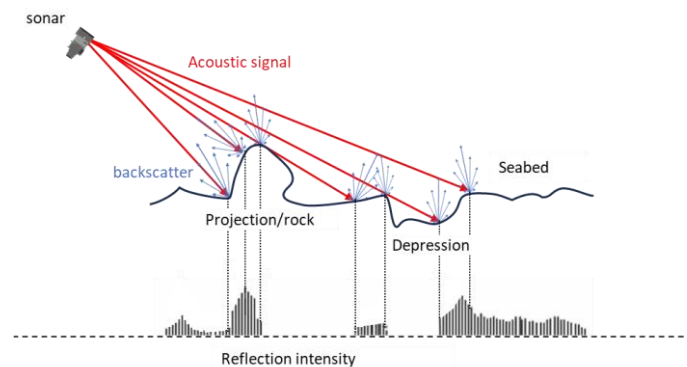
Figure 2. Reflection intensity of acoustic signals

reflectivity, such as rocks, that (ii) are normal to the sonar transducer (hot/light-coloured pixels). These surfaces may include the uphill side of projections or depressions in the bed. On the other hand, the location of surfaces with low or no reflectivity is also known in the sonar images (cool/dark-coloured pixels). For example, surfaces that are parallel with the sonar transducer, silt or mud-covered areas, areas overshadowed by rocks, or the downhill side of depressions and projections. Figure 2 schematically demonstrates reflection intensities against surfaces of the seabed in different directions such as the uphill/downhill facing of projections/depressions.

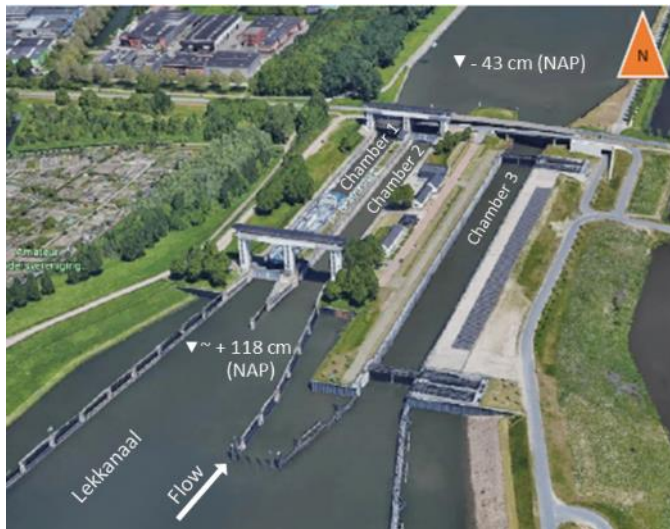
Figure 3. Aerial photo of The Beatrix lock [22]

The Princess Beatrix Lock is the largest monumental inland navigation complex in the Netherlands. The lock complex, with three chambers, is located within the Lekkanaal, connecting the Lek River and the Amsterdam-Rhine Canal. This connection is the main and shortest freight corridor and inland waterway between the North of the Netherlands/Amsterdam and Rotterdam/Antwerp. Around 50,000 vessels pass through the lock every year [21]. The Beatrix lock is positioned in the north-south direction, the water flow is northwards. Filling and emptying the lock system is performed via the gates. That means water is brought into or leaves lock chambers through openings in gates, instead of bypassing culverts or stilling chambers. The hydraulic head differences between the two sides of the lock can exceed two meters. Two of the chambers; the twin chambers, with a length of 225 m and a width of 18 m were built in 1938. These chambers can host ships with a maximum draft of 3.5 m. However, the third chamber, built in 2019, is designed to accommodate vessels of CEMT class Vb

with a draft of 4 m. The length of the third chamber is 276 m and its width is 25 m. Figure 3 shows an annotated aerial view of the Beatrix lock complex.

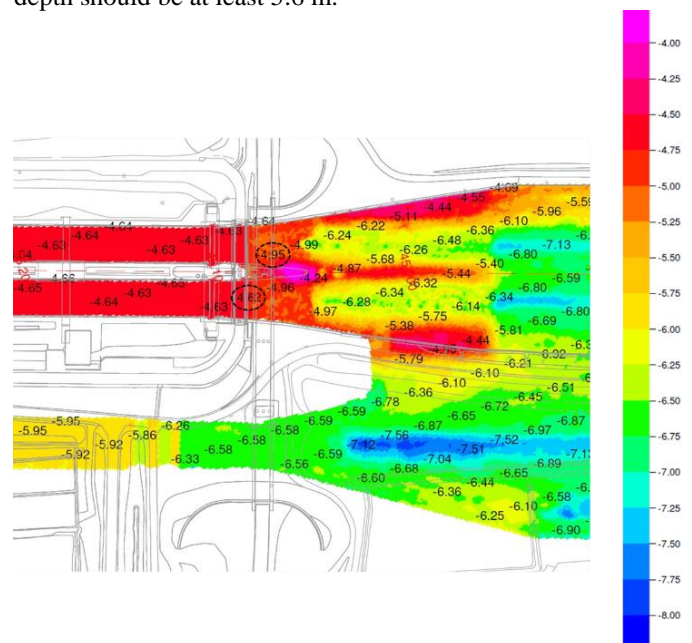
Figure 4. The bathymetry map of the north side of the Beatrix lock (downstream)

The level of the canal bed is extracted from a bathymetry map of the lock and surrounding canal. The bathymetry is conducted by Martens en Van Oord in the year 2021. Figure 4 shows a segment of the bathymetry map of the chambers and the approach at the downstream side of the lock. Bed levels at the twin chambers and approach are estimated at -4.62 m and -4.95 m respectively (these numbers are circled in the figure). Therefore, the water depth of the old chamber during the passage of class VIa ships is on an average between 4.24 m and 4.56 m for the chamber and approach of the lock respectively. However, according to the guidelines, in this case, the water depth should be at least 5.6 m.

The point cloud data in Figure 4 from the north side of chamber 1 indicates degradation of the protection layer at its intersection with the natural bed, revealing the progress of the

scour hole. While the protection layer on the south side of this chamber shows signs of degradation, the intensity or depth of degradation is not as high as observed on the north side. This difference could be attributed to the lower water depth on the downstream (north side) resulting in more pronounced effects of the ship's propeller wash. The bed protection of the north side of chamber 2 and the south side of chamber 3 have not experienced any significant degradation. However, on the south side of chamber 3, a scour hole has formed at the natural bed of the canal, which could be an initial indication of degradation in the protection layer.

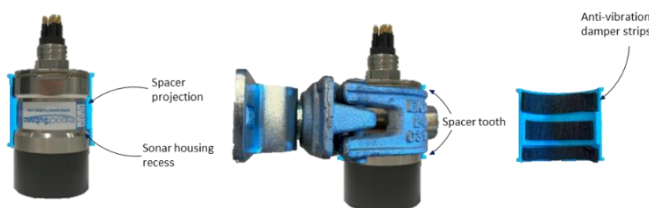
Figure 7. Detailed parts of the spacer

The thickness of the spacer was considered to be 1.5 mm so that, when placed around the sonar, the total diameter of the sonar and the spacer is 50 mm, fitting the size of the clamp. To minimize the risk of the sonar slipping off the mount under high-pressure currents caused by ship propellers, the spacer was designed to provide a firm grip between the sonar and the clamp. The grip between the sonar and the clamp is facilitated by a projection in the spacer that fits into a recess in the sonar housing. Additionally, two teeth were added to the outer side of the spacer to ensure the grip between the spacer and the clamp. Figure 7 shows the detailed design of the spacer. To dampen vibrations between the sonar and the spacer, anti-vibration damper strips were affixed to the spacer. Shows the printed spacer placed between the sonar and the clamp. To prevent self-loosening of the clamp nut and ensure that the sonar remains securely in its place, a spring washer with a double nut configuration is being considered for the clamp
