Ansicht des Lehrgerüsts

Details der Verspannung

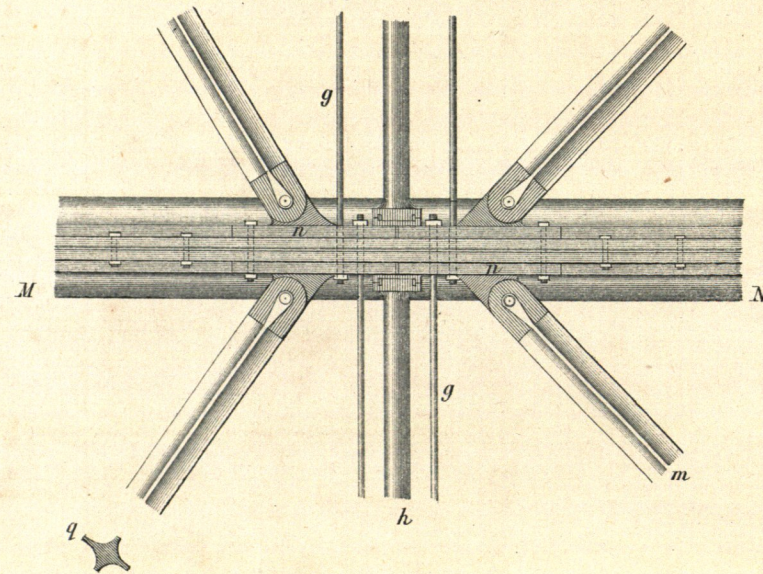
Fig. 32. Verspannung der mittleren Rippen.

Zu Fig. 31 u. 32. 0 5 1 2 Meter.

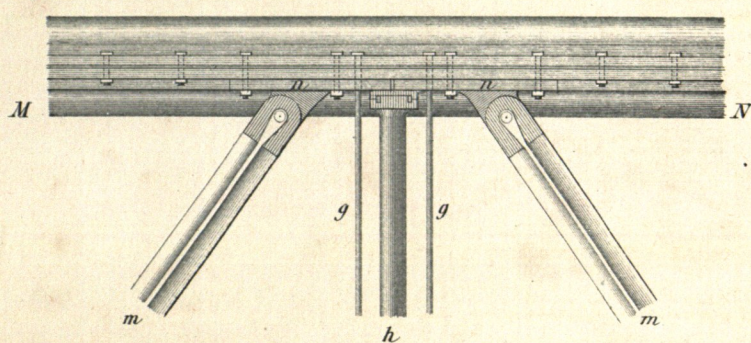
Fig. 31. Verspannung der äusseren mit den mittleren Rippen.

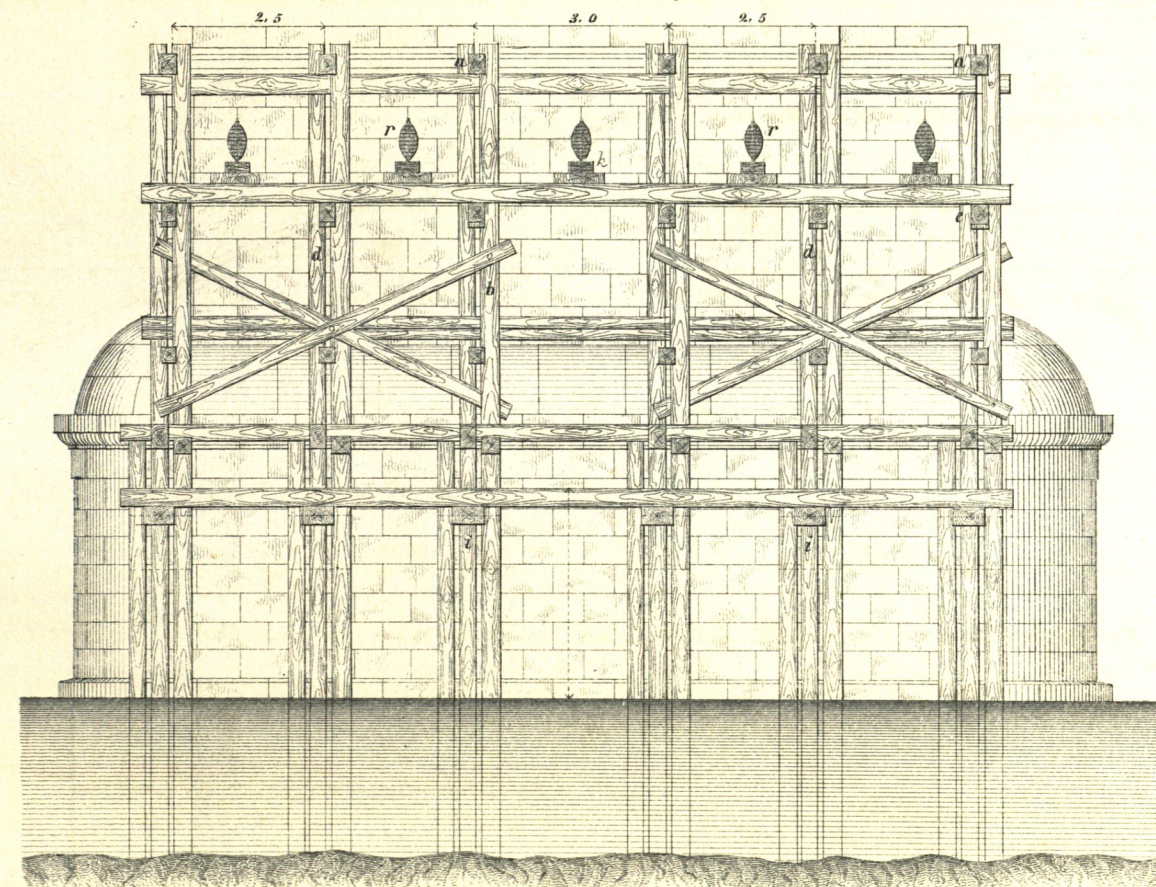
Fig. 40. Querschnitt in der Mitte des Lehrgerüsts.

Zu Fig. 39 u. 40. 0 1 2 3 4 5 6 7 8 9 10 11 12 13 14 15 16 17 Meter.
