Ansicht des Lehrgerüsts

Details der Verspannung

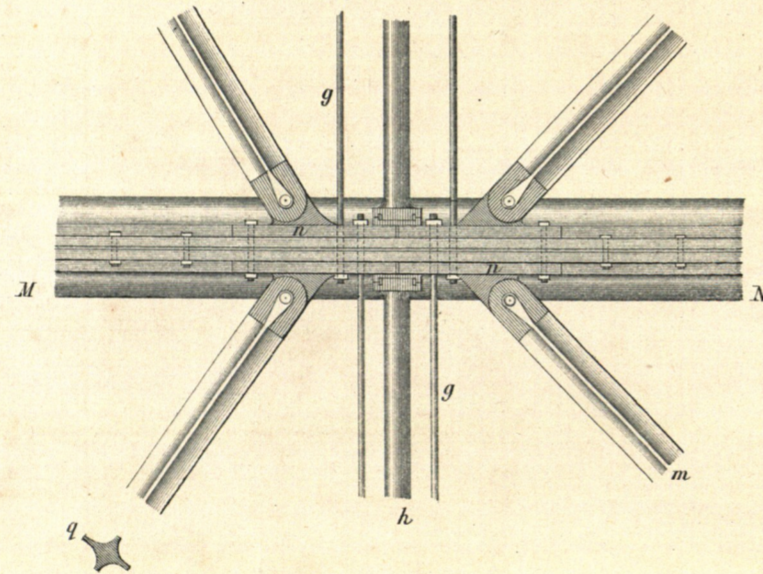
Fig. 32. Verspannung der mittleren Rippen.

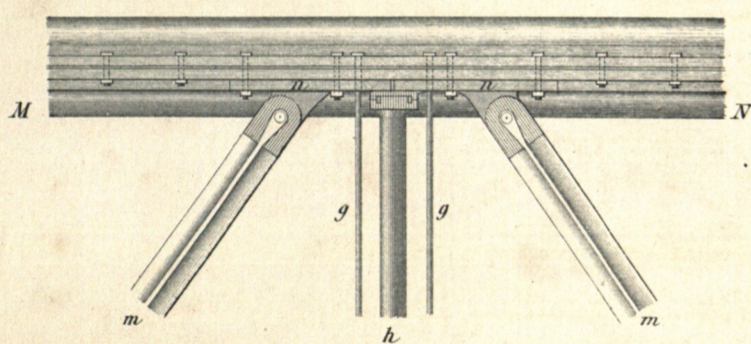
Fig. 31. Verspannung der äusseren mit den mittleren Rippen.

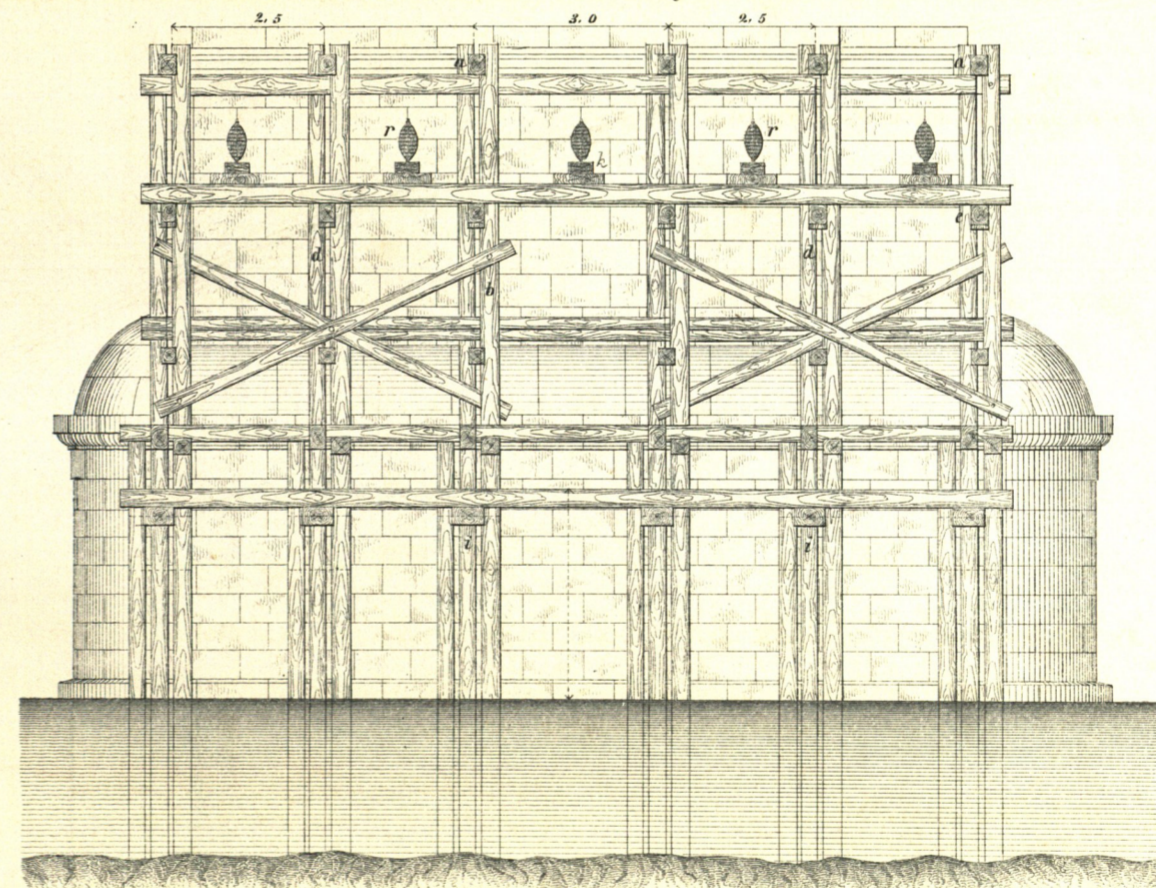
Fig. 40. Querschnitt in der Mitte des Lehrgerüsts.
